**FIRE HALL #1
125 IDYLWYLD DRIVE SOUTH
SASKATOON, SASKATCHEWAN**

**ASBESTOS SURVEY REPORT
JULY 2016**

**Prepared for: Hazel Fernandez – City of Saskatoon
Prepared by: Bersch & Associates Ltd.
Project No. B67.16**

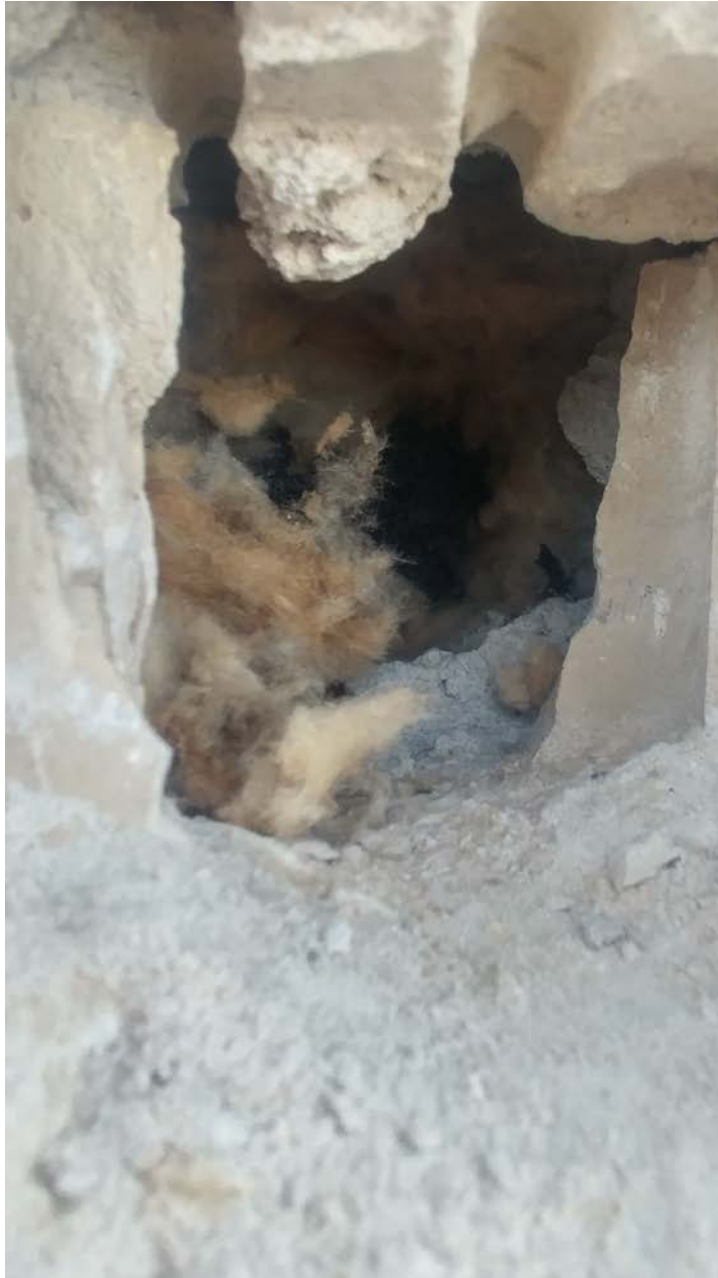
Photo 1- Wall Cavity on Second Floor. (fiberglass insulation)

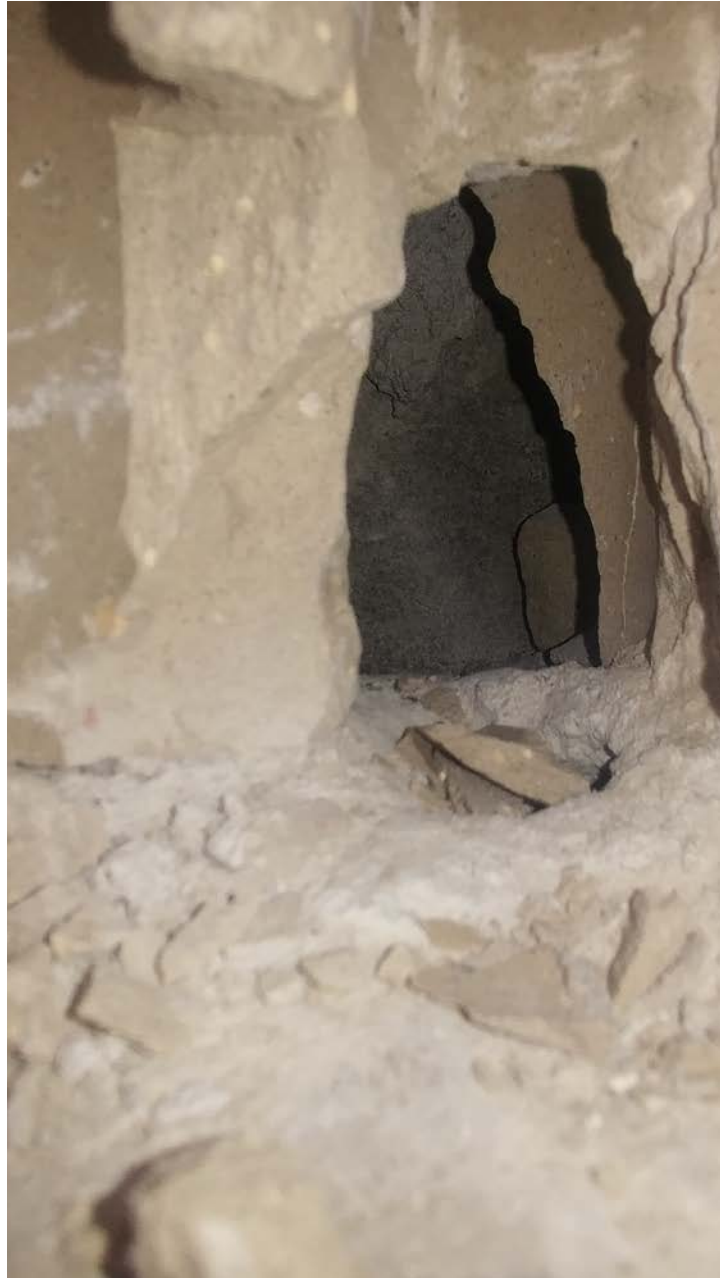
Photo 2- Wall Cavity in Lower Section

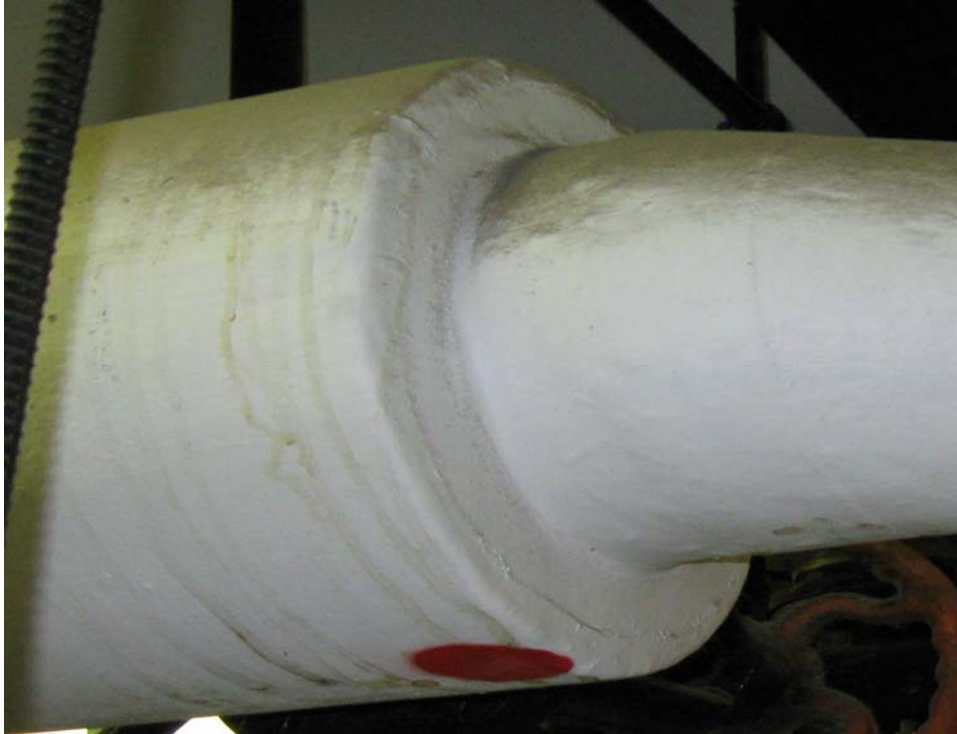
Photo #1

Asbestos Mud Compound on mechanical pipeline end cap

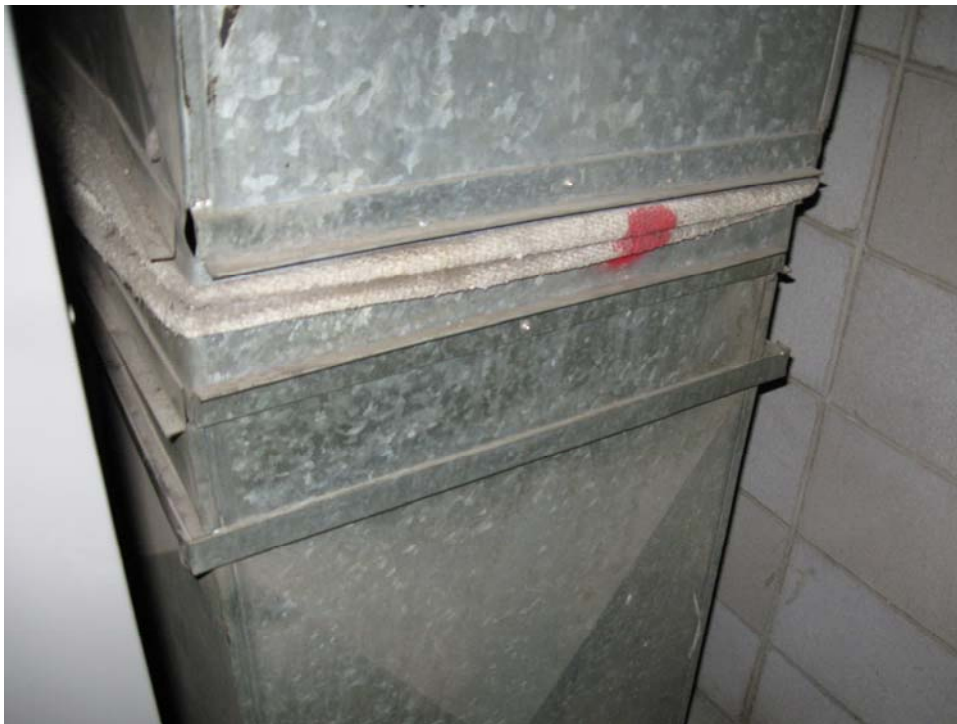
Photo #2

Asbestos Duct Work Woven Expansion Gasket

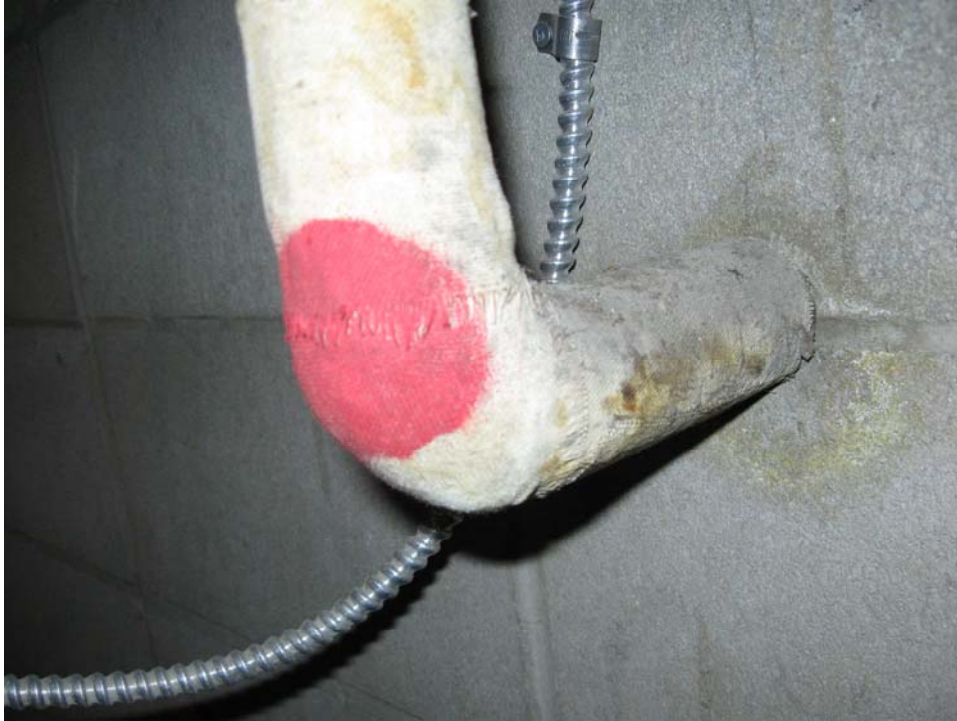
Photo #5

Asbestos Pipeline Fitting (elbow)

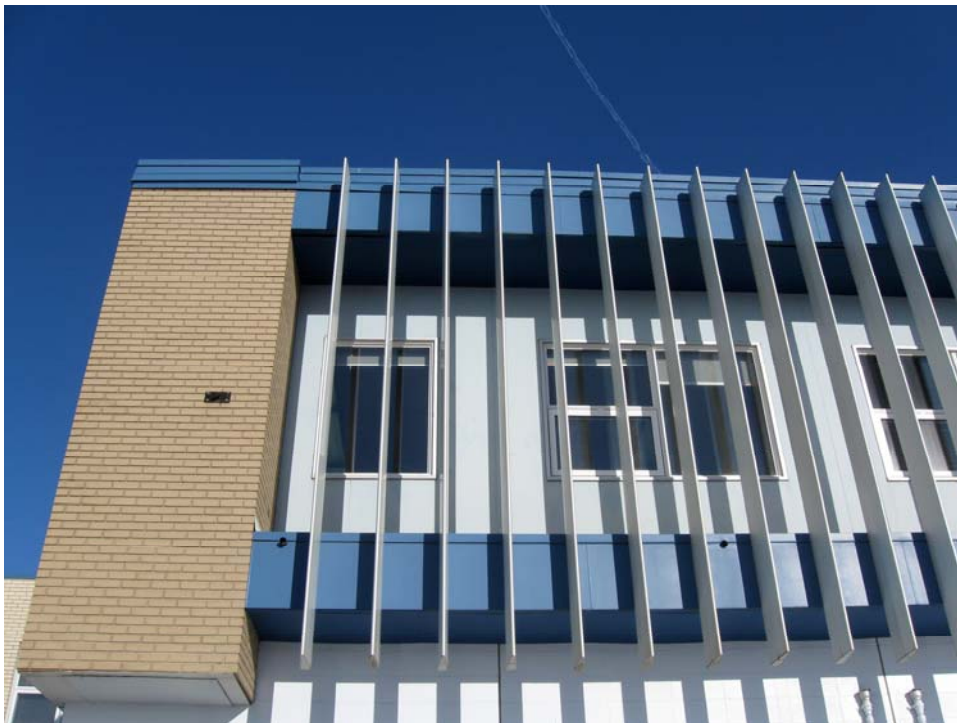
Photo #6

Asbestos Board on wall surface surrounding windows, on the soffit and on the fascia

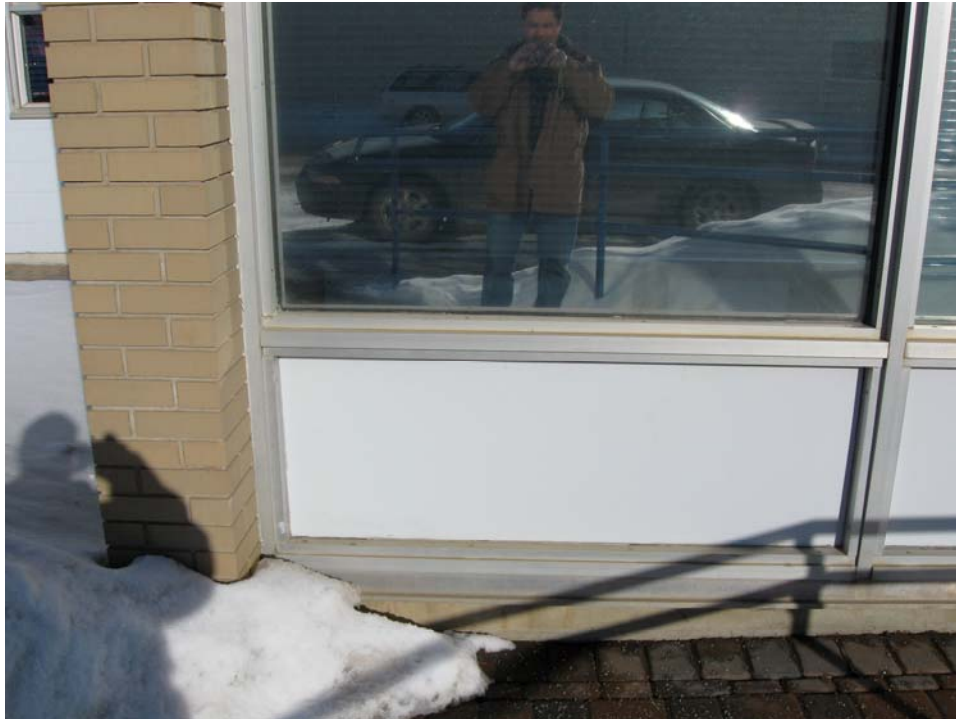
Photo #7

Asbestos Board below main entry windows

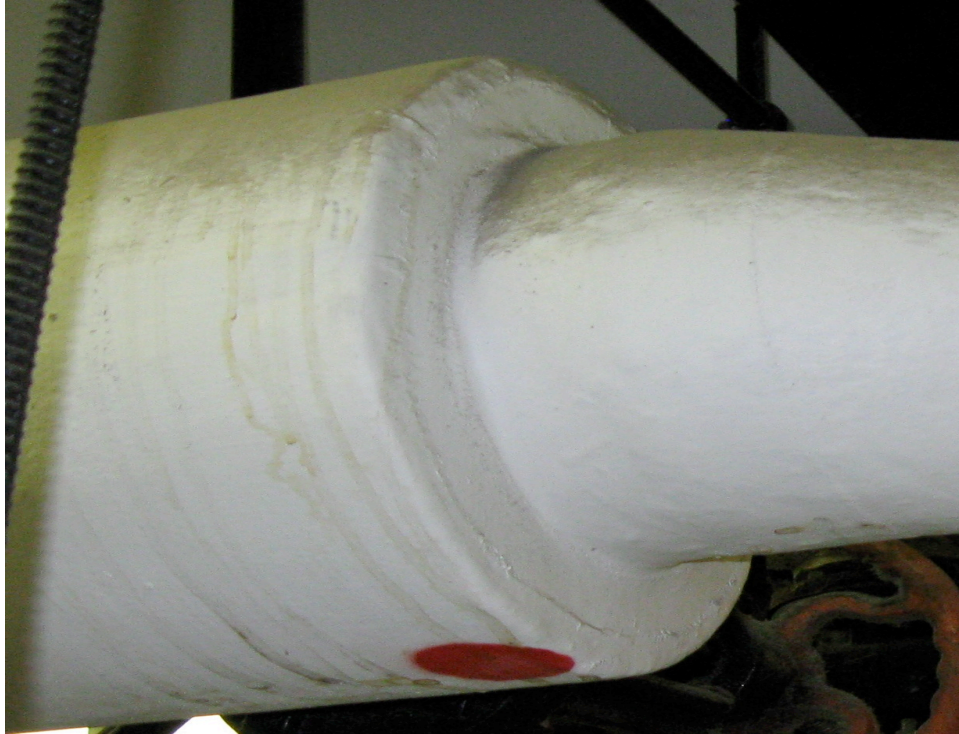
Photo #1

Asbestos Mud Compound on mechanical pipeline end cap

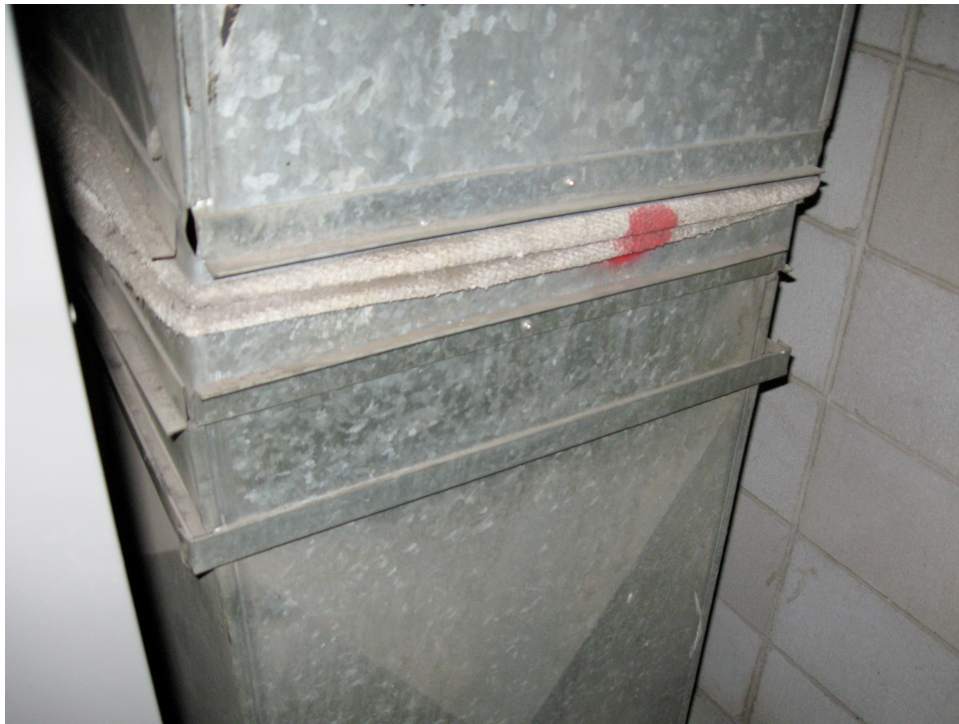
Photo #2

Asbestos Duct Work Woven Expansion Gasket

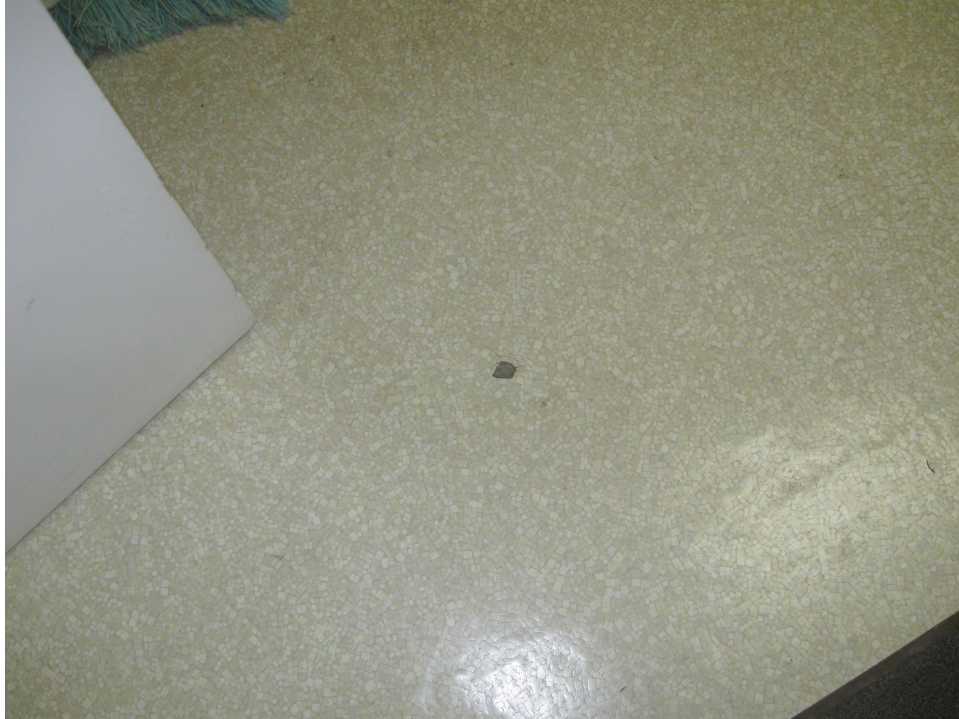
Photo #3

1. Asbestos containing sheet flooring covers the floor of the entire room. The flooring is in good to moderate condition with the recommendation of management of the floor covering material. See photograph #3 in *Appendix III*.

PRIORITY: **THREE**
CONDITION: **MODERATE/ GOOD**
POTENTIAL FOR DISTURBANCE: **LOW**
ACTION: **MANAGE**

Asbestos Sheet Floor Covering

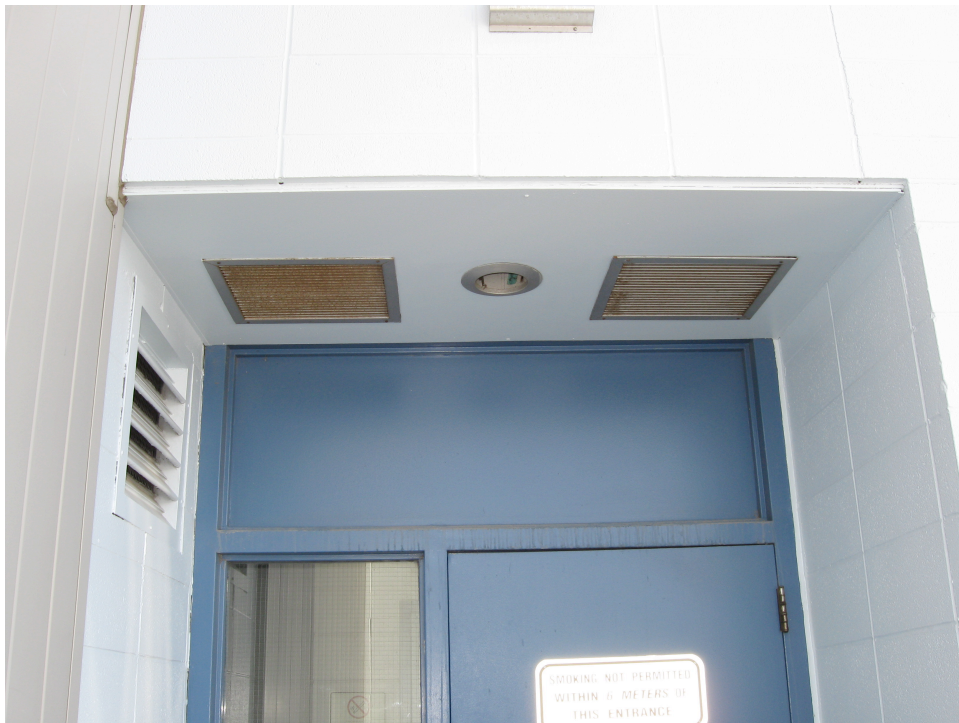
Photo #4

2. Transite board containing asbestos is present above the doorways entering into rooms B05, B06, B07, Boiler Room and the Stairwell double doors. The asbestos board is in good condition and the management of this material is recommended. The board has not been identified with a label but is identified on the floor plans in *Appendix II*. See photograph #4 in *Appendix III*.

PRIORITY: **FOUR**
CONDITION: **LOW**
POTENTIAL FOR DISTURBANCE: **LOW**
ACTION: **MANAGE**

Asbestos Board above doorways

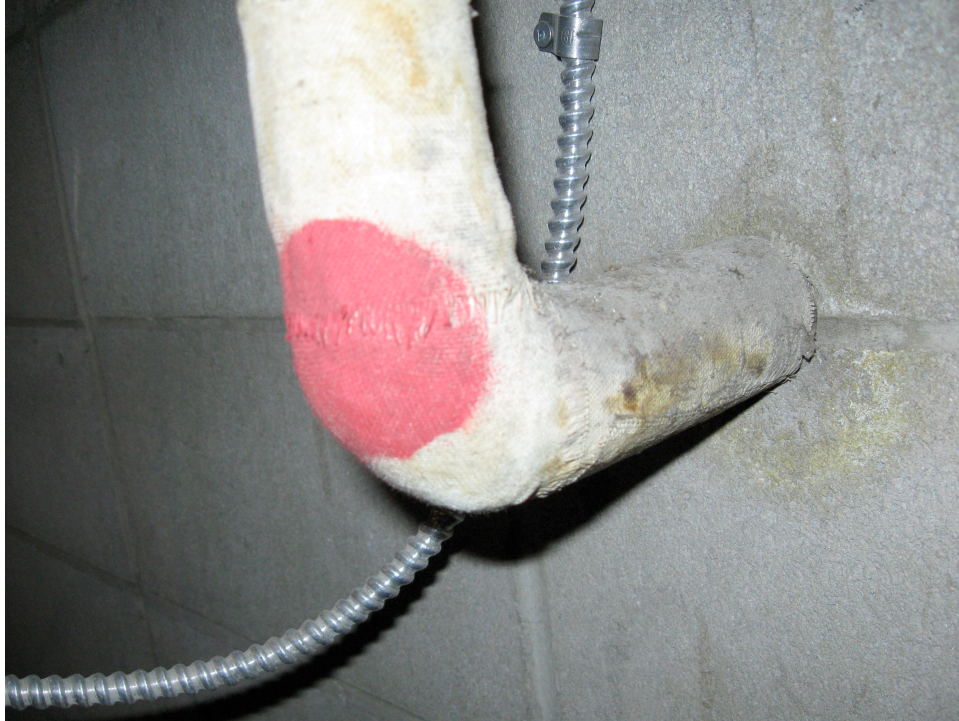
Photo #5

Asbestos Pipeline Fitting (elbow)

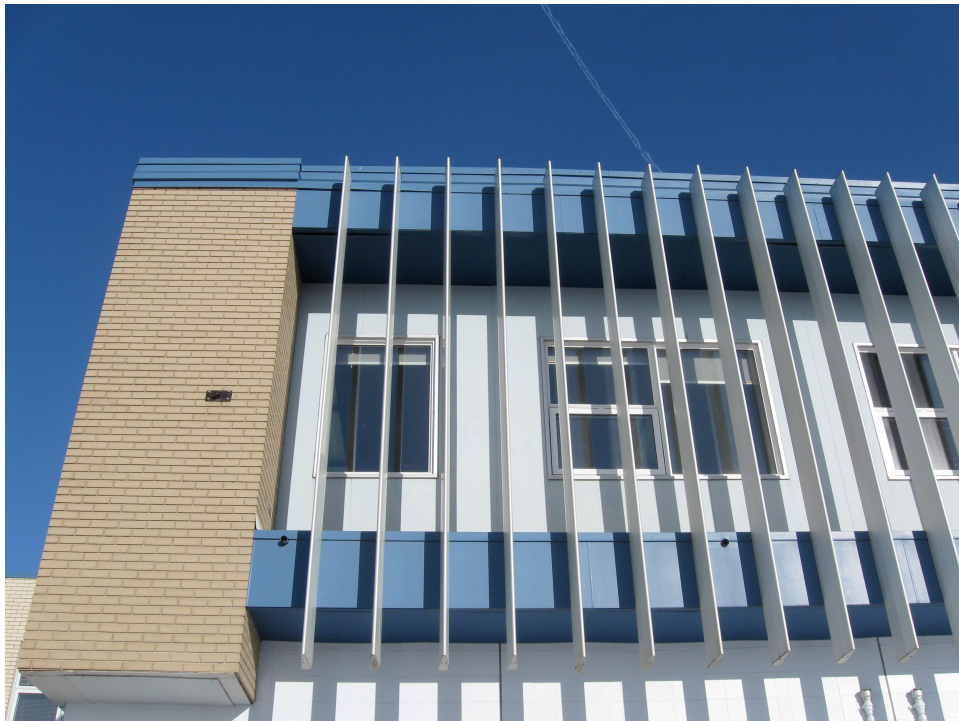
Photo #6

Asbestos Board on wall surface surrounding windows, on the soffit and on the fascia

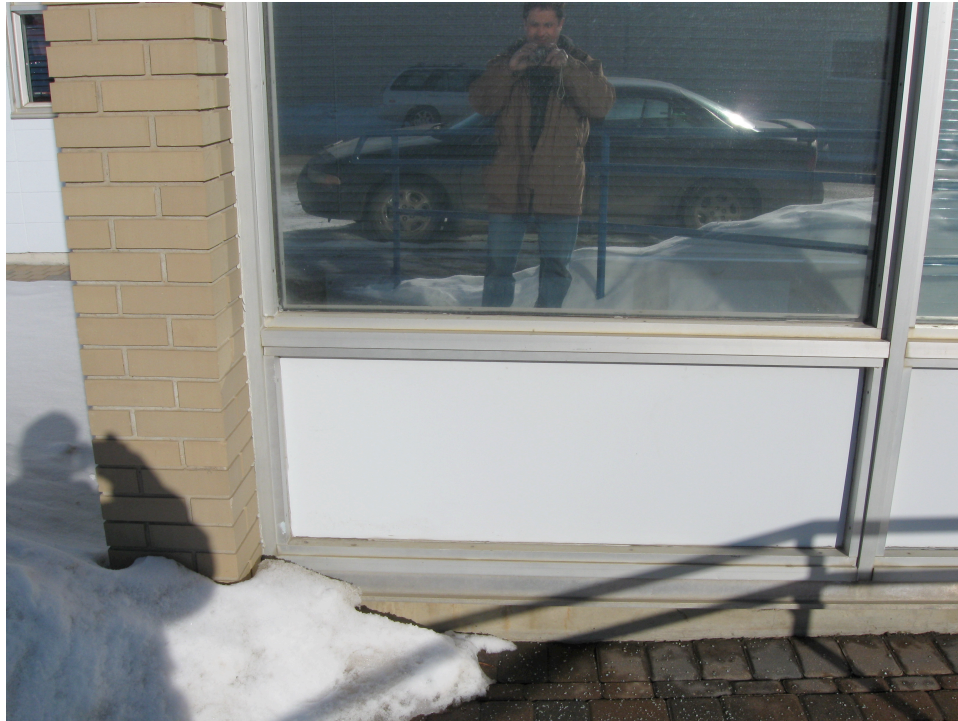
Photo #7

Asbestos Board below main entry windows
