**Fire Hall #5
Asbestos Survey Report**

February 2014

Prepared By: Bersch & Associates Ltd.
Project No. : B67SRE06

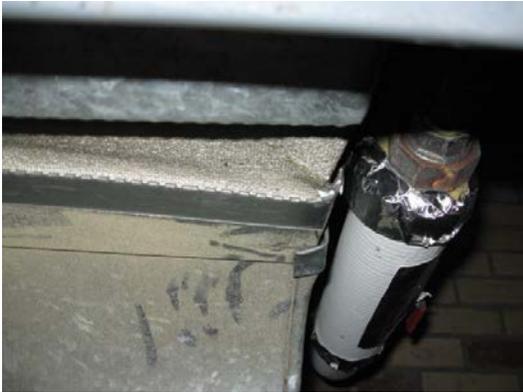
#5) Duct Expansion Gasket

- **Duct Expansion Gasket** is located within the ceiling space of the 106 vestibule.
- *Note: An inaccessible pipeline fitting was found in the northeast corner of room 101A behind the lockers. It is suspect that this fitting is ACM and should be treated as until testing can prove otherwise. Consider all pipeline fitting mud compound concealed in inaccessible areas to be ACM.*

NO.	DATE	SAMPLE INFORMATION	ASBESTOS	%	ANALYST
1	6-May-13	108 - 2`by 4` ceiling tile, textured with pin holes	None detected		WB
2	6-May-13	108 - Lineal Pipe insulation above ceiling tile	None detected		WB
3	6-May-13	108 - Sheet flooring, multi tone blue and green spec	None detected		WB
4	6-May-13	107 - Bulletin board on the east wall	None detected		WB
5	6-May-13	106 - Duct expansion gasket above ceiling	Chrysotile	80	WB
