Pre- Renovation Assessment

File Number: B67PRH29H- Fire Hall Dryer Installation

Project: Fire Halls #3, #6, #7, #8, #9 – Asbestos Inspection for Upcoming Dryer Installations

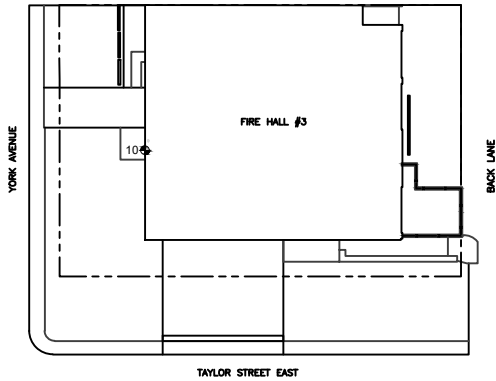
1 FIRE HALL #3 SITE PLAN
SCALE 1:500

The dryer in Fire Hall #3 is to be installed on the east wall immediately adjacent the overhead door. This wall is composed of two layers of brick masonry with one cavity between the two layers. One (1) hole (location 10) was cored through the interior layer of brick into the wall cavity. The cavity was found to be empty of any insulation or suspect material and no concerns were noted.

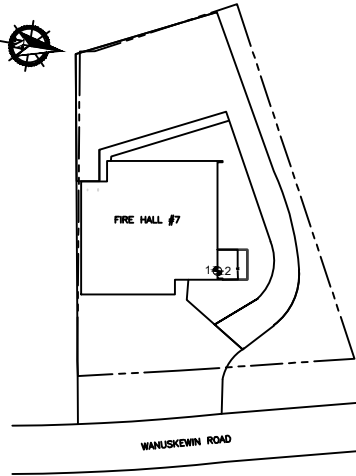
2 FIRE HALL #7 SITE PLAN
SCALE 1:1000

The dryer in Fire Hall #7 is to be installed near the exit in the northeast corner of the building. The wall, through which the dryer vent is to run, is composed of a cinderblock interior and brick exterior with a cavity between the two layers. Two (2) walls were investigated for the presence of insulation. One (1) hole was cored (location 7) into the cinderblock cavity, where the dryer vent is to be installed. The cavity was found to be empty. A second hole was cored opposite the first through the exterior brick wall (location 2). The cavity between the brick and cinderblock layers was found to be empty. No concerns were noted during the investigation of Fire Hall #7.

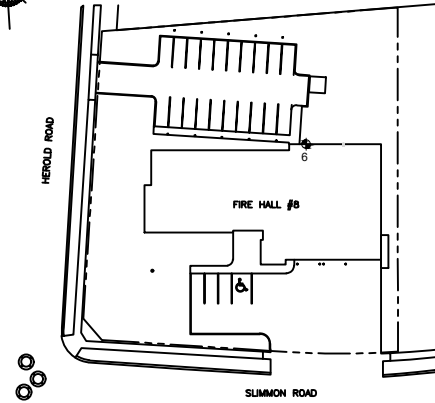
3 FIRE HALL #8 SITE PLAN
SCALE 1:1000

The dryer in Fire Hall #8 is to be installed near the north wall of the building adjacent the hose room. The dryer is to be vented out the north wall immediately adjacent the installation area. This wall is composed of cinderblock interior and silver tin exterior siding. The interior cinderblock wall was cored (location 6) and found to be empty. The exterior siding was not able to be removed without destructive methods. Based on the age of the building Bersch Consulting Ltd. does not have any concerns regarding the installation of the dryer within Fire Hall #8.

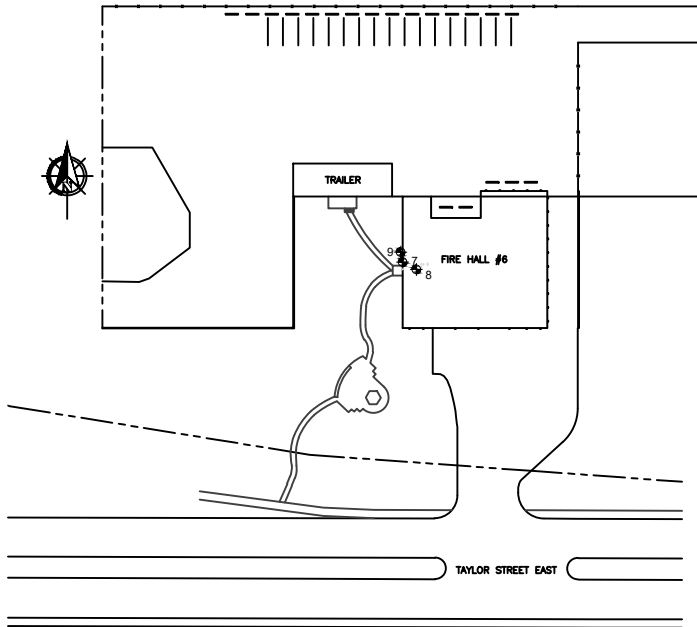
4 FIRE HALL #6 SITE PLAN
SCALE 1:1000

The dryer in Fire Hall #6 is to be installed within the west corridor. The dryer duct will run through the wall into the exercise room where it will be run through the exterior cinderblock wall. Three (3) areas of wall were investigated for the presence of insulation. One (1) hole (location 7) was drilled through the west exterior wall of the exercise room as well as through the south cinderblock wall (location 8) adjacent the corridor. The exterior wall, where the dryer vent is to be ducted, is composed of cinderblock covered in red tin fascia. The tin fascia was removed, and the cavity was found to be empty. The cinderblock within the cavity was cored (location 9) and found to be empty. No concerns were noted during the investigation of Fire Hall #6.

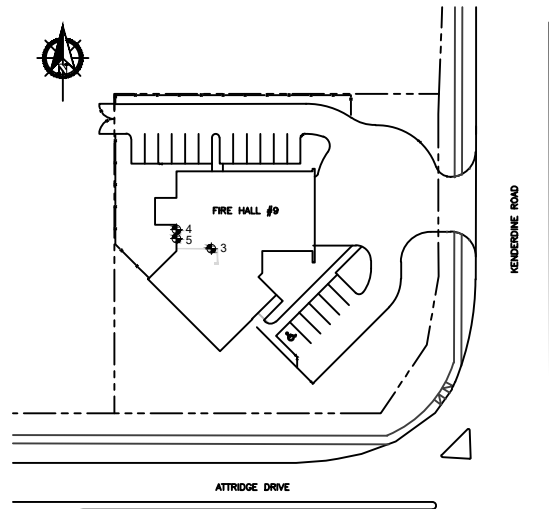
5 FIRE HALL #9 SITE PLAN
SCALE 1:1000

The dryer in Fire Hall #9 is to be installed opposite the SCBA mask washing station. The dryer will be vented through the north wall of this room proceeding along the wall through the east exterior wall. The north cinderblock wall adjacent the mask washing station was cored (location 3) and found to be empty. The east exterior wall is composed of cinderblock interior wall and brick exterior with a cavity in between. The east wall was cored from both the interior and exterior (locations 4 and 5). Both the cinderblock cavity and cavity between the cinderblock and brick was found to be empty. There are no concerns regarding the dryer installation in Fire Hall #9.
