**CITY OF SASKATOON – FIRE MAINTENANCE BUILDING
ASBESTOS SURVEY REPORT**

MAY 2013

Prepared By: Bersch & Associates Ltd.
Project No. : B67SRE01FM

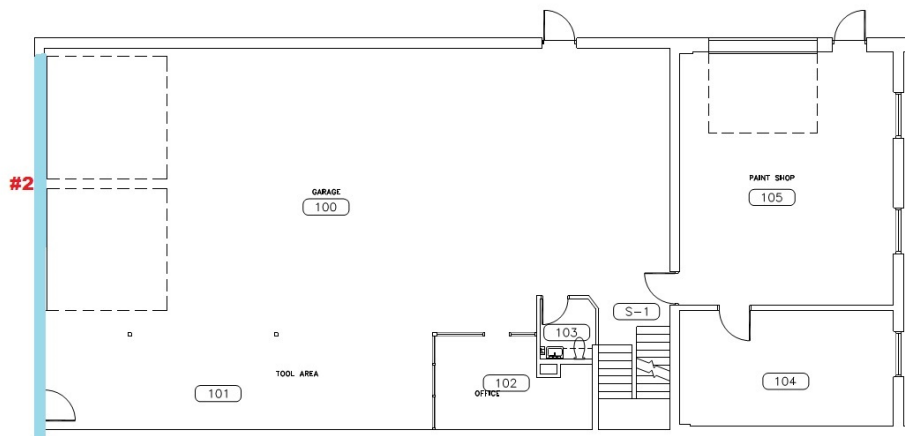
SHEET NAME: Main Floor Base Plan

- Sample # Location
Transite Board

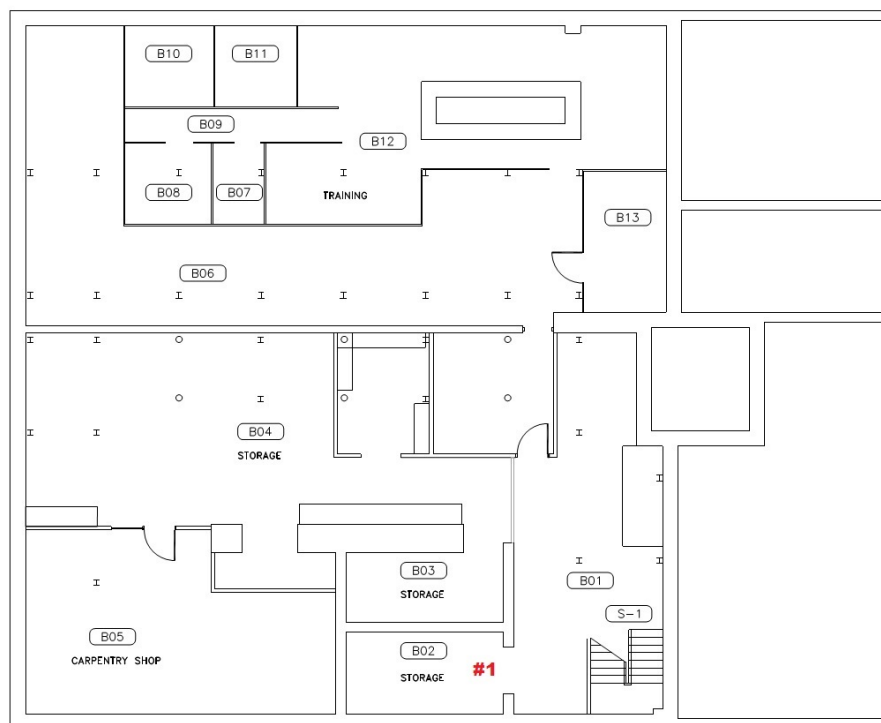
Lower Floor
Base Plan

#_ - Sample # Location

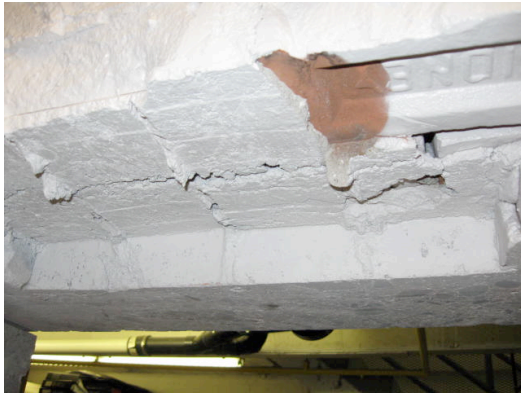
#1) Brick Mortar

NO.	DATE	SAMPLE INFORMATION	ASBESTOS	%	ANALYST
B1	1-May-13	Room B02 - Brick mortar above the doorway cutout to the west of the stairwell	None detected		WB
B2	1-May-13	Building Exterior - Black transite board on the exterior west wall surrounding the overhead doors	Chrysotile	30	WB

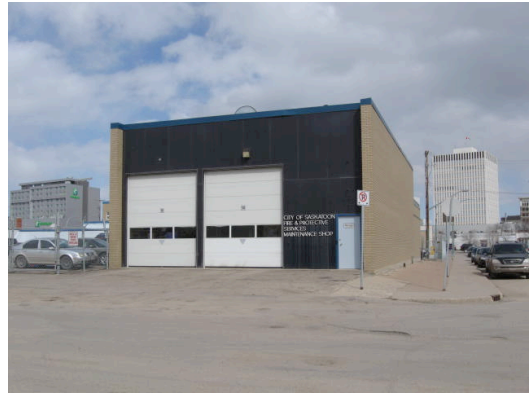
#2) Transite Board

Transite asbestos board was identified as containing asbestos. This material was observed to be in good condition with a low potential for disturbance. The material is the black board surrounding the overhead doors on the exterior wall surface. The material may be managed.

PRIORITY:	THREE
CONDITION:	GOOD
POTENTIAL FOR DISTURBANCE:	LOW
ACTION:	MANAGE

For the specifics of this report Management of the asbestos containing materials is the recommended planned activity. In the event of renovations or maintenance to areas containing asbestos materials, written procedures must be developed to conduct the activity or prior removal if the situation warrants.
