SUBJECT: Fire Hall #4 - Asbestos Registry Report

PROJECT NO. B67.13**CLIENT: City of Saskatoon****Infrastructure Services - Facilities Branch****Contact: Brent Anderson****Location: Fire Hall #4 - 2106 Faithful Avenue, Saskatoon, SK.**

BULK SAMPLE ANALYSIS REPORT

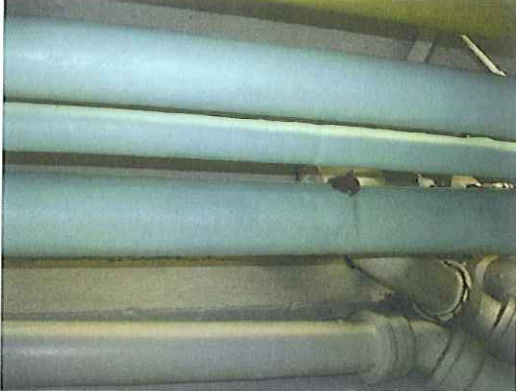
#1) Pipeline Insulation

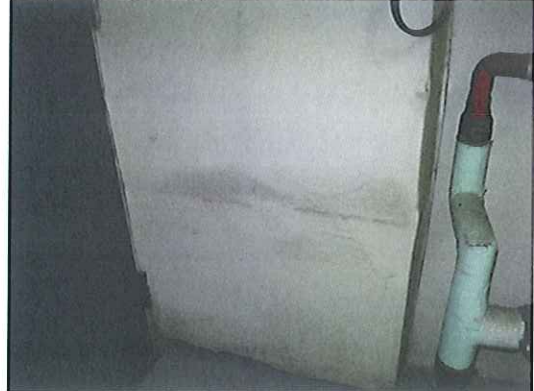
#2) Ducting Insulation

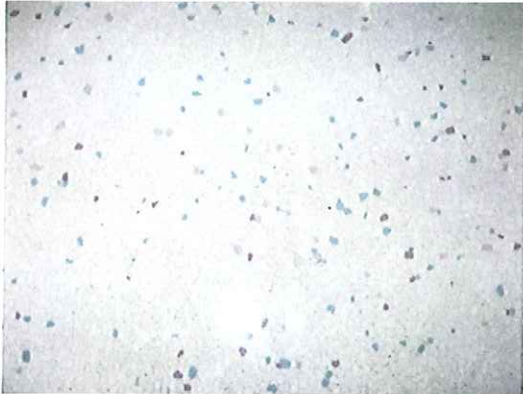
#3) Sheet Flooring

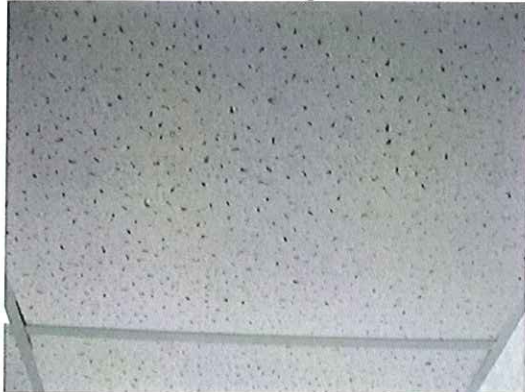
#5) 2' x 4' Ceiling Tile
