December 5, 2017

CITY OF SASKATOON

Asbestos-Containing Building Materials Assessment Report - Fire Station No. 2

Report Number: 1667963

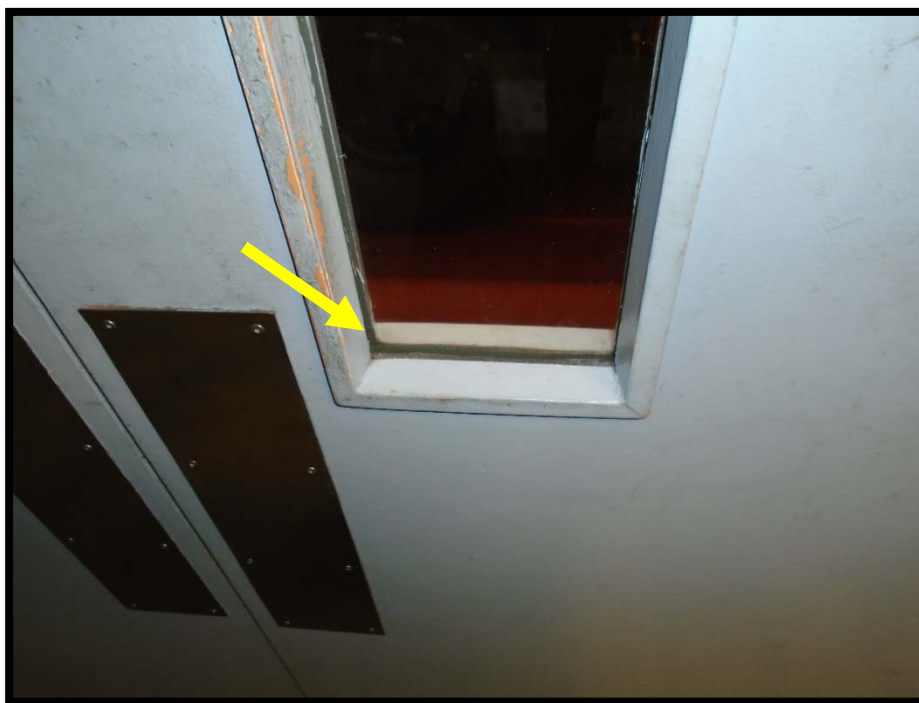
One (1) sample of grey window caulking was collected during the assessment. The sample collected was found to contain 10% Chrysotile asbestos. Asbestos-containing grey window caulking (see Photograph 1 in Appendix B) was observed in the following locations:

- Room 101 (approximately 60 linear ft); and
- Room 114 (approximately 15 linear ft).

Photograph 1: Asbestos-Containing Grey Window Caulking.

If scheduled for impact, asbestos-containing grey window caulking should be abated following low-risk abatement work procedures as outlined in the *Saskatchewan Asbestos Abatement Manual* (2017). Alternatively, as the caulking was observed in good condition, and with a priority rating of 5 (please see the room by room spreadsheet provided in Appendix C for a description of the priority ratings), the caulking can be managed in place if not scheduled for impact.

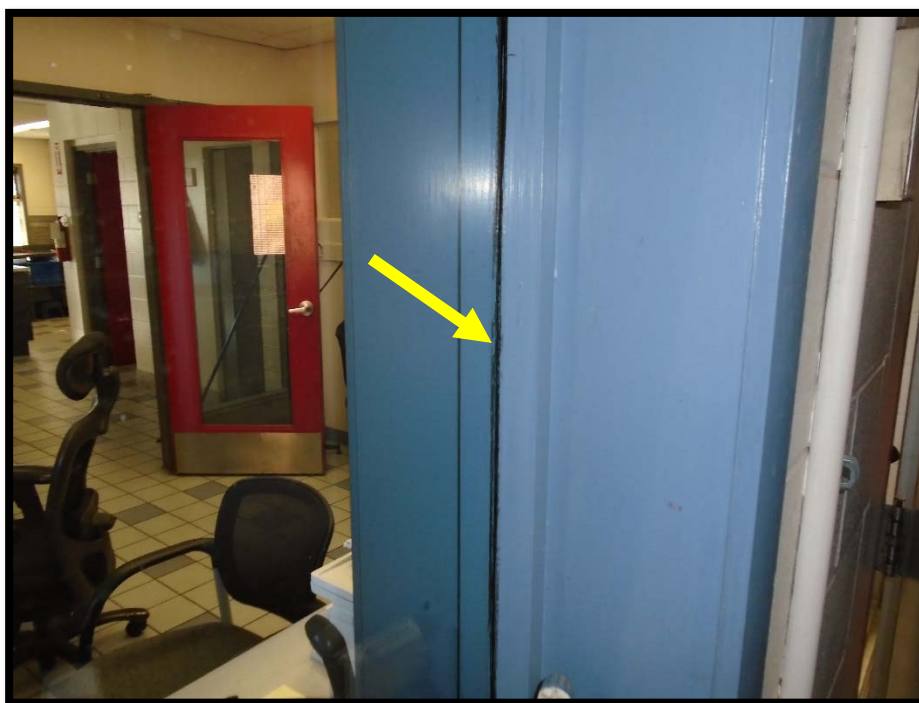
One (1) sample of black window caulking was collected during the assessment. The sample collected was found to contain 4.3% Chrysotile asbestos. Asbestos-containing black window caulking (see Photograph 2 in Appendix B) was observed in the following locations:

- Room 102 (approximately 15 linear ft); and
- Room 118 (approximately 15 linear ft).

Photograph 2: Asbestos-Containing Black Window Caulking.

If scheduled for impact, asbestos-containing black window caulking should be abated following low-risk abatement work procedures as outlined in the *Saskatchewan Asbestos Abatement Manual* (2017). Alternatively, as the caulking was observed in good condition, and with a priority rating of 5 (please see the room by room spreadsheet provided in Appendix C for a description of the priority ratings), the caulking can be managed in place if not scheduled for impact.
