SUBJECT: Fire Hall #6 - Asbestos Registry Report

FINAL
**Limited Asbestos
Building Materials
Assessment**

Fire Hall #6 Cable Drop Project
3309 Taylor Street East,
Saskatoon, Saskatchewan

April 4, 2017

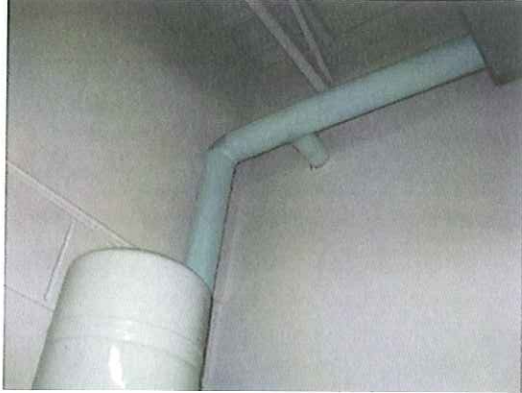
#1) Pipeline Fitting

NO.	DATE	SAMPLE INFORMATION	ASBESTOS	%	ANALYST
B1	6-May-13	114 - Pipeline fitting on small green line	None detected		WB
B2	6-May-13	121 - Pipeline fitting on small white line, overhead adjacent unit heater in the northeast corner	None detected		WB
B3	6-May-13	103 - Pipeline fitting above ceiling tile adjacent women's dorm entry	None detected		WB
B4	6-May-13	124 - Duct expansion gasket on ducting in upper deck	None detected		WB
B5	6-May-13	102 - Sheet flooring- tan, beige and blue stone pattern	None detected		WB
B6	6-May-13	112 - Sheet flooring- grey, white and black stone pattern	None detected		WB

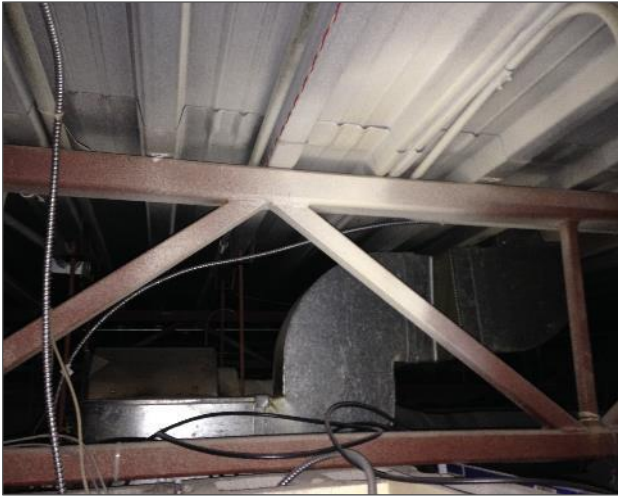
Ducts are not insulated.

Photo 1: Un-insulated metal duct, structural steel, and metal roof decking above acoustic ceiling tiles in Men's Washroom (Location 105)

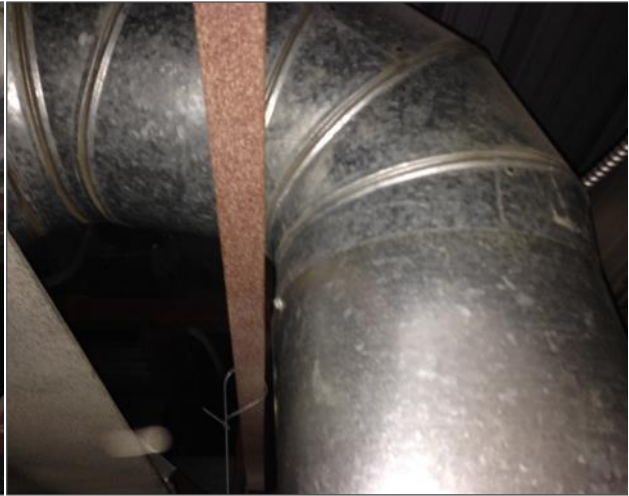
Photo 2: Un-insulated metal duct with no mastic above acoustic ceiling tiles in Men's Washroom (Location 105).

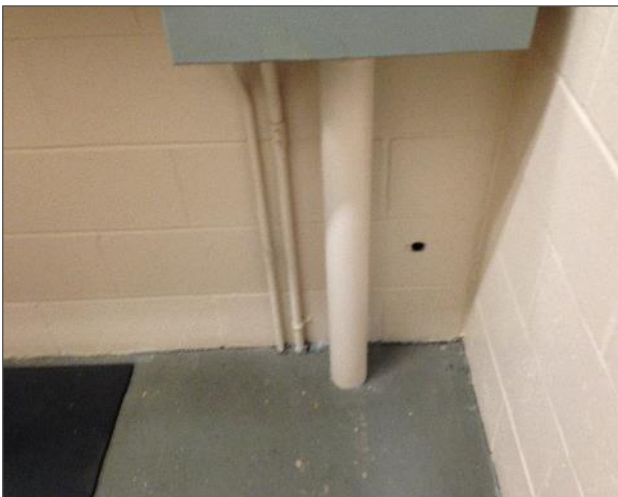
Destructive testing was conducted of masonry block walls. The masonry block wall, between the Study (Location 119) and the Compressor Room (Location 118), was penetrated in one location, loose fill vermiculite is not present. The location of destructive testing are indicated on the drawings in Appendix I.

Photo 3: Intrusive hole in concrete block wall that separates the Compressor Room (Location 118) and the Study Room (Location 119). No insulation was found.

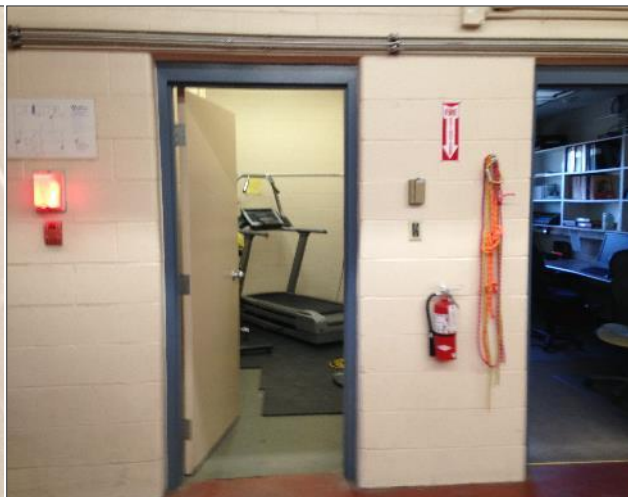
Photo 4: Compressor Room (Location 118) on left and the Study Room (Location 119) on the right.

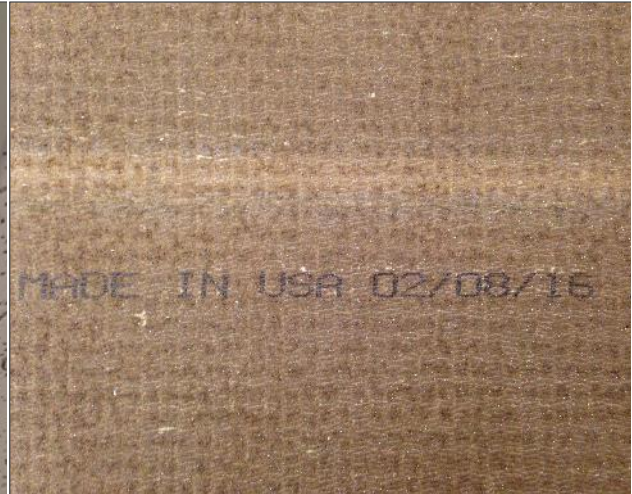
All ceiling tiles are presumed to be non-asbestos based on the date of manufacture determined from the date stamp applied to the top of the tiles or the age of the materials determined from the age of the building or the renovation. The tiles were manufactured after asbestos stopped being used in acoustic ceiling tiles.

Photo 6: Acoustic Ceiling Tiles, 24"x48" Pinhole and Fissure (Non-asbestos containing Date Stamp 02/08/16), Men's Washroom (Location 105)
