December 7, 2017

CITY OF SASKATOON

Asbestos-Containing Building Materials Assessment Report - Fire Station No. 7

Report Number: 1667963

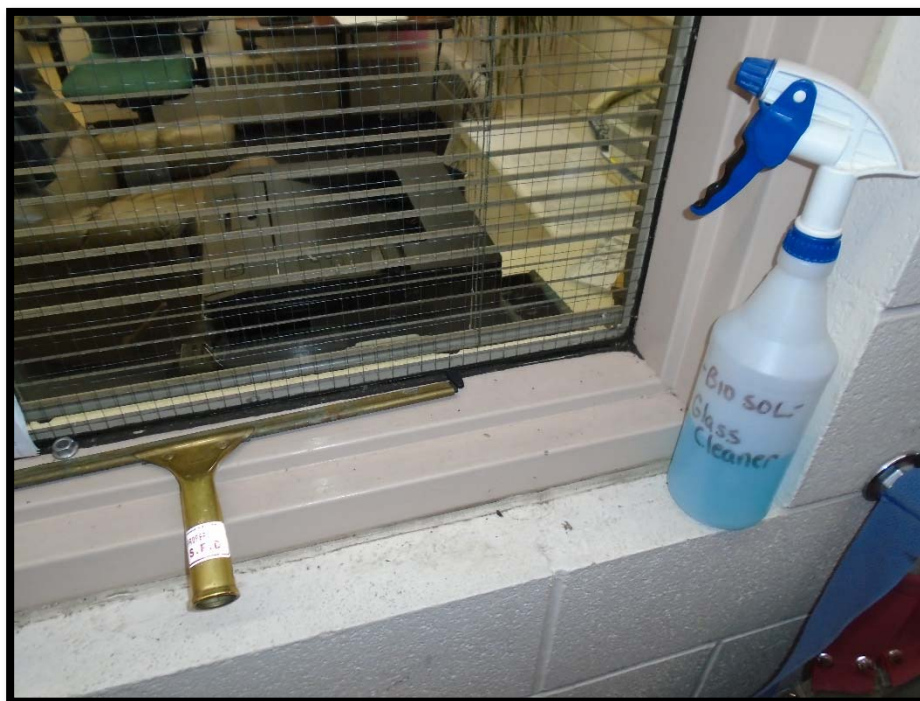
Two (2) samples of black window caulking were collected during the assessment. One of the samples collected was found to contain 3.8% Chrysotile asbestos. Asbestos-containing black window caulking (see Photograph 1 in Appendix B) was observed in the following location:

- Room 120 (approximately 10 linear feet).

Photograph 1: Asbestos-Containing Black Window Caulking.

If scheduled for impact, asbestos-containing black window caulking should be abated following low-risk abatement work procedures as outlined in the *Saskatchewan Asbestos Abatement Manual* (2017). Alternatively, as the black window caulking was observed in good condition, and with a priority rating of 5 (please see the room by room spreadsheet provided in Appendix C for a description of the priority ratings), it can be managed in place if not scheduled for impact.

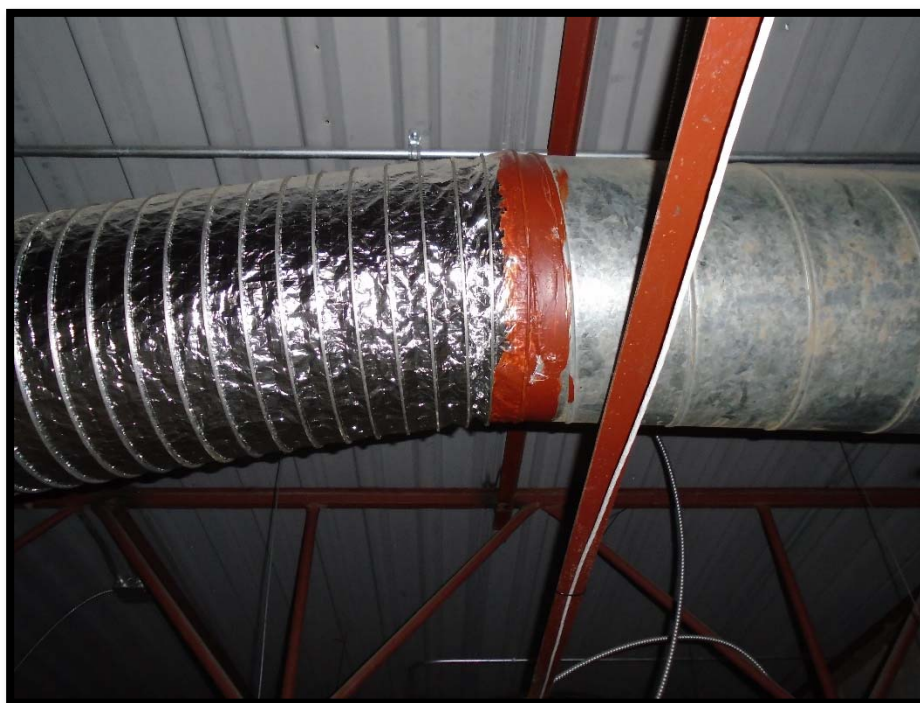
One (1) sample of red/brown duct mastic was collected during the assessment. The sample collected was found to contain 3.4% Chrysotile asbestos. Asbestos-containing red/brown duct mastic (see Photograph 2 in Appendix B) was observed in the following locations:

- Room 109 (approximately 15 linear feet);
- Room 110 (approximately 40 linear feet);
- Room 113 (approximately 5 linear feet);

- Room 114 (approximately 3 linear feet);
- Room 116 (approximately 5 linear feet);
- Room 117 (approximately 20 linear feet);
- Room 118 (approximately 5 linear feet);
- Room 119 (approximately 3 linear feet);
- Room 121 (approximately 3 linear feet);
- Room 122 (approximately 3 linear feet); and
- Room 123/124 (approximately 3 linear feet).

Photograph 2: Asbestos-Containing Red/Brown Duct Mastic.

If scheduled for impact, asbestos-containing red/brown duct mastic should be abated following low-risk abatement work procedures as outlined in the *Saskatchewan Asbestos Abatement Manual* (2017). Alternatively, as the red/brown duct mastic was observed in good condition, and with a priority rating of 5 (please see the room by room spreadsheet provided in Appendix C for a description of the priority ratings), it can be managed in place if not scheduled for impact.
