**City of Saskatoon
Staff Development Center
Asbestos Survey Report**

December 2015

FINAL
**Limited Asbestos
Building Materials
Assessment**

City of Saskatoon Staff
Development Centre, Training
Room Drop, 116 Avenue W
South, Saskatoon,
Saskatchewan

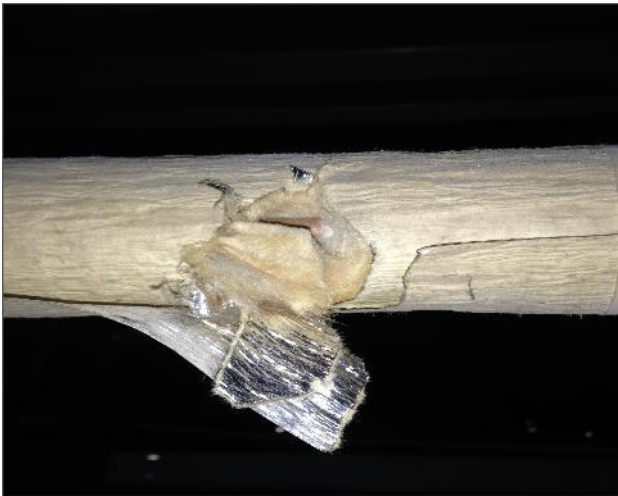
Pipes are insulated with fibreglass, or other non-asbestos insulation such as mineral fibre or elastomeric foam insulation.

Photo 1 - Non-Asbestos containing fiberglass piping insulation on piping above acoustic ceiling tiles in boardroom

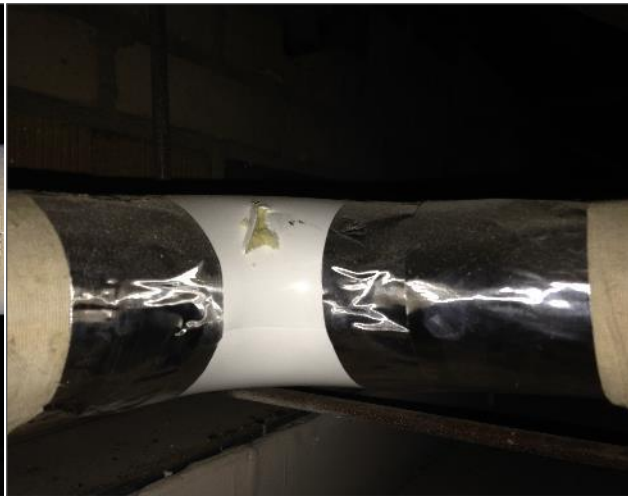
Photo 2 - Non-Asbestos containing fiberglass piping insulation on pipe elbows above acoustic ceiling tiles in boardroom.

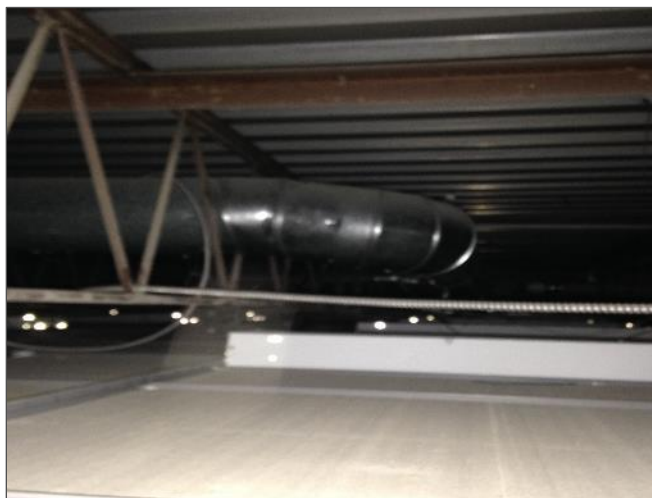
Ducts are not insulated.

Photo 3: Un-insulated metal duct, structural steel roof truss, and metal roof decking above acoustic ceiling tiles in training room.

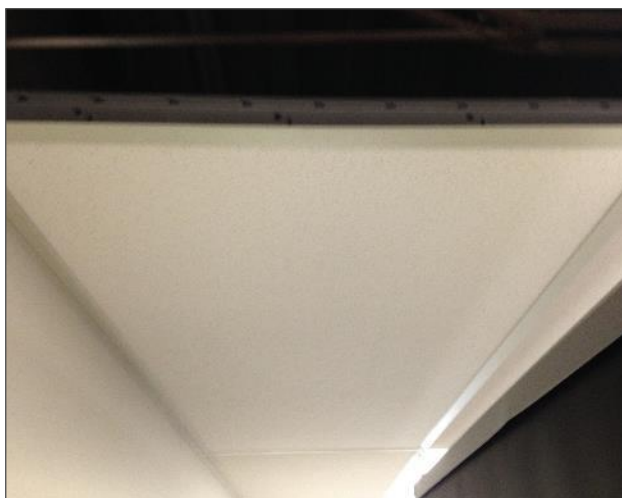
Size, Type, Pattern, Photo #	Locations (Quantity in Square Feet)	Sample Number or Date Code	Asbestos Type
24"x48", lay-in, fissure and pinhole, Photos #4 and #5	Training Room 900 ft ²	Date Stamp 06/05/92	Non-Asbestos Containing

All ceiling tiles are presumed to be non-asbestos based on the date of manufacture determined from the date stamp applied to the top of the tiles or the age of the materials determined from the age of the building or the renovation. The tiles were manufactured after asbestos stopped being used in acoustic ceiling tiles.

Photo 4: Acoustic Ceiling Tiles, 24"x48" Pinhole and Fissure, Date Stamp 06/05/92, Training Room

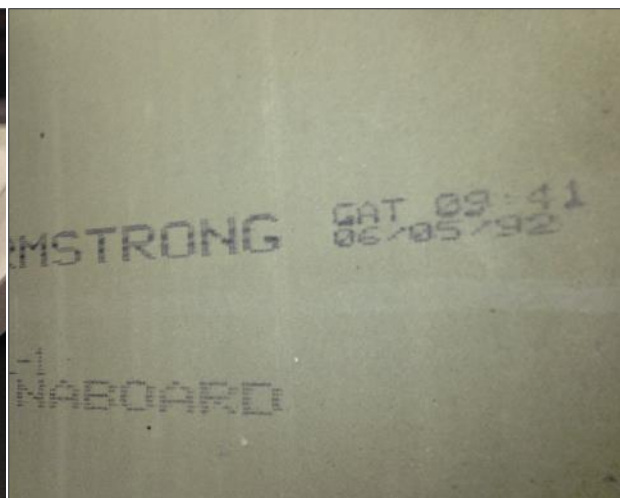
Photo 5: Acoustic Ceiling Tiles, 24"x48" Pinhole and Fissure, Date Stamp 06/05/92, Training Room

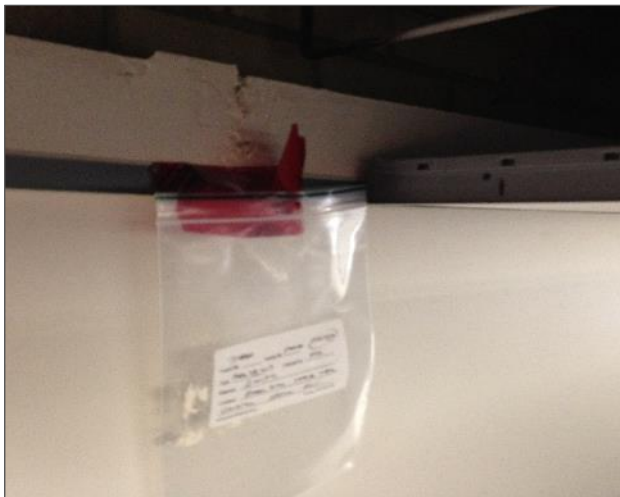
Drywall (gypsum board) and drywall joint compound is present as a wall finish in the Training Room. Based on the results of the testing (samples S0001a-c), the drywall joint compound in the Training Room does not contain asbestos.

Photo 6 - Drywall Joint Compound on walls (Sample S0001A-C) Boardroom

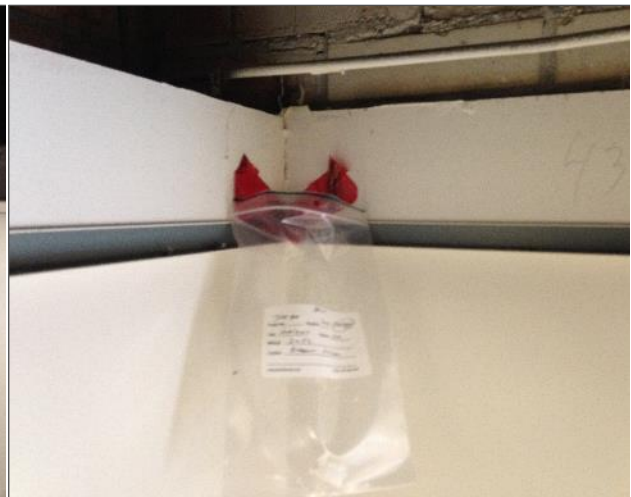
Photo 7 - Drywall Joint Compound on walls (Sample S0001A-C) Boardroom

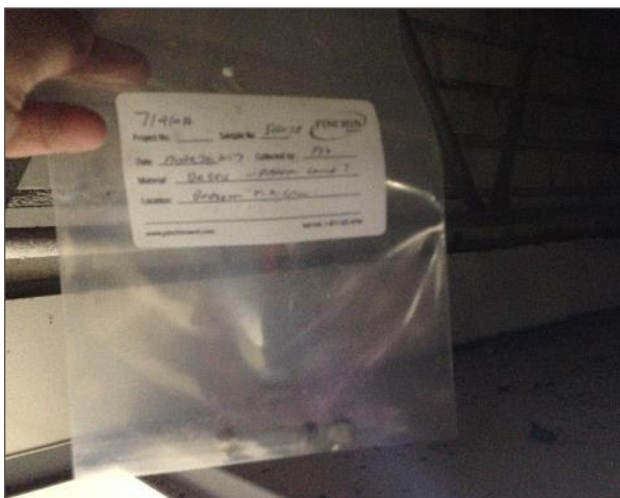
Debris was observed on the top of the acoustic ceiling tiles below piping. The debris was suspected to be remaining from previous pipe insulation removal. The debris was sampled in (samples S0002a-c) and found not to contain asbestos.

Photo 8 - Debris on acoustic ceiling tiles (samples S0002a-c), training room.

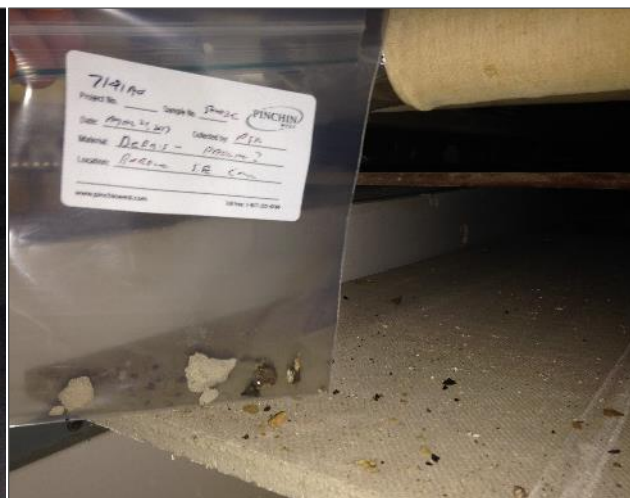
Photo 8 - Debris on acoustic ceiling tiles (samples S0002a-c), training room.
