***BERSCH & ASSOCIATES LTD.***

**SUBJECT: Gordon Howe Campground - Asbestos Registry Report**

**BULK SAMPLE ANALYSIS REPORT****PROJECT NO. B67.13****CLIENT: City of Saskatoon****Infrastructure Services - Facilities Branch****Contact: Brent Anderson****Location: Gordon Howe Campground - 1640 Avenue P South, Saskatoon, SK.**

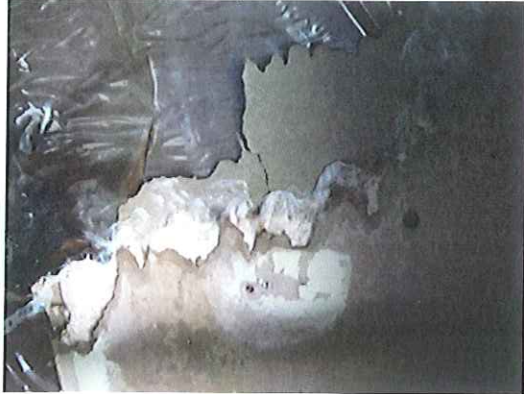
#1) Ceiling Drywall

NO.	DATE	SAMPLE INFORMATION	ASBESTOS	%	ANALYST
B1	15-May-13	119 Furnace Room - Ceiling drywall & insulation	None detected		WB
B2	15-May-13	114 Mechanical - 1' x 1' floor tile	None detected		WB
B3	15-May-13	107 Washroom - Sheet flooring, sandstone	None detected		WB
