**Holiday Park Golf Course
1630 Avenue U South, Saskatoon, SK.**

**Asbestos Survey Report
January 2014**

Prepared By: Bersch & Associates Ltd.
Project No. : B67SRA28

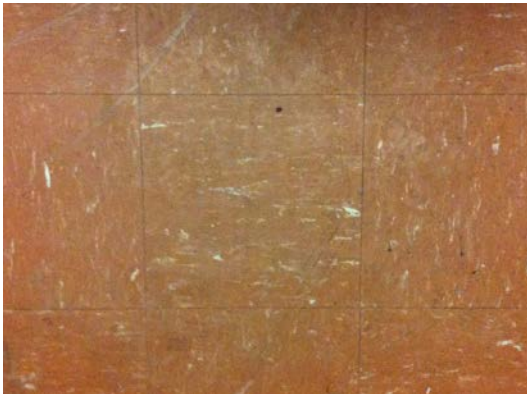
#3) Floor Tile

NO.	DATE	SAMPLE INFORMATION	ASBESTOS	%	ANALYST
7	28-Jan-14	123- 1' x 1' floor tile orange with white streak	None detected		WB
8	28-Jan-14	116- Sheet flooring tiny irregular blue stone pattern	None detected		WB
9	28-Jan-14	104- 1' x 1' 3- toned grey floor tile	Chrysotile	1 to 5	WB
10	28-Jan-14	102 Corridor- 2' x 4' ceiling tile	None detected		WB

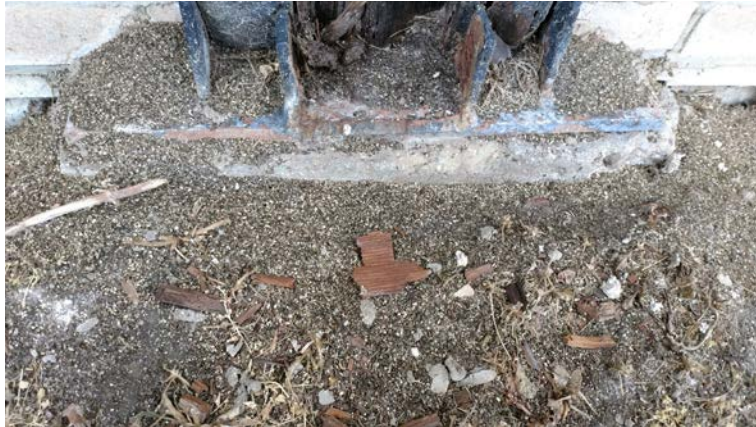
PHOTO 1 – Exterior Brick Wall

Exterior Walls "Red brick exterior walls suspected of containing asbestos vermiculite."
