CITY OF SASKATOON

Asbestos-Containing Building Materials Assessment Report - Holiday Park Golf Course Maintenance Building

Report Number: 1667963

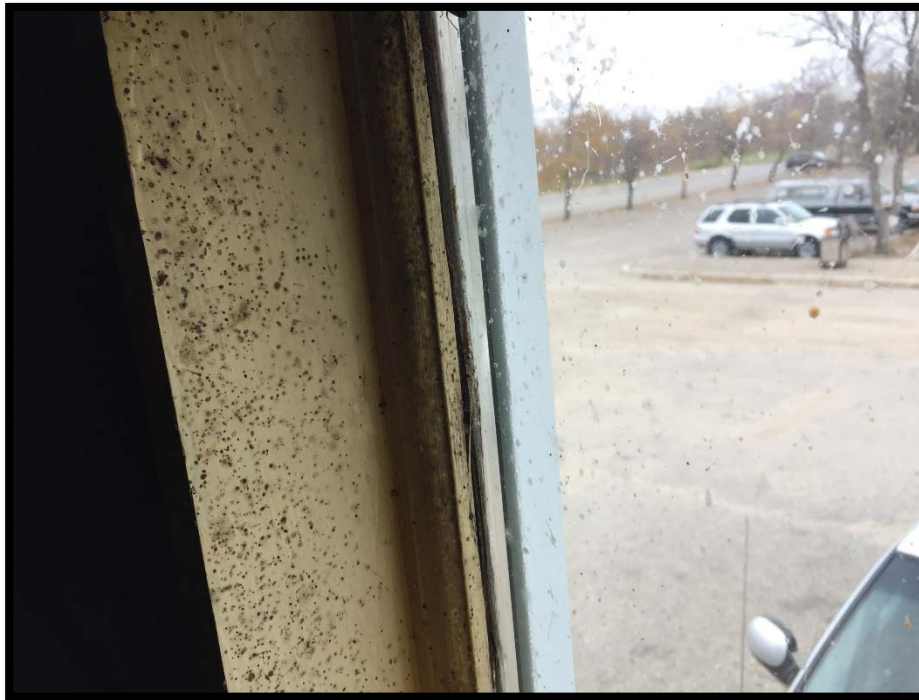
One (1) sample of black interior window caulking was collected during the assessment. The sample collected was found to contain 2.0% Chrysotile asbestos. Asbestos-containing black interior window caulking (see Photograph 1 in Appendix B) was observed in the following location:

- Room 100 (approximately 40 linear feet); and
- Room 200 (approximately 20 linear feet).

Photograph 1: Asbestos-Containing Black Interior Window Caulking.

If scheduled for impact, asbestos-containing black interior window caulking should be abated following low-risk abatement work procedures as outlined in the *Saskatchewan Asbestos Abatement Manual* (2017). Alternatively, as the black interior window caulking was observed in good condition, and with a priority rating of 5 (please see the room by room spreadsheet provided in Appendix C for a description of the priority ratings), it can be managed in place if not scheduled for impact.

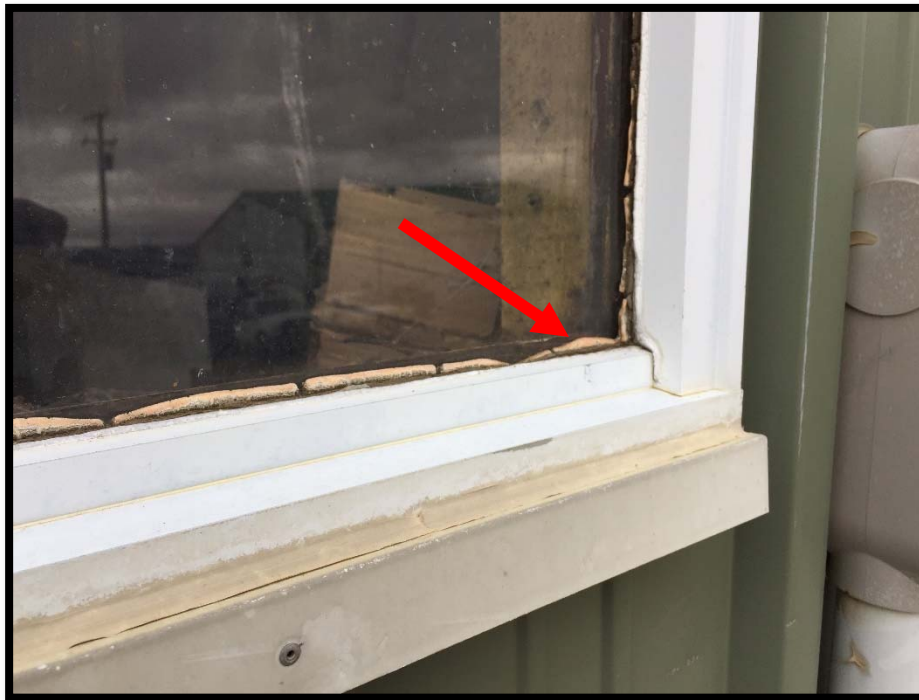
One (1) sample of white exterior window caulking was collected during the assessment. The sample collected was found to contain 1.3% Chrysotile asbestos. Asbestos-containing white exterior window caulking (see Photograph 2 in Appendix B) was observed in the following location:

- Exterior (approximately 60 linear feet).

Photograph 2: Asbestos-Containing White Exterior Window Caulking.

If scheduled for impact, asbestos-containing white exterior window caulking should be abated following low-risk abatement work procedures as outlined in the *Saskatchewan Asbestos Abatement Manual* (2017). Alternatively, as the white exterior window caulking was observed in good condition, and with a priority rating of 5 (please see the room by room spreadsheet provided in Appendix C for a description of the priority ratings), it can be managed in place if not scheduled for impact.
