CITY OF SASKATOON

Asbestos-Containing Building Materials Assessment Report - Holiday Park Golf Course Pump House

Report Number: 1667963

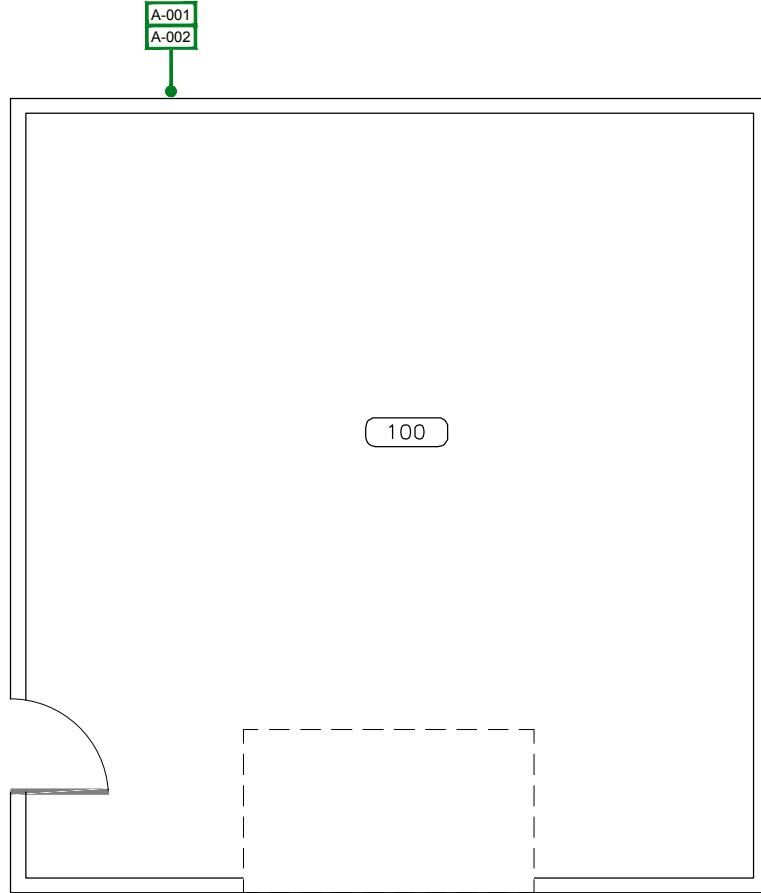
TITLE
PUMP HOUSE

NOTE(S)
 1. ASBESTOS IS A CARCINOGEN. DO NOT BREATHE ASBESTOS DUST.
 2. ASBESTOS-CONTAINING MATERIALS WERE NOT OBSERVED ON SITE DURING THE ASSESSMENT.
