December 7, 2017

## CITY OF SASKATOON

# Asbestos-Containing Building Materials Assessment Report - Inventory and Disposal Services Building

**Report Number: 1667963**

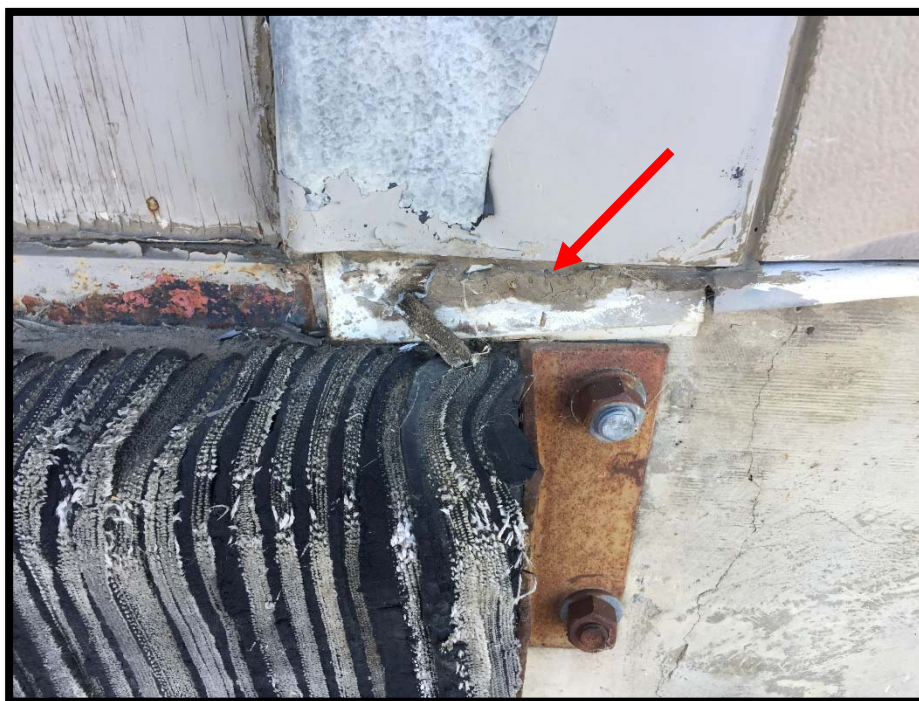
One (1) sample of grey overhead door caulking was collected during the assessment. The sample collected was found to contain 2.8% Chrysotile asbestos. Asbestos-containing grey overhead door caulking (see Photograph 1 in Appendix B) was observed in the following location:

- Exterior (approximately 200 linear feet).

Photograph 1: Asbestos-Containing Grey Overhead Door Caulking.

If scheduled for impact, asbestos-containing grey overhead door caulking should be abated following low-risk abatement work procedures as outlined in the *Saskatchewan Asbestos Abatement Manual* (2017). Alternatively, as the grey overhead door caulking was observed in good condition, and with a priority rating of 5 (please see the room by room spreadsheet provided in Appendix C for a description of the priority ratings), it can be managed in place if not scheduled for impact.

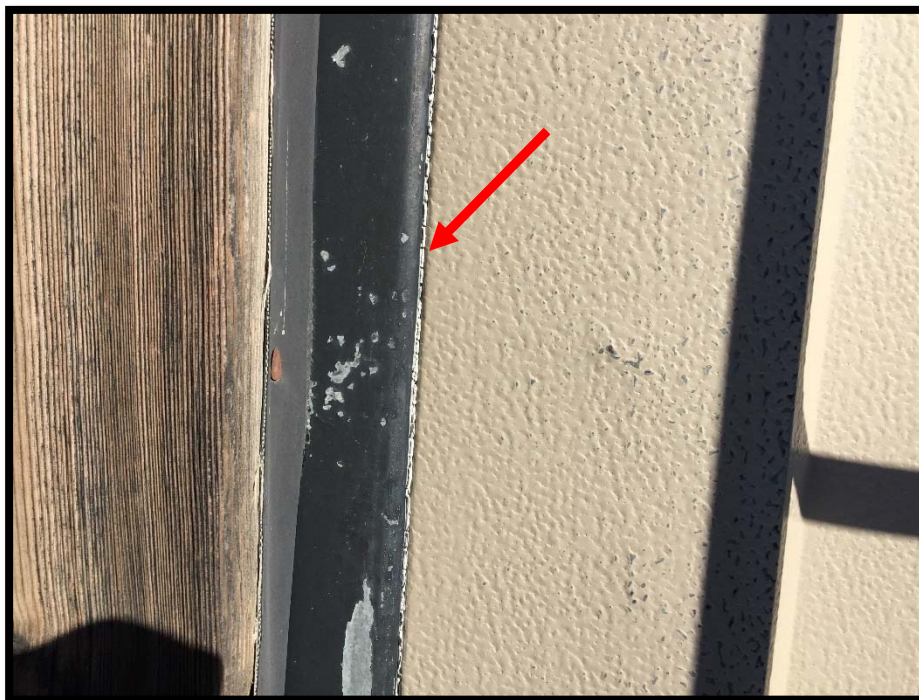
Two (2) samples of white overhead door caulking were collected during the assessment. One of the samples collected was found to contain 4.1% Chrysotile asbestos. Asbestos-containing white overhead door caulking (see Photograph 2 in Appendix B) was observed in the following location:

- Exterior (approximately 400 linear feet).

Photograph 2: Asbestos-Containing White Overhead Door Caulking.

If scheduled for impact, asbestos-containing white overhead door caulking should be abated following low-risk abatement work procedures as outlined in the *Saskatchewan Asbestos Abatement Manual* (2017). Alternatively, as the white overhead door caulking was observed in good condition, and with a priority rating of 5 (please see the room by room spreadsheet provided in Appendix C for a description of the priority ratings), it can be managed in place if not scheduled for impact.

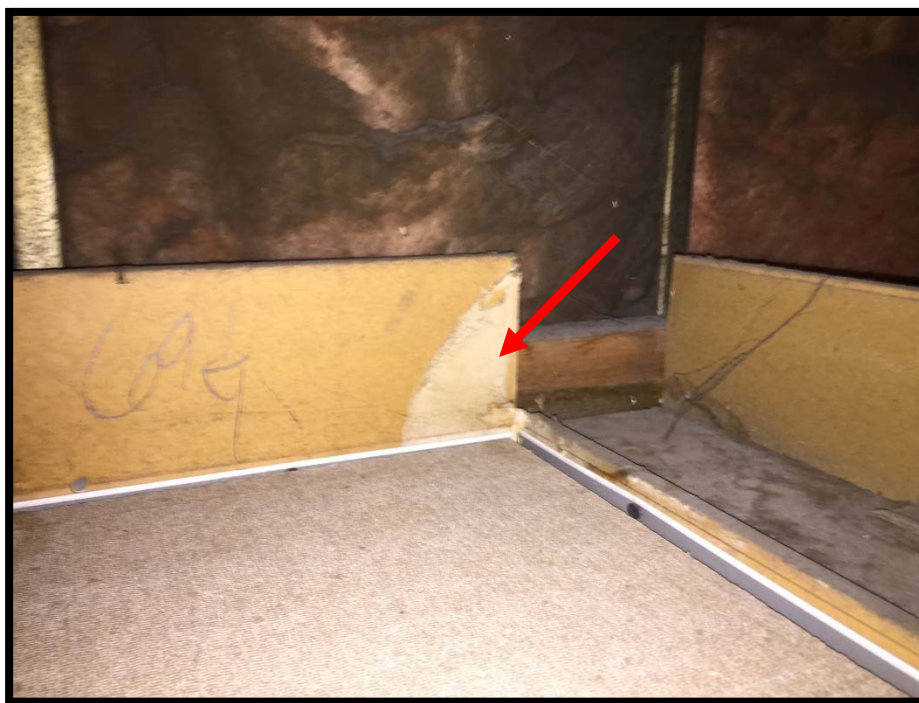
Five (5) samples of drywall joint compound were collected during the assessment. One of the samples collected was found to contain 3.1% Chrysotile asbestos. Asbestos-containing drywall joint compound (see Photograph 3 in Appendix B) was observed in the following locations:

- Room 100 (approximately 325 ft<sup>2</sup>);
- Room 100.1 (approximately 160 ft<sup>2</sup>);
- Room 100.2 (approximately 400 ft<sup>2</sup>);
- Room 100.3 (approximately 400 ft<sup>2</sup>);
- Room 101 (approximately 250 ft<sup>2</sup>);
- Room 102 (approximately 425 ft<sup>2</sup>);
- Room 103 (approximately 200 ft<sup>2</sup>);
- Room 104 (approximately 500 ft<sup>2</sup>);
- Room 105 (approximately 500 ft<sup>2</sup>);
- Room 106 (approximately 550 ft<sup>2</sup>); and
- Room 107 (approximately 500 ft<sup>2</sup>).

Based upon the representative sampling guidelines outlined within the *Saskatchewan Asbestos Abatement Manual* (2017), all drywall joint compound throughout the Site should be treated as asbestos-containing. During our assessment, there were two types of drywall joint compound observed, a white and a tan. The tan drywall joint compound was the sample found to contain asbestos, and it is suspected that this is original drywall joint compound that was not impacted by renovation activities within the office area. This tan drywall joint compound is suspected to be located along the exterior walls of the offices. Based upon the information provided by the Site Representative, no known renovations took place within the facility therefore this could not be confirmed. Additionally, the drywall joint compound within the majority of the office area was painted, and therefore, a colour could not be observed.

**Photograph 3: Asbestos-Containing Drywall Joint Compound.**

If scheduled for impact, asbestos-containing drywall joint compound should be abated following low-risk abatement work procedures as outlined in the *Saskatchewan Asbestos Abatement Manual* (2017). Alternatively, as the drywall joint compound was observed in good condition, and with a priority rating of 5 (please see the room by room spreadsheet provided in Appendix C for a description of the priority ratings), it can be managed in place if not scheduled for impact.
