**John Deere Building  
Saskatoon, SK.**

**Asbestos Survey Report  
February 2015**

**Prepared For:** City of Saskatoon Infrastructure Services - Facilities Branch  
3130 Laurier Drive, Saskatoon, SK.  
Attn: Brent Anderson

**Prepared By:** Bersch & Associates Ltd.  
**Project No. :** B67SRB05

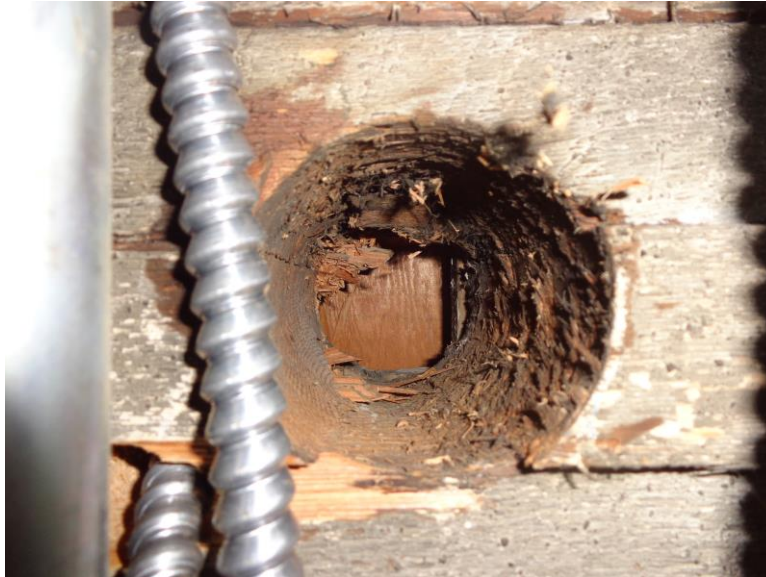
**AREA 1:** Basement Level Room 001 Looking Up Through the Penetration at the Column Adjacent the Training Room 112 Projector Screen. Fir Timber on Edge, Plywood Floor, Asbestos Floor Tile and Asbestos Sheet Flooring in the 112 Floor Composition.

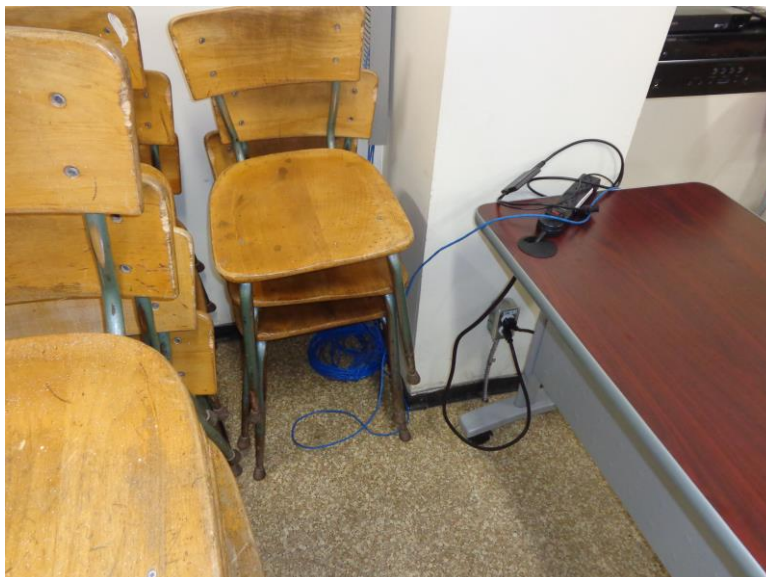
**AREA 2:** First Level – Room 112 Asbestos Detected in Floor Covering. The floor composition consists of asbestos sheet floor covering and asbestos floor tile above the fir lumber on edge viewed in the above area 1.

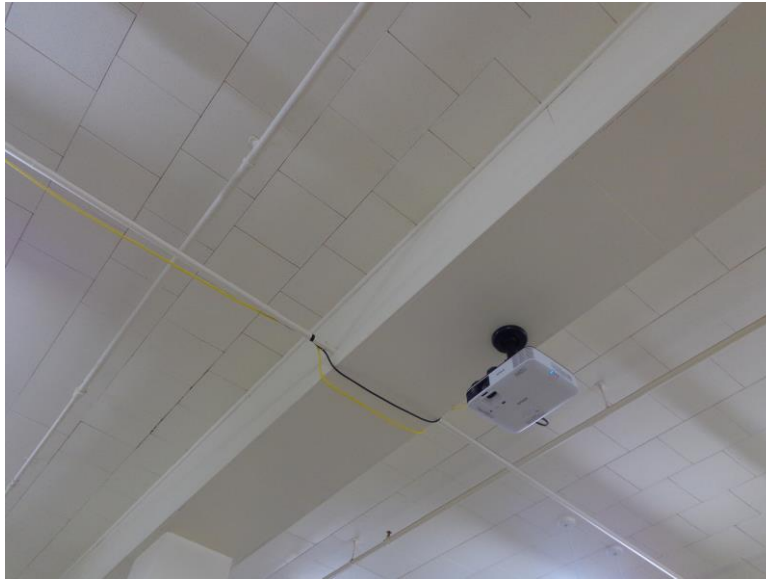
**AREA 3:** First Level – Room 112, No Asbestos Detected in Bulk Head Surface. The Surface Consists of Painted 3/8" Plywood.

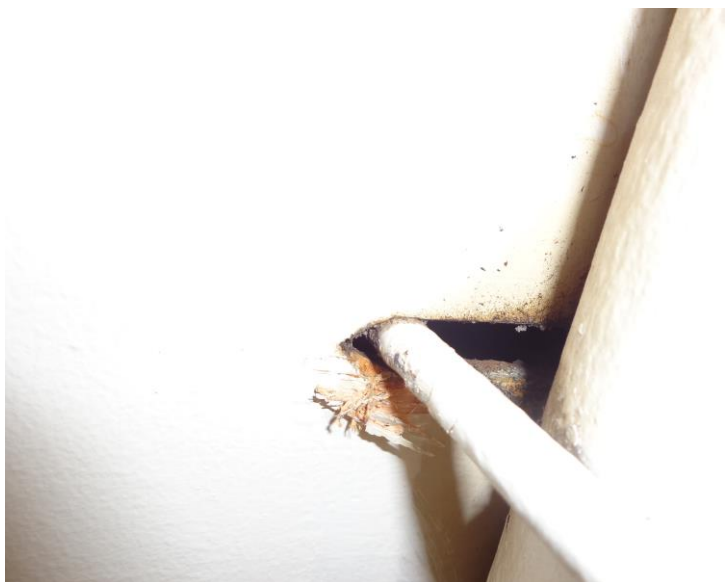
**AREA 4:** First Level – Room 112, No Asbestos Detected in Bulk Head Surface. This Photo is at the Pipe Hanger to the South of the Projector. The Surface Consists of Painted 3/8" Plywood.

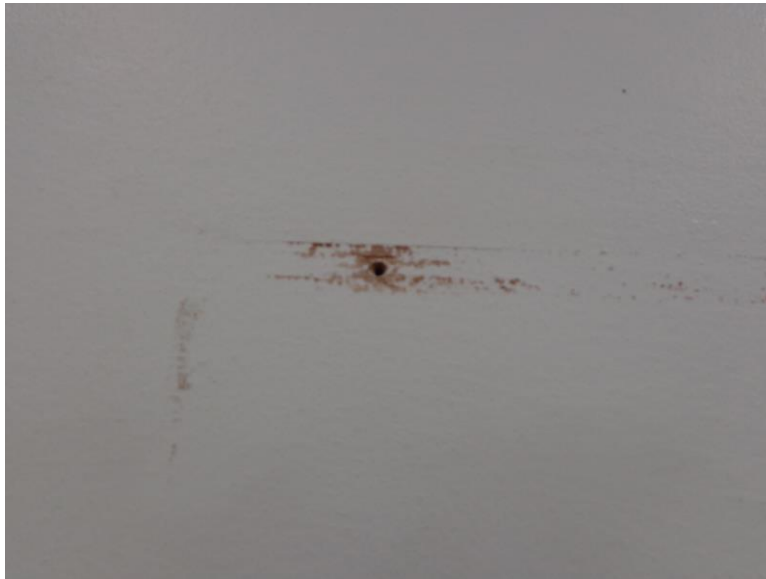
**AREA 5:** First Level – Room 112, No Asbestos Detected on West Wall Surface Where the Projector Screen is Mounted to. The Surface Consists of Painted 3/8" Plywood.

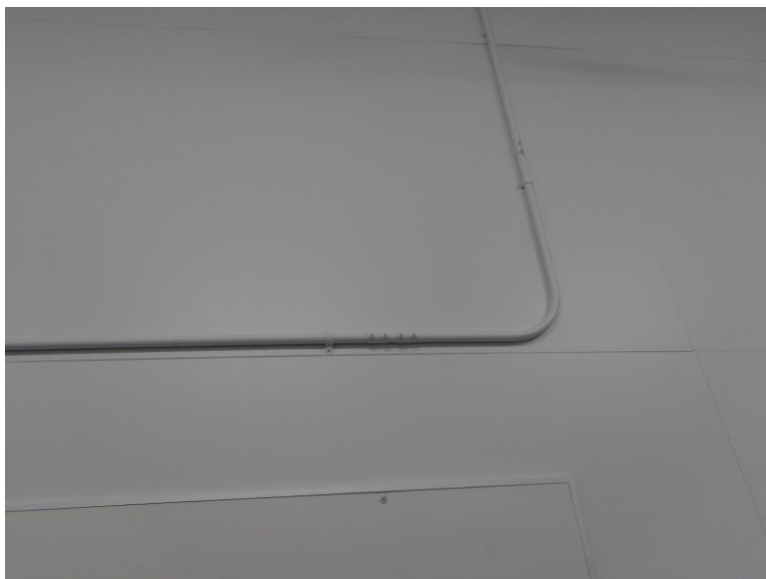
**AREA 6:** First Level – Room 118, No Asbestos Detected on North Wall Surface Where the Conduit is Mounted to. The Surface Consists of Painted 3/8" Plywood.

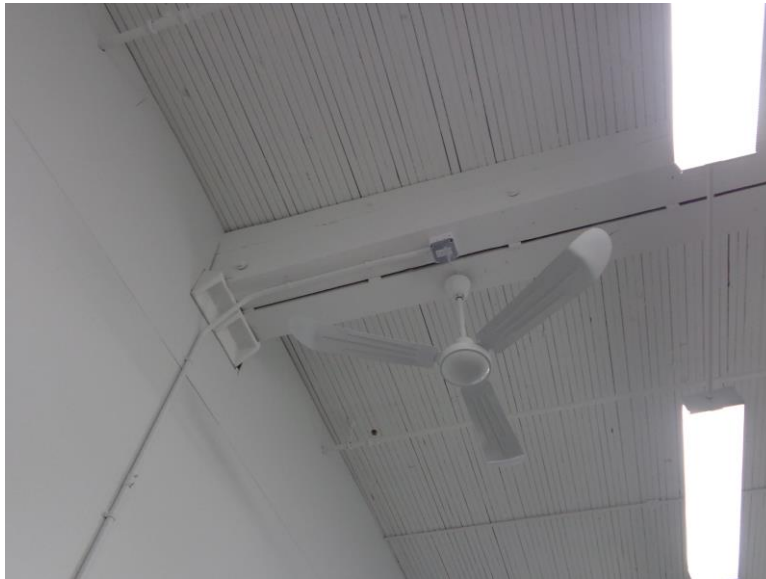
**AREA 7:** First Level – Room 118, No Asbestos Detected on Overhead Fir Beam Surface the Fan is Mounted to.

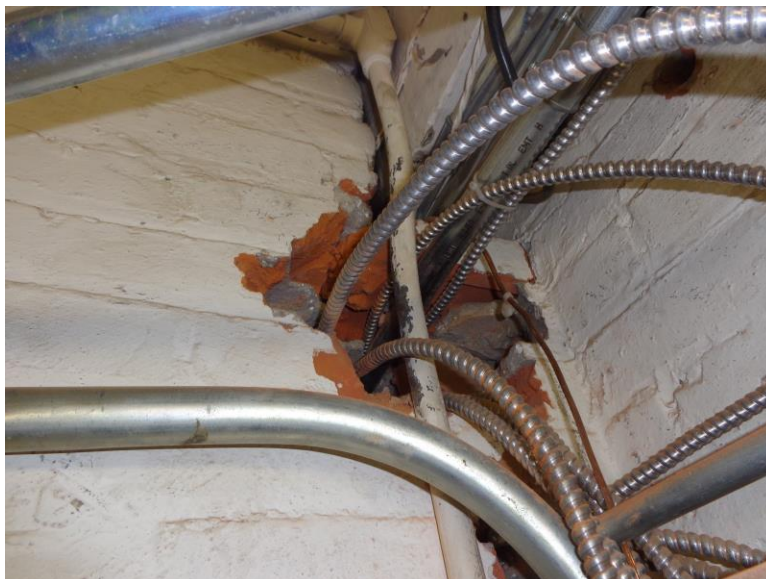
**AREA 8:** Second Level – 2S2 Stairwell Upper Northeast Corner Adjacent 2A Electrical Panel. No Asbestos Material Detected in #32 Clay Brick or #33 Brick Mortar Bulk Samples. Refer to the Attached Bulk Analysis Report.

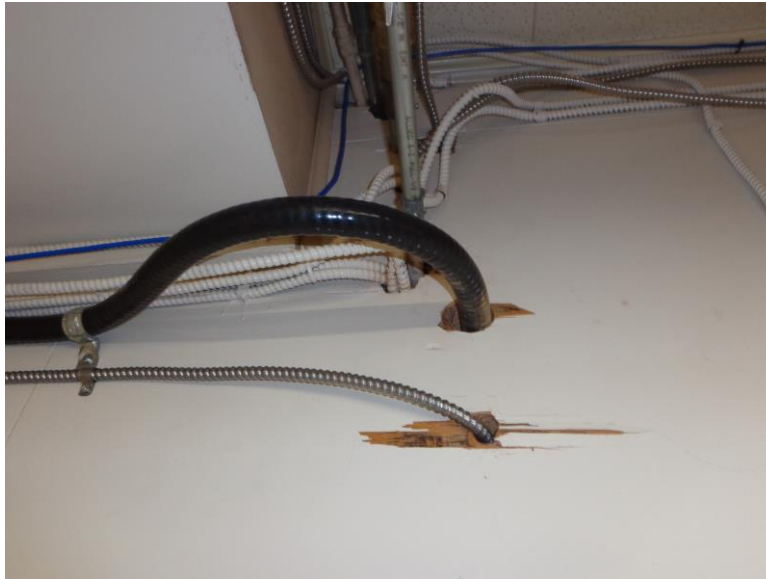
**AREA 9:** Second Level – 236A South Upper Wall Above 2S2 Stairwell Doorway. The Surface Consists of Painted 3/8" Plywood.

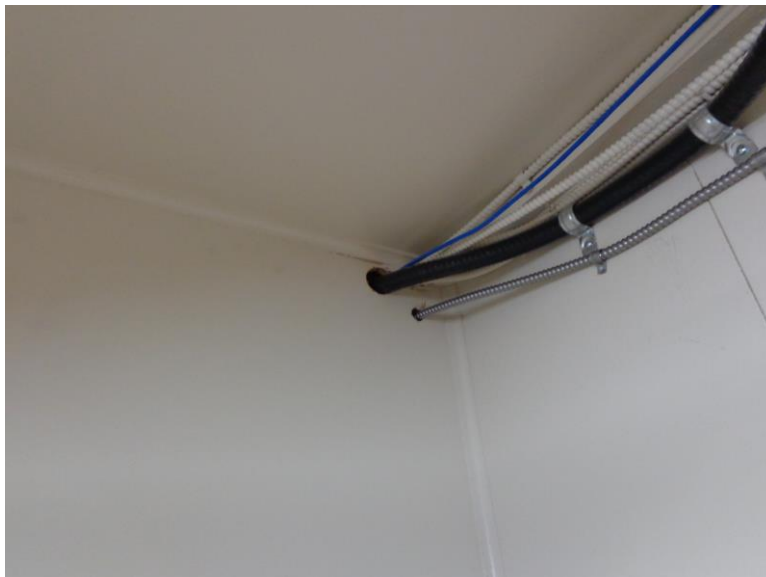
**AREA 10:** Second Level – 236A Upper Southeast Corner. The Surface Consists of Painted 3/8" Plywood.

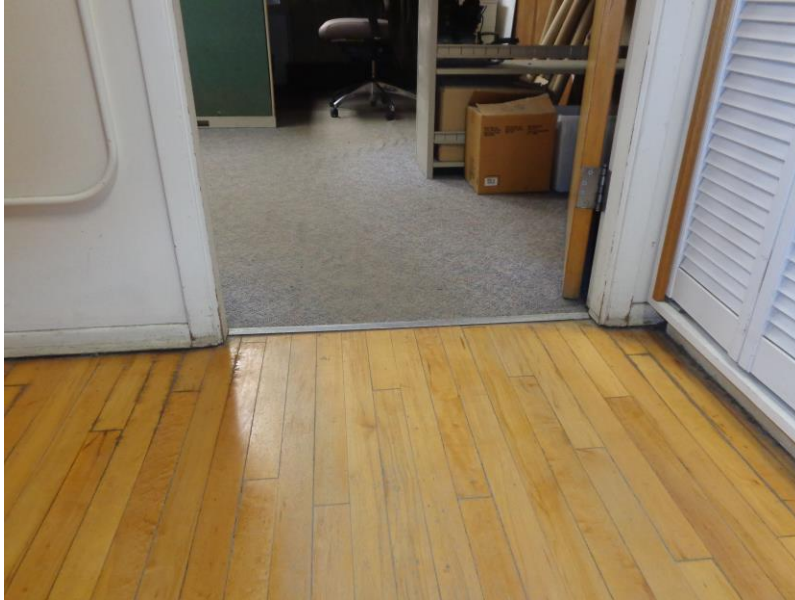
**AREA 11:** Second Level – Room 30 Hardwood Floor Continues Beneath Carpet.

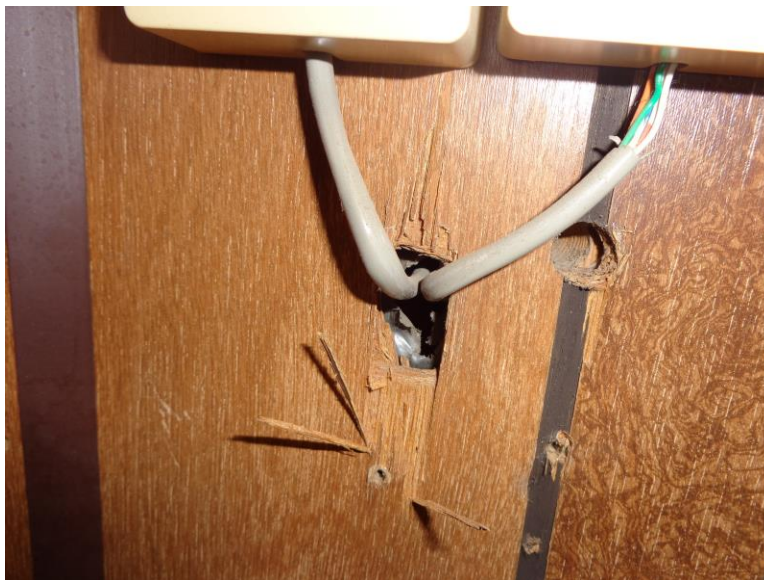
**AREA 12:** Second Level – Room 30 Lower Southwest Corner Wall Composition. Panel Board and Wall Cavity Directly Behind. No Asbestos Material Observed on the Surface or Directly Behind the Paneling on all Four Walls.

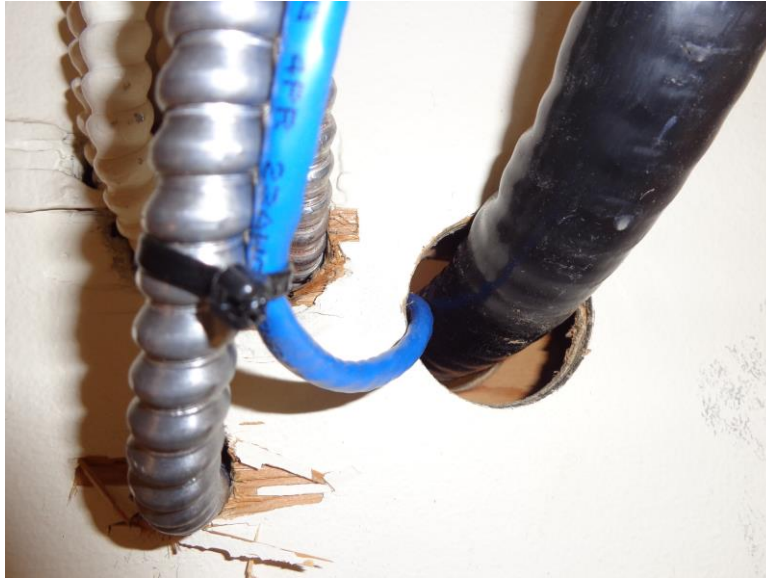
**AREA 13:** Second Level – Room 35B West Upper Wall. The Surface Consists of Painted 3/8" Plywood, an Empty Wall Cavity and 3/8" Plywood on the Opposite Side of the Wall (236A Corridor).

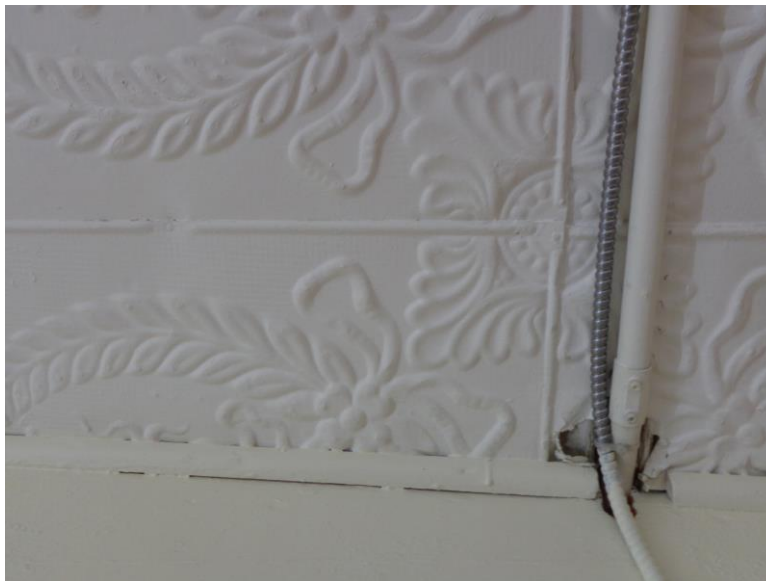
**AREA 14:** Second Level – Room 35B Decorative Ceiling. The Surface Consists of Painted Rolled Metal. (Presumed to be Lead).

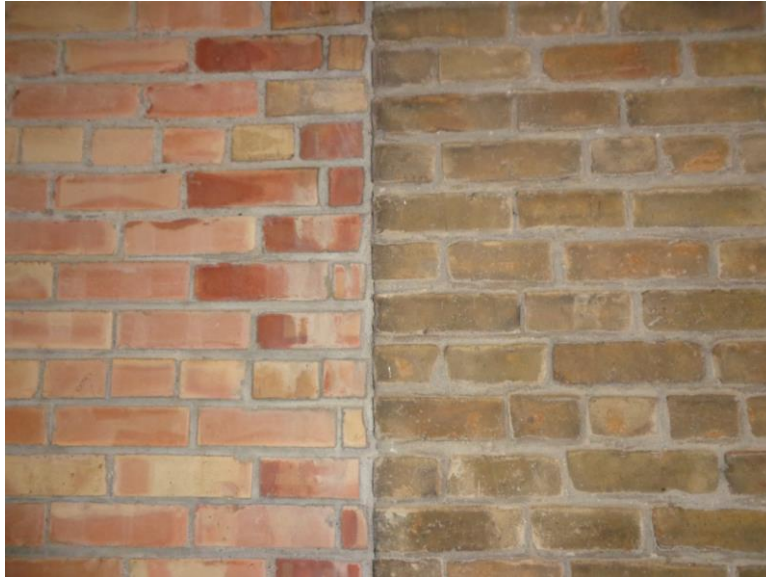
**AREA 15:** North Exterior Wall. Mortar Within Either Brick Does Not Contain Asbestos.

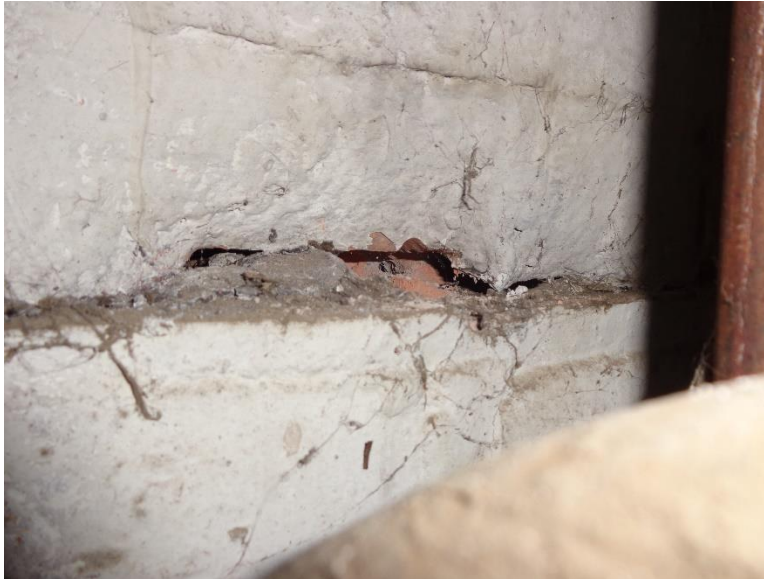
**AREA 1:** Basement Level Room 001 in the Northeast Corner Adjacent the Boiler Room Wall at the Location of the SaskEnergy Gas Connection Upgrade.

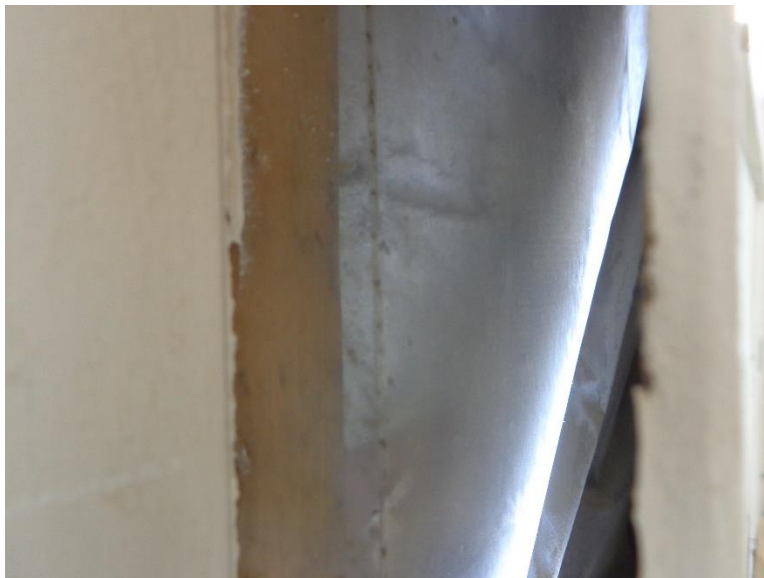
**AREA 2:** Main Level South Wall of Room 10B – Brick Wall Behind the Poly and Interior Panel at the Location of the Access Card Reader.
