**City of Saskatoon
Kilburn Park Building
Asbestos Survey Report**

December 2015

**Prepared By: Bersch & Associates Ltd.
Project No. : B67SRL03**

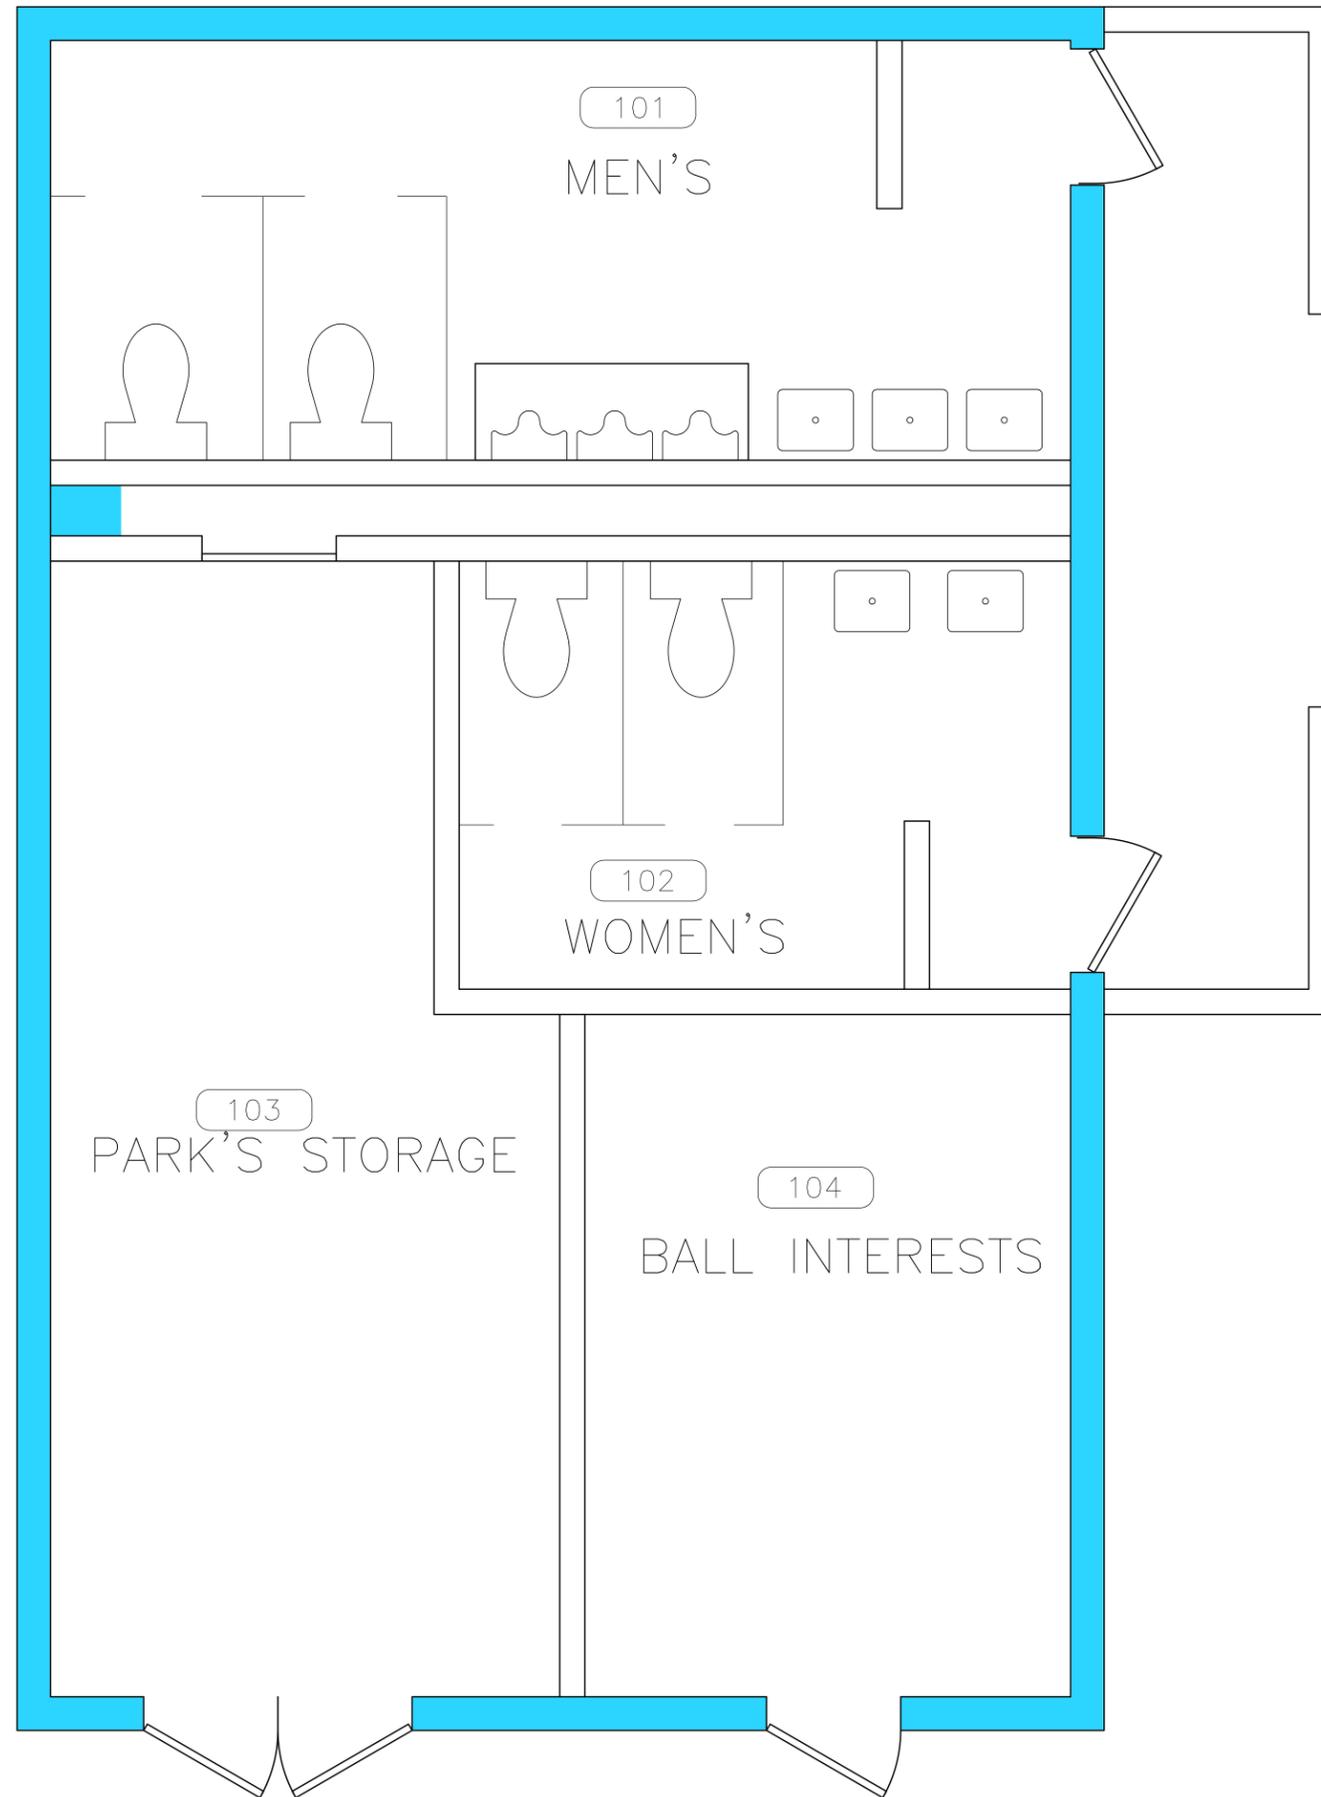
SHEET NAME
**Main Floor
 Floor Plan**

- **Vermiculite** block wall insulation has been identified within the Kilburn Park Building. The samples were collected from Room 103 Park’s Storage and Room 104 Balls Interest from an existing wall penetration and the pipe chase. All perimeter walls are assumed to contain vermiculite insulation. The interior block walls shall also be considered suspect of containing vermiculite insulation.

Asbestos containing vermiculite is present within the facility. This material is located within the exterior block walls of the facility. The material for the most part is in good condition with the exception of the vermiculite debris within the pipe chase. Bersch recommends HEPA vacuuming the vermiculite insulation within the bathroom pipe chase. Consider all block walls to be asbestos containing.

PRIORITY:	ONE
CONDITION:	POOR
POTENTIAL FOR DISTURBANCE:	LOW
ACTION:	CLEANUP/MANAGE
