**CITY OF SASKATOON – SURVEYOR’S BUILDING
ASBESTOS SURVEY REPORT**

MAY 2013

Prepared By: Bersch & Associates Ltd.
Project No. : B67SRE01S

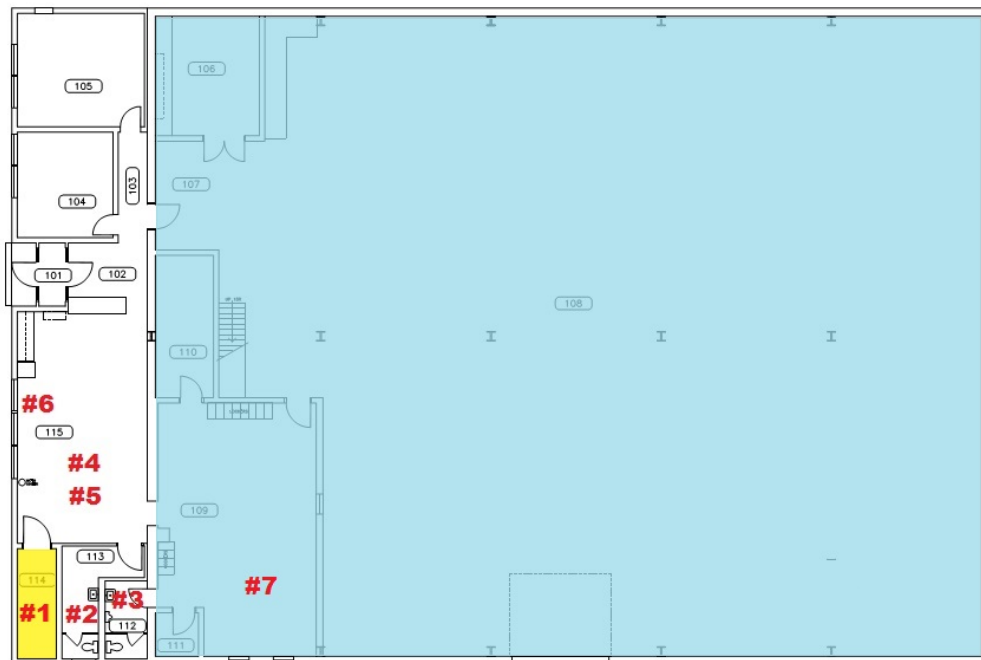
Survey Floor Base Plan

Transite Liner Panel

Asbestos Floor Tile

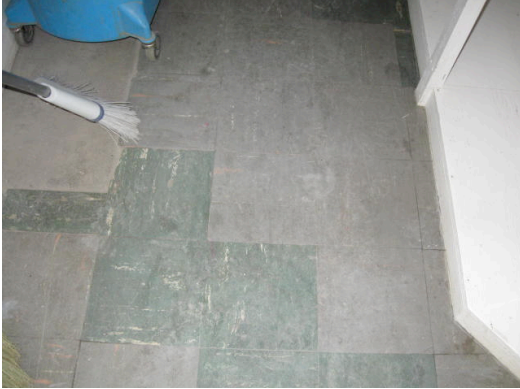
9-inch by 9-inch floor tile was identified as containing asbestos. This material was observed to be in good condition with a low potential for disturbance. The material may be managed.

PRIORITY:	THREE
CONDITION:	GOOD
POTENTIAL FOR DISTURBANCE:	LOW
ACTION:	MANAGE

#1) 9" X 9" Floor Tile

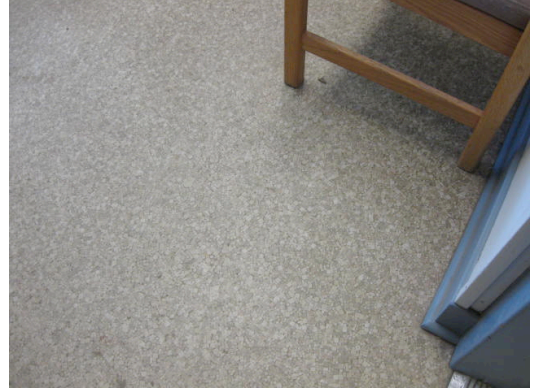
#2) Sheet Floor Covering

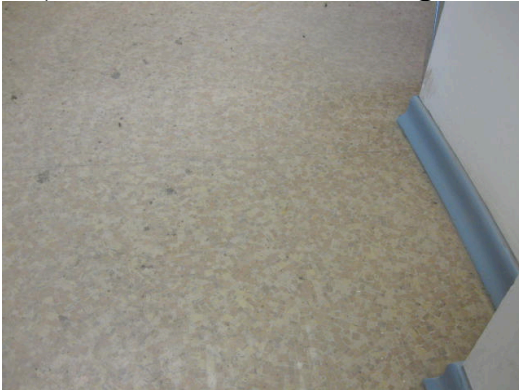
#3) Sheet Floor Covering

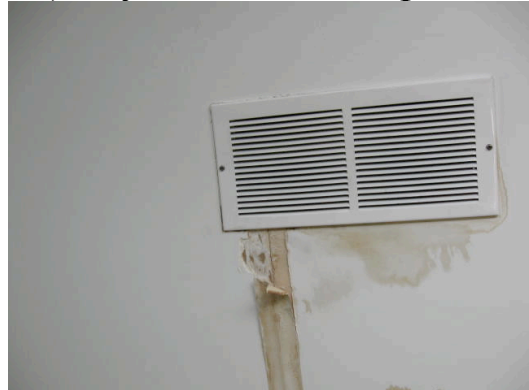
#4) Drywall Mud Compound

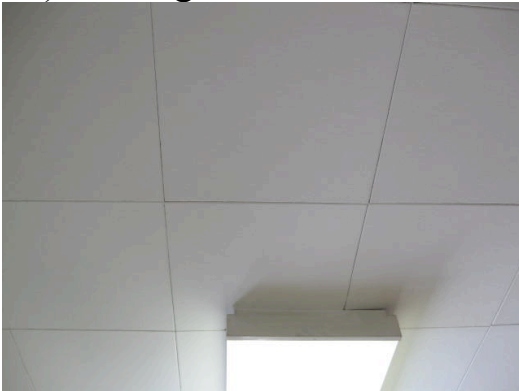
#5) Ceiling Tiles

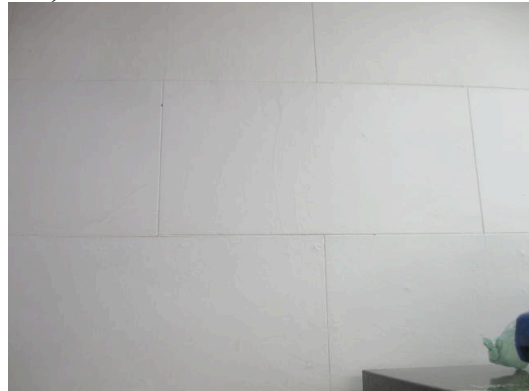
#6) Wall Tiles

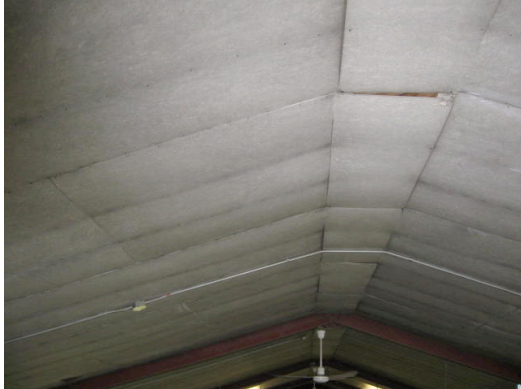
Transite liner panel was identified throughout the shop ceiling as containing asbestos. This material was observed to be in good condition with a low potential for disturbance except for three slightly damaged areas. One damaged area in the northwest corner of the shop consists of a fragment hanging from the ceiling that should be removed and the edges of the remaining fracture encapsulated with silicone or encapsulant. Two small damaged areas adjacent the top of the mezzanine stairs should also be encapsulated. Management of the material is recommended.

PRIORITY:	ONE
CONDITION:	MODERATE
POTENTIAL FOR DISTURBANCE:	LOW
ACTION:	REPAIR / MANAGE

#7) Transite board

For the specifics of this report Repair/Encapsulation and Management of the asbestos containing materials is the recommended planned activity. In the event of renovations or maintenance to areas containing asbestos materials, written procedures must be developed to conduct the activity or prior removal if the situation warrants.
