CITY OF SASKATOON

Asbestos-Containing Building Materials Assessment Report - Lathey Pool

Report Number: 1667963

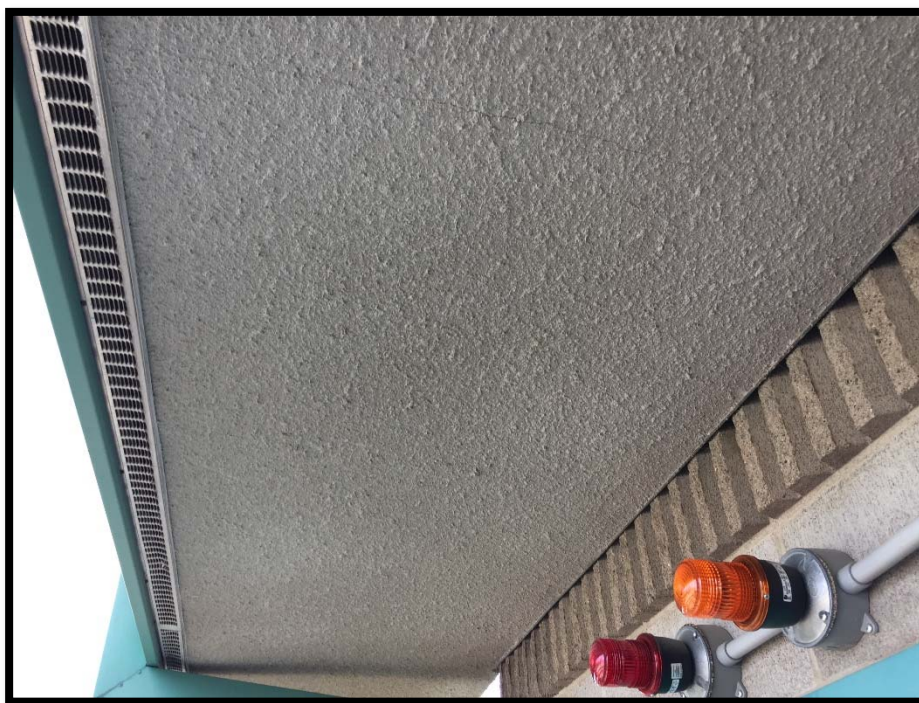
Concrete Texture Coat

Three (3) samples of concrete texture coat were collected during the assessment. The three samples collected were found to contain 10% Chrysotile asbestos. Asbestos-containing concrete texture coat (see Photograph 1 in Appendix B) was observed in the following location:

- Exterior (approximately 1,600 ft²).

Photograph 1: Asbestos-Containing Concrete Texture Coat.

If scheduled for impact, asbestos-containing concrete texture coat should be abated following high-risk abatement work procedures as outlined in the *Saskatchewan Asbestos Abatement Manual* (2017). Alternatively, as the concrete texture coat was observed in good condition, and with a priority rating of 5 (please see the room by room spreadsheet provided in Appendix C for a description of the priority ratings), it can be managed in place if not scheduled for impact.

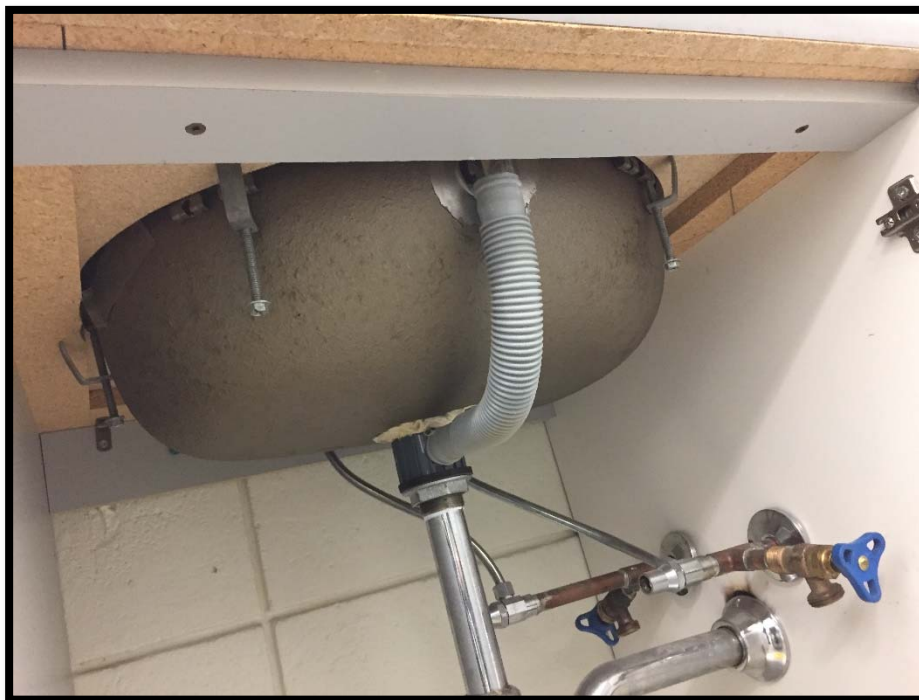
Gold Sink Undercoat

One (1) sample of gold sink undercoat was collected during the assessment. The sample collected was found to contain 1.5% Chrysotile asbestos. Asbestos-containing gold sink undercoat (see Photograph 2 in Appendix B) was observed in the following locations:

- Room 103 (approximately 1 sink);
- Room 105 (approximately 1 sink); and
- Room 114 (approximately 1 sink).

Photograph 2: Asbestos-Containing Gold Sink Undercoat.

If scheduled for impact, asbestos-containing gold sink undercoat should be abated following low-risk abatement work procedures as outlined in the *Saskatchewan Asbestos Abatement Manual* (2017). Alternatively, as the gold sink undercoat was observed in good condition, and with a priority rating of 5 (please see the room by room spreadsheet provided in Appendix C for a description of the priority ratings), it can be managed in place if not scheduled for impact.
