November 28, 2017

CITY OF SASKATOON

Asbestos-Containing Building Materials Assessment Report - Lathey Pool Concession

Report Number: 1667963

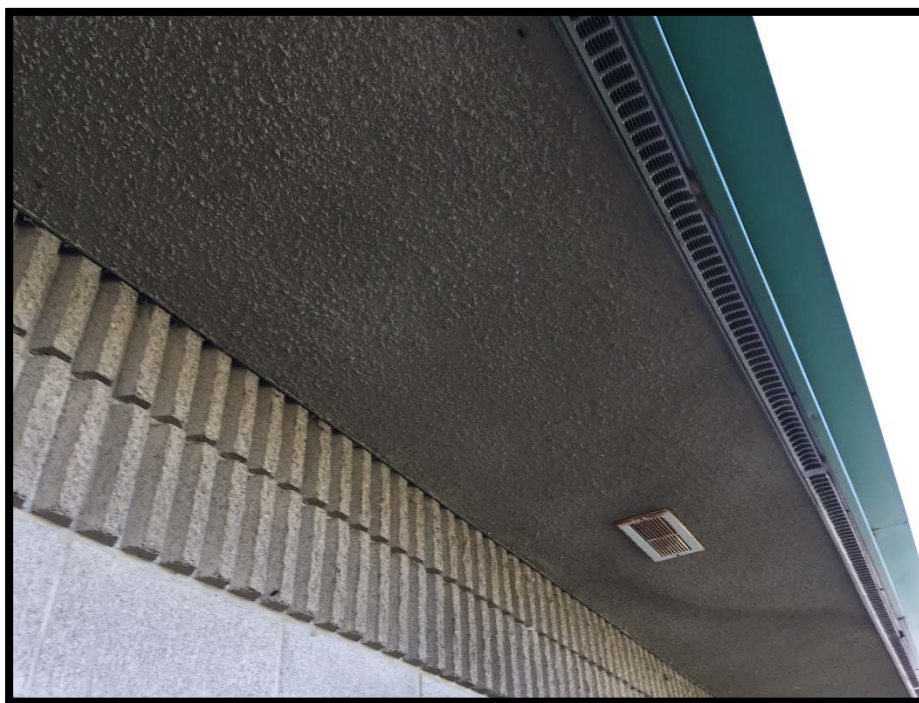
Three (3) samples of concrete texture coat were collected during the assessment. The three samples collected were found to contain 1.3% to 1.6% Chrysotile asbestos. Asbestos-containing concrete texture coat (see Photograph 1 in Appendix B) was observed in the following location:

- Exterior (approximately 750 ft²).

Photograph 1: Asbestos-Containing Concrete Texture Coat.

Included	E	Exterior	Exterior	Overhang	Overhang	Concrete Texture Coat	High	Yes	Yes	Yes	Good	Located on the upper walls and overhangs along the exterior of the building at heights.	Bulk	A-006, A-007, A-008	17-Oct-17	Chrysotile	Concrete Texture Coat	1.3% to 1.6%	No	No	No	Annually	5	Moderate	Manage in place.	Included above.	Photograph 1	Door Jamb
Included	E	Exterior	Exterior	Walls	Caulking	White Window Frame Caulking	High	No	Yes	No	Good		Bulk	A-009	17-Oct-17													
Included	E	Exterior	Exterior	Walls	Caulking	Grey Window Frame Caulking	High	No	Yes	No	Good		Bulk	A-010	17-Oct-17													
Included	E	Exterior	Exterior	Walls	Firestop	White Firestop	High	No	Yes	No	Good		Bulk	A-011	17-Oct-17													
Included	E	Exterior	Exterior	Walls	Firestop	Beige Firestop	High	No	Yes	No	Good		Bulk	A-012	17-Oct-17													
Included	E	Exterior	Exterior	Walls	Firestop	Clear Firestop	High	No	Yes	No	Good		Bulk	A-013	17-Oct-17

If scheduled for impact, asbestos-containing concrete texture coat should be abated following high-risk abatement work procedures as outlined in the *Saskatchewan Asbestos Abatement Manual* (2017). Alternatively, as the concrete texture coat was observed in good condition, and with a priority rating of 5 (please see the room by room spreadsheet provided in Appendix C for a description of the priority ratings), it can be managed in place if not scheduled for impact.
