## CITY OF SASKATOON

# Asbestos-Containing Building Materials Assessment Report - Lawson Heights Civic Centre and Rusty MacDonald Library

**Report Number: 1667963**

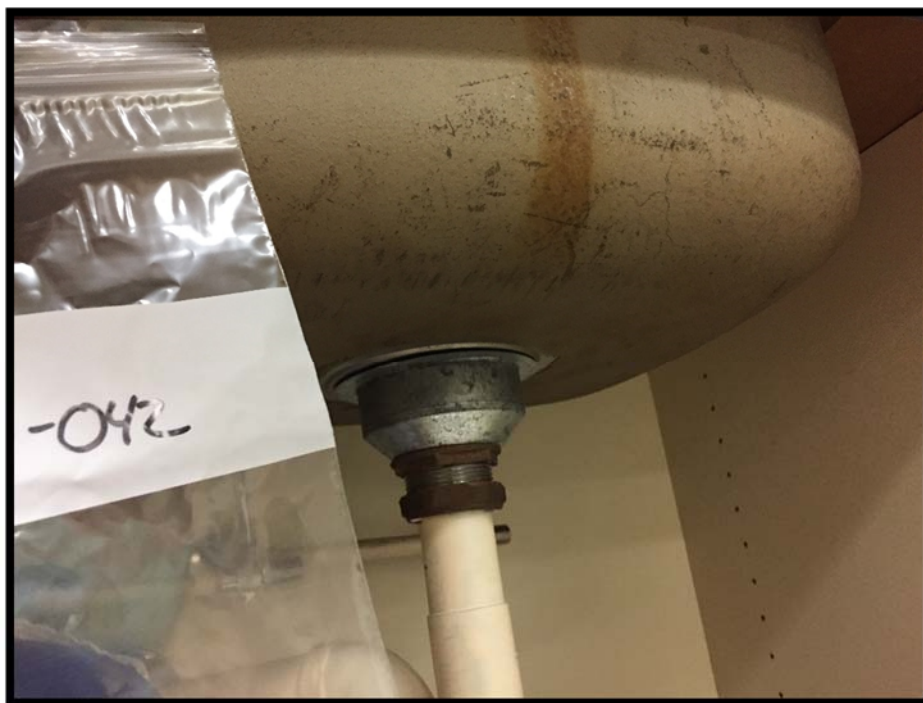
One (1) sample of gold sink undercoat was collected during the assessment. The sample collected was found to contain 2.7% Chrysotile asbestos. Asbestos-containing gold sink undercoat (see Photograph 1 in Appendix B) was observed in the following location:

- Room 105 (approximately 1 sink);
- Room 106 (approximately 1 sink); and
- Room 115 (approximately 1 sink).

**Photograph 1: Asbestos-Containing Gold Sink Undercoat.**

If scheduled for impact, asbestos-containing gold sink undercoat should be abated following low-risk abatement work procedures as outlined in the *Saskatchewan Asbestos Abatement Manual* (2017). Alternatively, as the gold sink undercoat was observed in good condition, and with a priority rating of 5 (please see the room by room spreadsheet provided in Appendix C for a description of the priority ratings), it can be managed in place if not scheduled for impact.

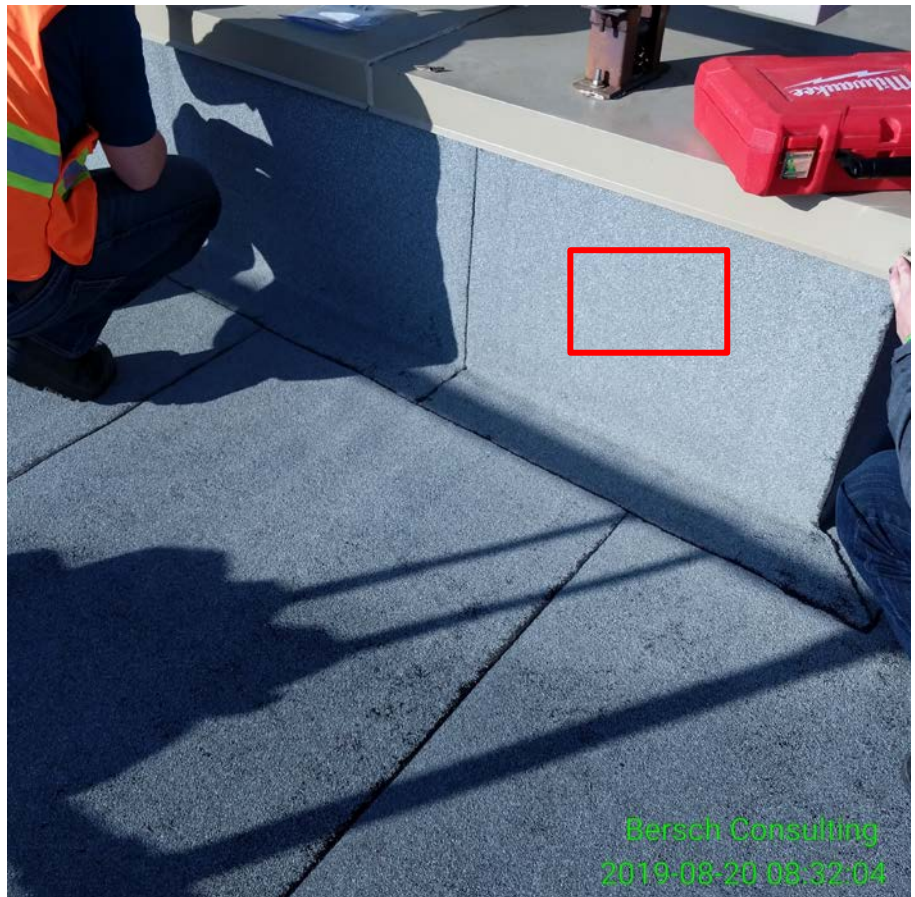
B67BLH20I – 002

Grey/Black Roof Shingle.  
Roof Surface Beneath Air Units.

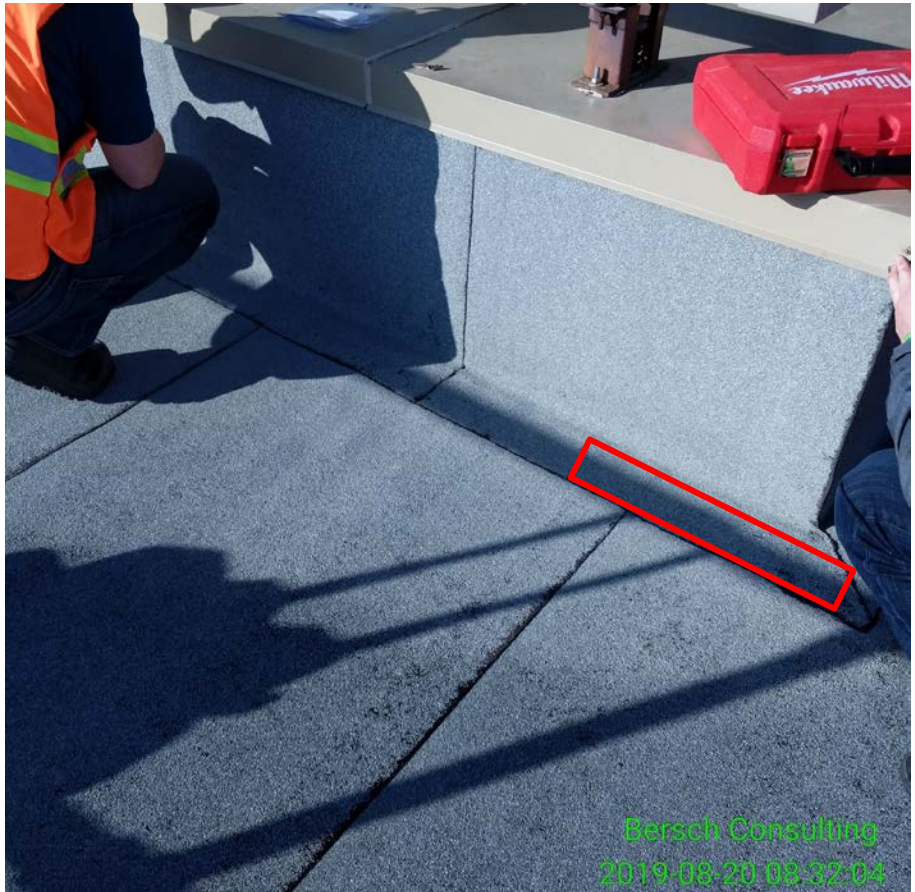
B67BLH20I – 003

Black Roof Membrane.  
Roof Surface Beneath Air Units.

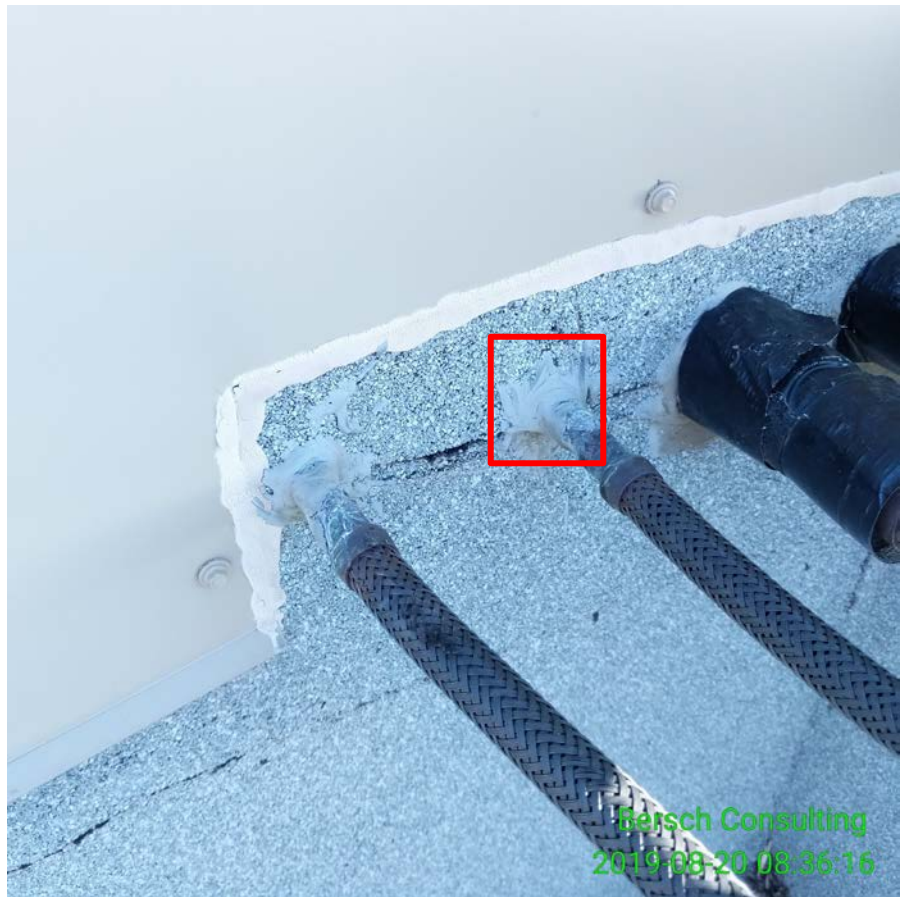
B67BLH20I – 004

Between Conduit and Curb.

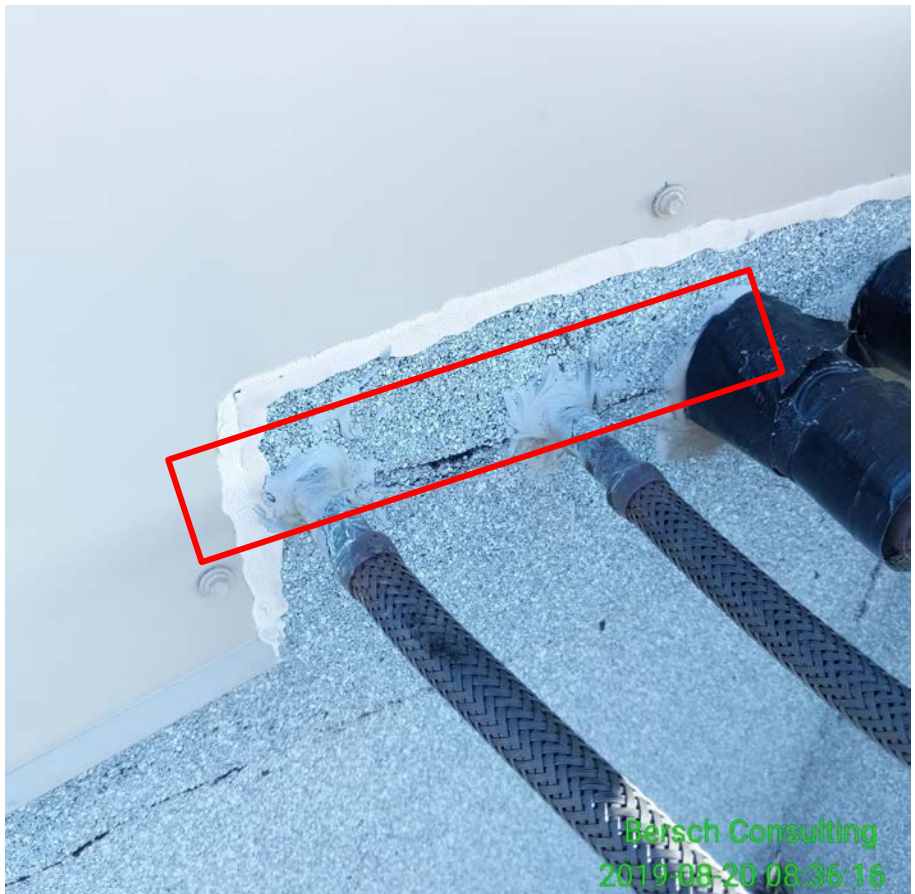
Between Air Unit and Curb.
