CITY OF SASKATOON

Asbestos-Containing Building Materials Assessment Report - Low Lift Station

Report Number: 1667963

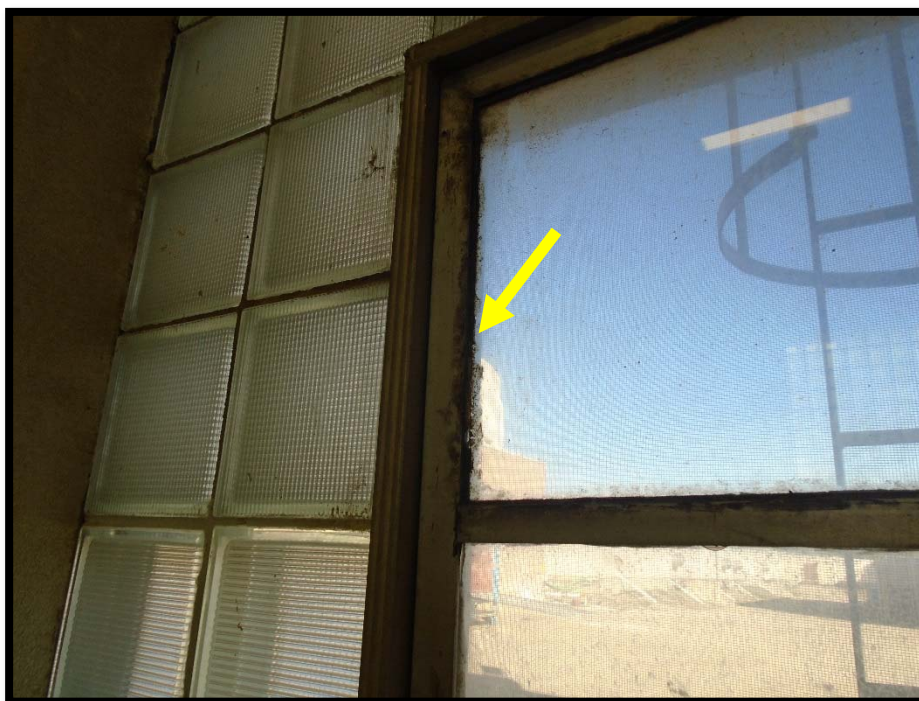
Black Window Glazing

One (1) sample of black window glazing was collected during the assessment. The sample collected was found to contain 2.2% Chrysotile asbestos. Asbestos-containing black window glazing (see Photograph 1 in Appendix B) was observed in the following locations:

- Room 100 (approximately 20 linear ft).

Photograph 1: Asbestos-Containing Black Window Glazing.

If scheduled for impact, asbestos-containing black window glazing should be abated following low-risk abatement work procedures as outlined in the *Saskatchewan Asbestos Abatement Manual* (2017). Alternatively, as the black window glazing was observed in good condition, and with a priority rating of 5 (please see the room by room spreadsheet provided in Appendix C for a description of the priority ratings), the glazing can be managed in place if not scheduled for impact.

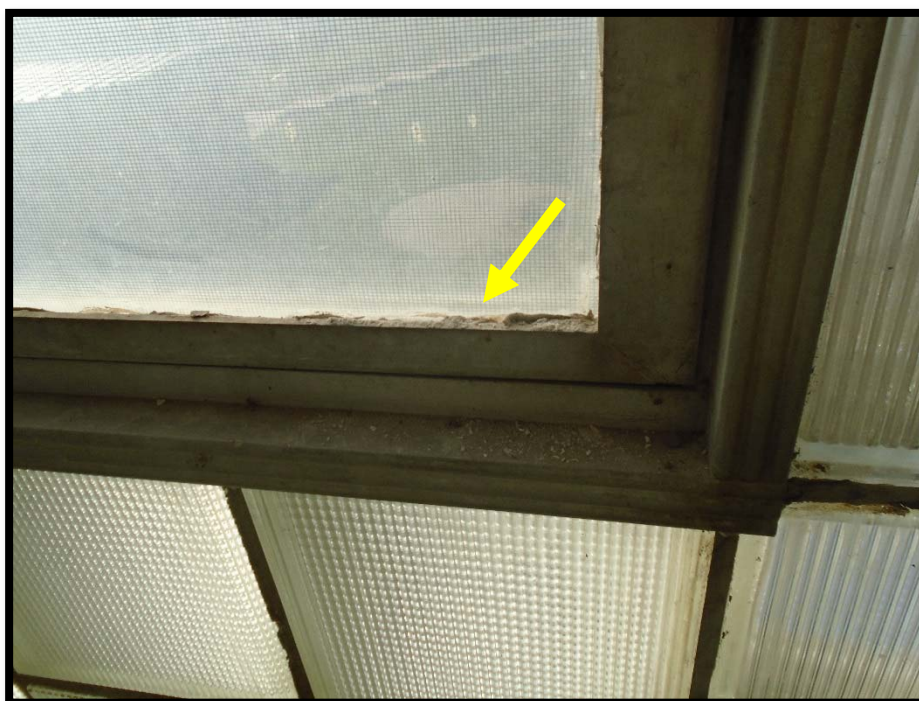
Grey Window Glazing

One (1) sample of white window caulking was collected during the assessment. A second layer described as grey window glazing was identified on the sample and this layer was found to contain 2.4% Chrysotile asbestos. Asbestos-containing grey window glazing (see Photograph 2 in Appendix B) was observed in the following locations:

- Room 100 (approximately 20 linear ft).

Photograph 2: Asbestos-Containing Grey Window Glazing Below White Caulking.

If scheduled for impact, asbestos-containing grey window glazing should be abated following low-risk abatement work procedures as outlined in the *Saskatchewan Asbestos Abatement Manual* (2017). Alternatively, as the grey window glazing was observed in good condition, and with a priority rating of 5 (please see the room by room spreadsheet provided in Appendix C for a description of the priority ratings), the glazing can be managed in place if not scheduled for impact.

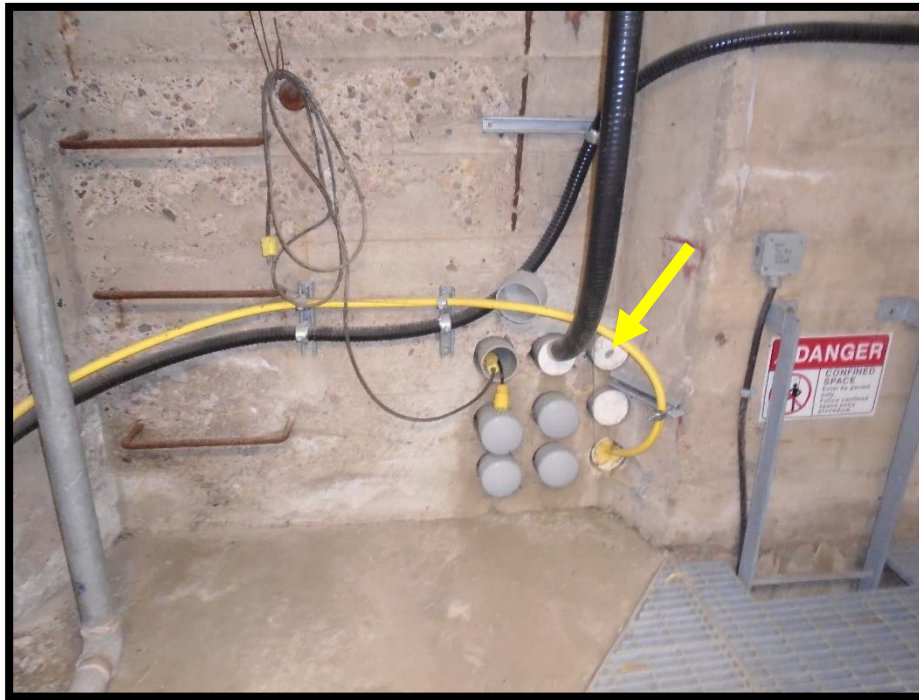
Yellow Insulation

One (1) sample of white firestop was collected during the assessment. A second layer described as yellow insulation was identified on the sample within the cable conduit and this layer was found to contain trace amounts of Chrysotile asbestos. Asbestos-containing yellow insulation (see Photograph 3 in Appendix B) was observed in the following locations:

- Lower Level (approximately 5 linear ft).

Photograph 3: Asbestos-Containing Yellow Insulation Inside Cable Conduit, Behind White Firestop

If scheduled for impact, asbestos-containing yellow insulation should be abated following low-risk abatement work procedures as outlined in the *Saskatchewan Asbestos Abatement Manual* (2017). Alternatively, as the yellow insulation was observed in good condition, and with a priority rating of 5 (please see the room by room spreadsheet provided in Appendix C for a description of the priority ratings), the insulation can be managed in place if not scheduled for impact.

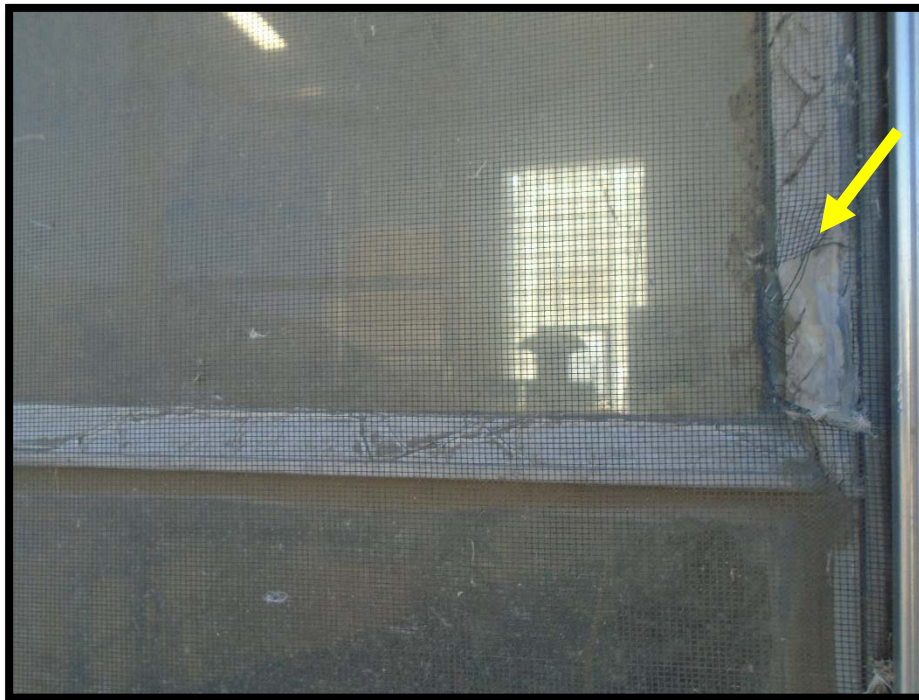
Exterior White Caulking on Window Panes

One (1) sample of exterior white window caulking on the window panes was collected during the assessment. The sample collected was found to contain 0.25% Tremolite asbestos. Asbestos-containing exterior white caulking (see Photograph 4 in Appendix B) was observed in the following locations:

- Exterior, on window panes (approximately 50 linear ft).

Photograph 4: Asbestos-Containing Exterior White Caulking on Window Pane

If scheduled for impact, asbestos-containing exterior white caulking should be abated following low-risk abatement work procedures as outlined in the *Saskatchewan Asbestos Abatement Manual* (2017). Alternatively, as the white caulking was observed in good condition, and with a priority rating of 5 (please see the room by room spreadsheet provided in Appendix C for a description of the priority ratings), the caulking can be managed in place if not scheduled for impact.
