May 31, 2017

## CITY OF SASKATOON

# Asbestos-Containing Building Materials Assessment Report - Lions Arena

**Report Number: 1667963**

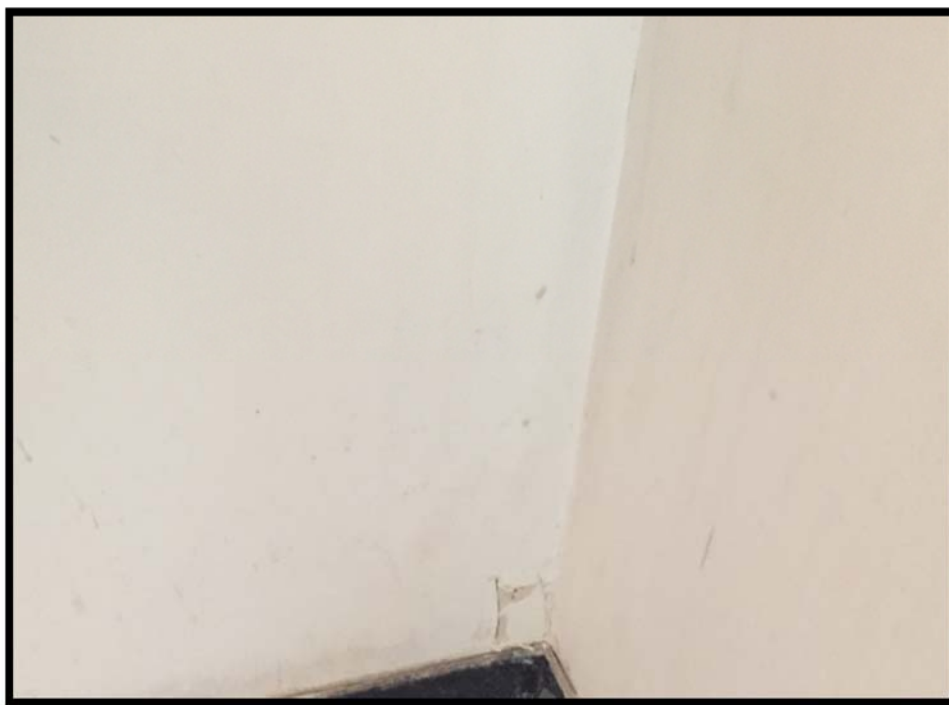
Eight (8) samples of drywall joint compound were collected during the assessment. Three of the samples collected within the second functional space were found to contain 1.8% to 2.1% Chrysotile asbestos. Asbestos-containing drywall joint compound (see Photograph 1 in Appendix B) was observed in the following locations:

- Room 107 (approximately 120 ft<sup>2</sup>);
- Room 108 (approximately 210 ft<sup>2</sup>);
- Room 109 (approximately 210 ft<sup>2</sup>); and
- Room 110 (approximately 120 ft<sup>2</sup>).

**Photograph 1: Asbestos-Containing Drywall Joint Compound.**

If scheduled for impact, asbestos-containing grey firestop should be abated following low-risk abatement work procedures as outlined in the *Saskatchewan Asbestos Abatement Manual* (2017). Alternatively, as the drywall joint compound was observed in good condition, and with a priority rating of 5 (please see the room by room spreadsheet provided in Appendix C for a description of the priority ratings), it can be managed in place if not scheduled for impact.

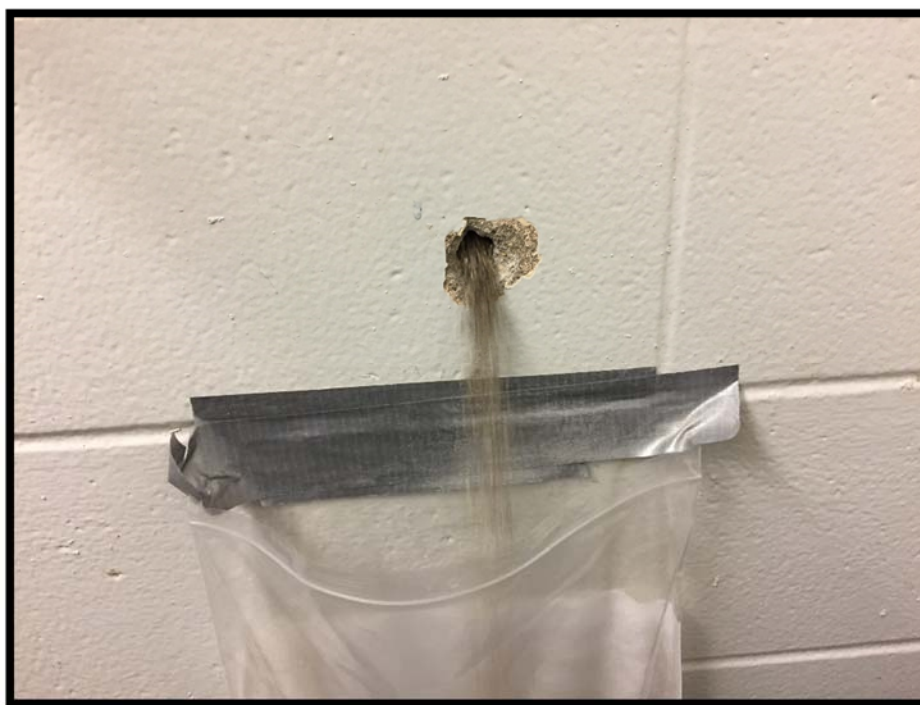
Three (3) samples of vermiculite were collected during the assessment. All three of the samples collected within the second functional space were found to contain 1.2% to 1.5% Actinolite asbestos. Asbestos-containing vermiculite (see Photograph 2 in Appendix B) was confirmed in the following locations:

- Room 104 (approximately 120 ft<sup>2</sup>);
- Room 112A (approximately 60 ft<sup>2</sup>); and
- Room 113 (approximately 120 ft<sup>2</sup>).

During the assessment, Golder cored into approximately 13 locations to evaluate for the presence or absence of vermiculite. The vermiculite insulation was observed to be located sporadically throughout the Site along exterior and interior walls. It is assumed that the vermiculite insulation is located around the perimeter walls of Rooms 113 to 101 based upon where the vermiculite insulation was observed, however this was not confirmed within each room. Please refer to the floor plan provided in Appendix D for the anticipated locations of the vermiculite. Further investigation activities may be required to confirm the exact locations of the vermiculite.

**Photograph 2: Asbestos-Containing Vermiculite Insulation.**

If scheduled for impact, asbestos-containing vermiculite insulation should be abated following high-risk abatement work procedures as outlined in the *Saskatchewan Asbestos Abatement Manual* (2017). Alternatively, as the vermiculite insulation is enclosed within block wall, with a priority rating of 5 (please see the room by room spreadsheet provided in Appendix C for a description of the priority ratings), it can be managed in place if not scheduled for impact.

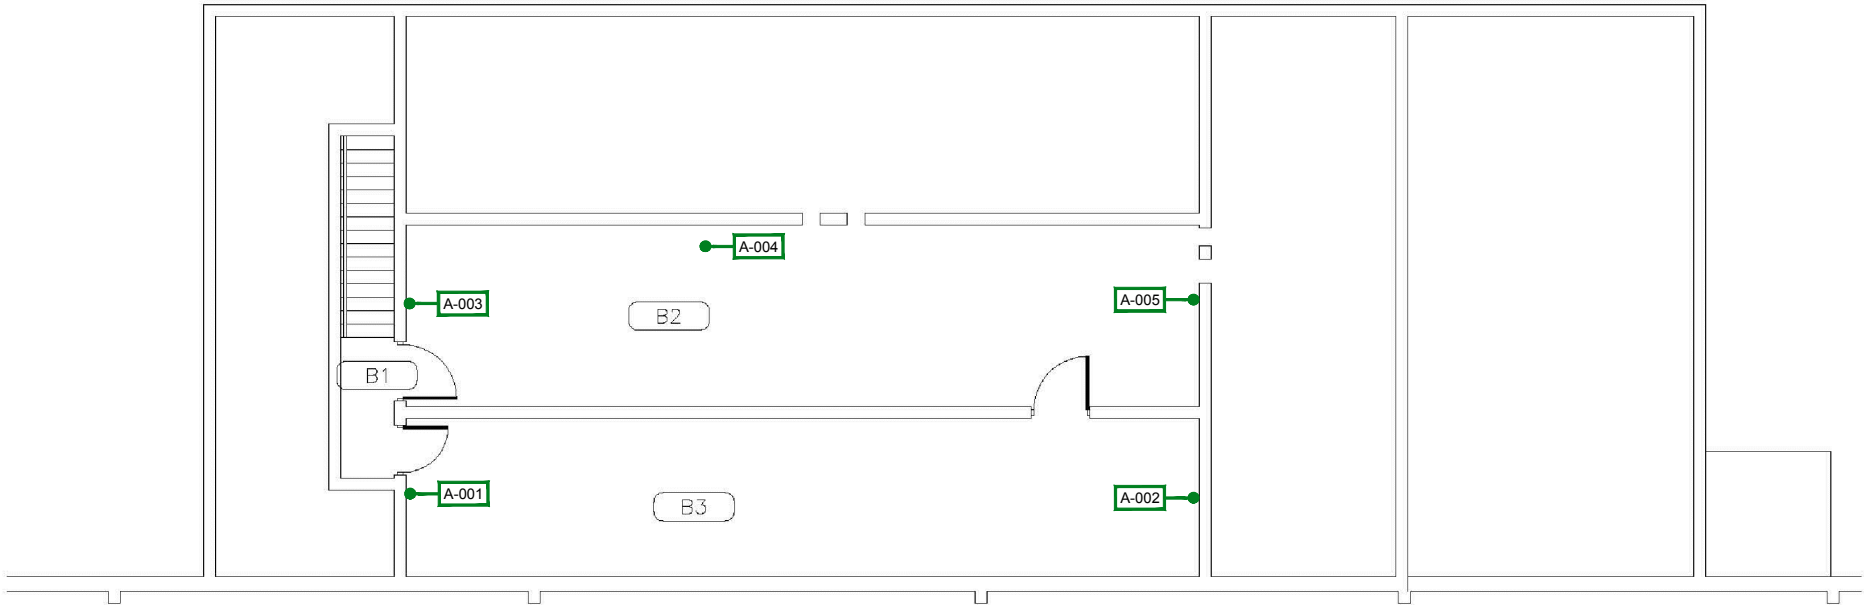
- 1. ASBESTOS IS A CARCINOGEN. DO NOT BREATHE ASBESTOS DUST.
- 2. ASBESTOS-CONTAINING VERMICULITE INSULATION WAS IDENTIFIED IN SELECT LOCATIONS OF THE SITE. ADDITIONAL ASBESTOS-CONTAINING VERMICULITE INSULATION MAY BE LOCATED IN ADDITIONAL BLOCK WALL THROUGHOUT THE SITE.

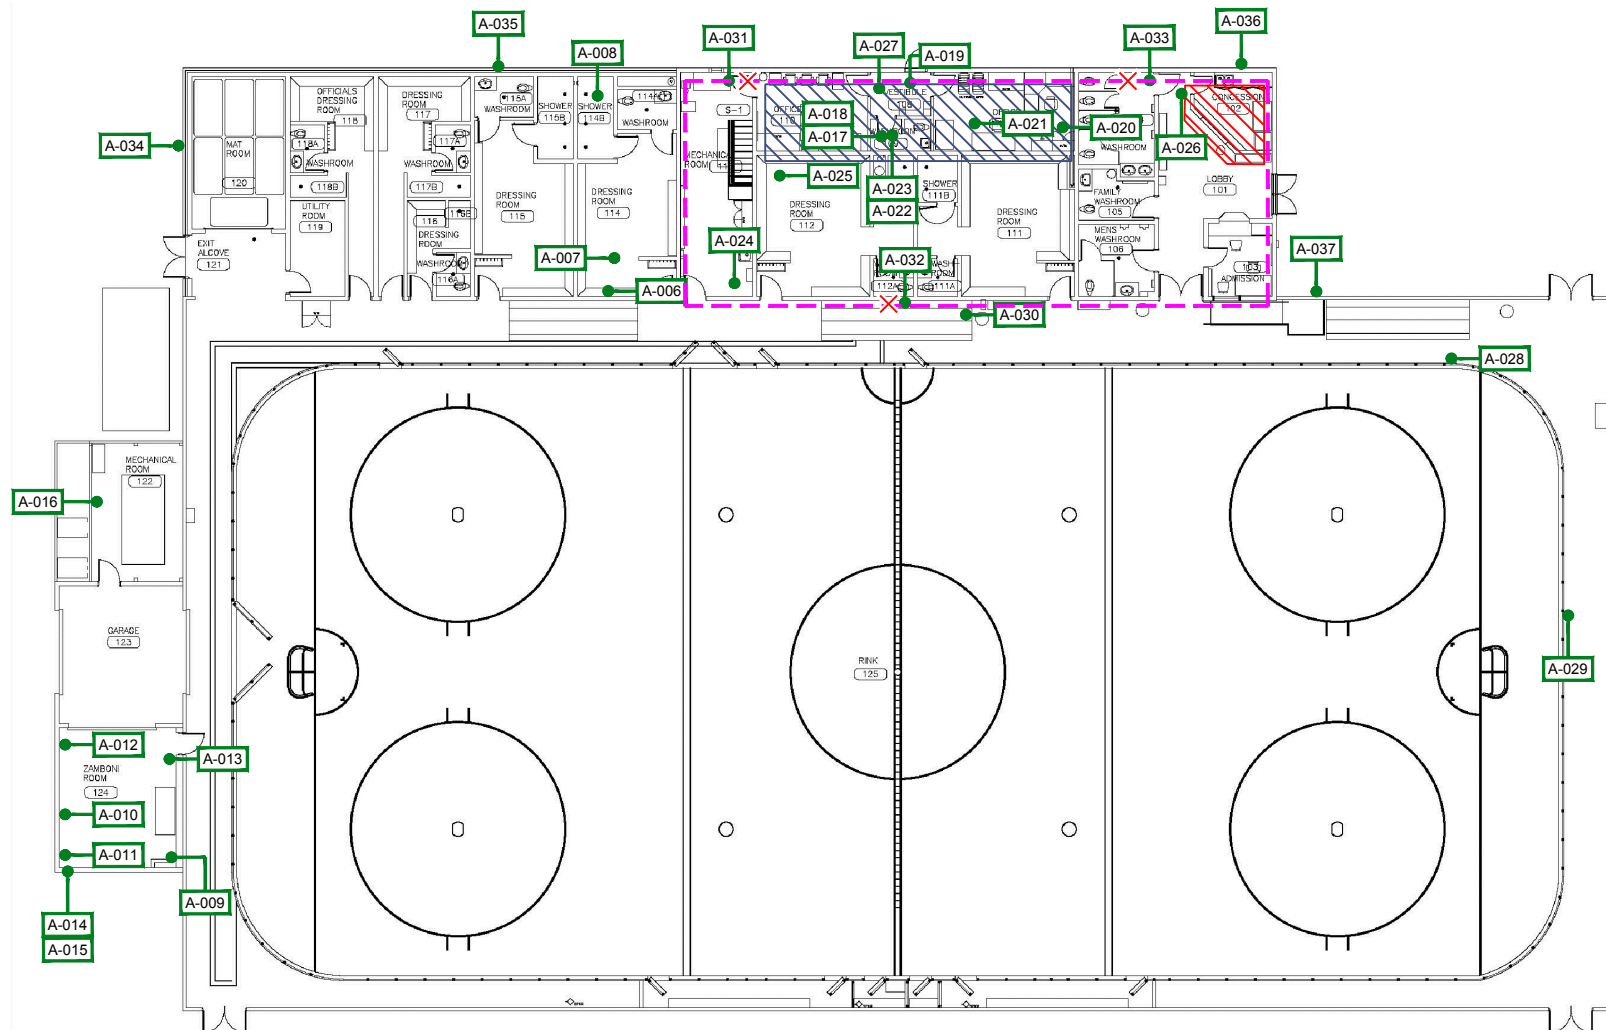
1. ASBESTOS IS A CARCINOGEN. DO NOT BREATHE ASBESTOS DUST.
2. ASBESTOS-CONTAINING VERMICULITE INSULATION WAS IDENTIFIED IN SELECT LOCATIONS OF THE SITE. ADDITIONAL ASBESTOS-CONTAINING VERMICULITE INSULATION MAY BE LOCATED IN ADDITIONAL BLOCK WALL THROUGHOUT THE SITE.
