CITY OF SASKATOON

Asbestos-Containing Building Materials Assessment Report - Landfill Main Office

Report Number: 1667963

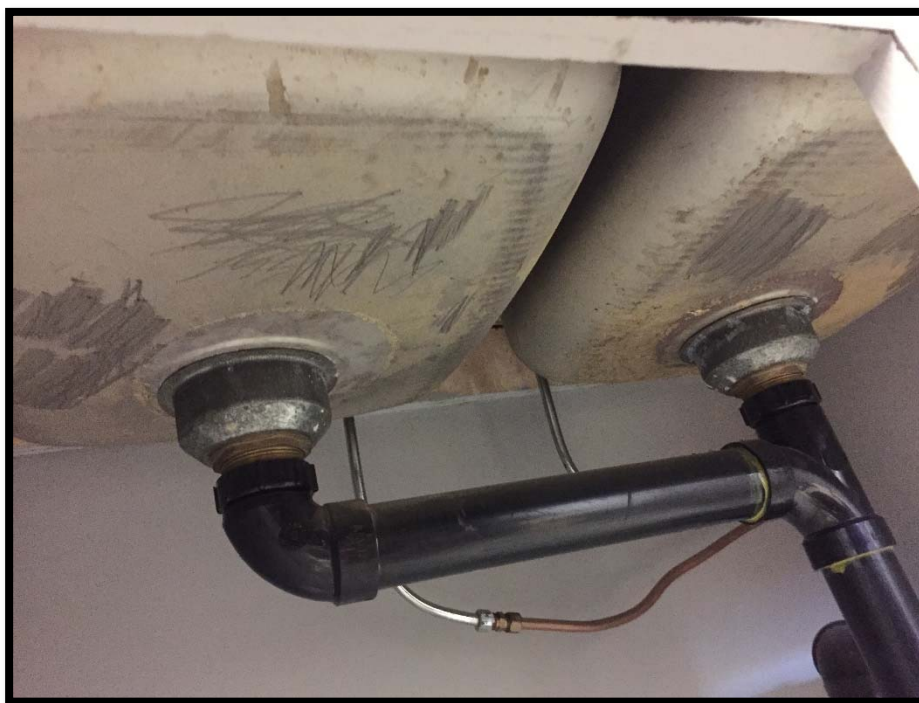
One (1) sample of silver sink undercoat was collected during the assessment. The sample collected was found to contain 2.0% Chrysotile asbestos. Asbestos-containing silver sink undercoat (see Photograph 1 in Appendix B) was observed in the following location:

- Room 103 (approximately 2 sinks).

Photograph 1: Asbestos-Containing Silver Sink Undercoat.

If scheduled for impact, asbestos-containing silver sink undercoat should be abated following low-risk abatement work procedures as outlined in the *Saskatchewan Asbestos Abatement Manual* (2017). Alternatively, as the silver sink undercoat was observed in good condition, and with a priority rating of 5 (please see the room by room spreadsheet provided in Appendix C for a description of the priority ratings), it can be managed in place if not scheduled for impact.

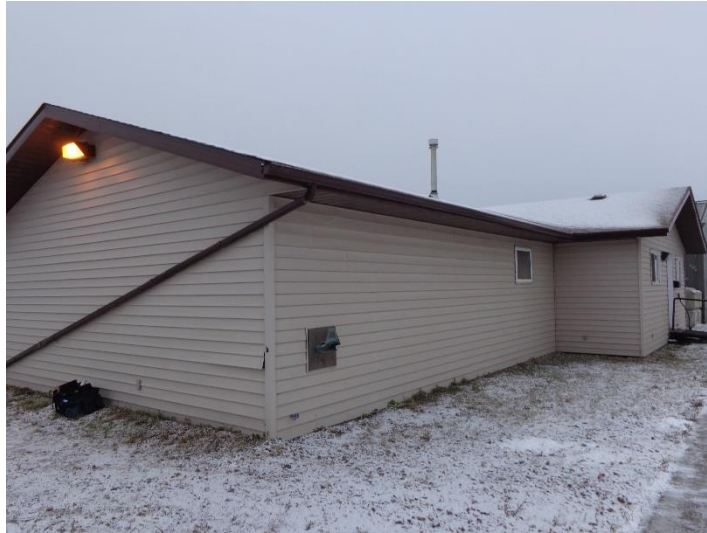
PHOTO 1 – EXTERIOR MAIN OFFICE

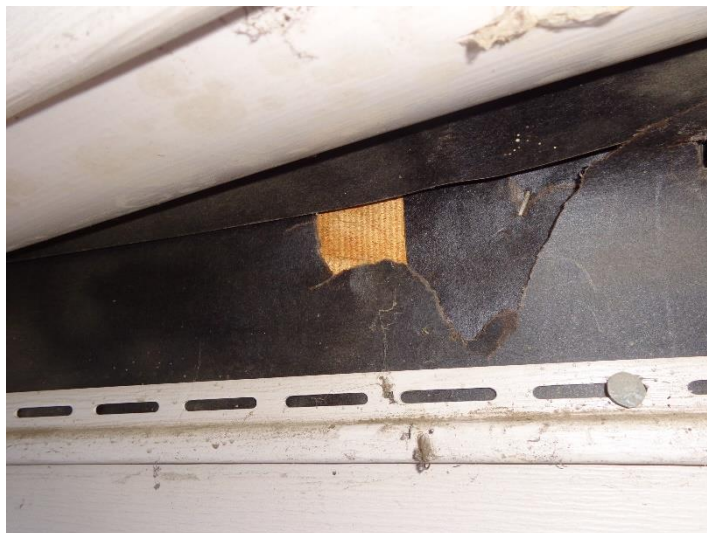
PHOTO 2 – EXTERIOR TAR PAPER SAMPLE #2

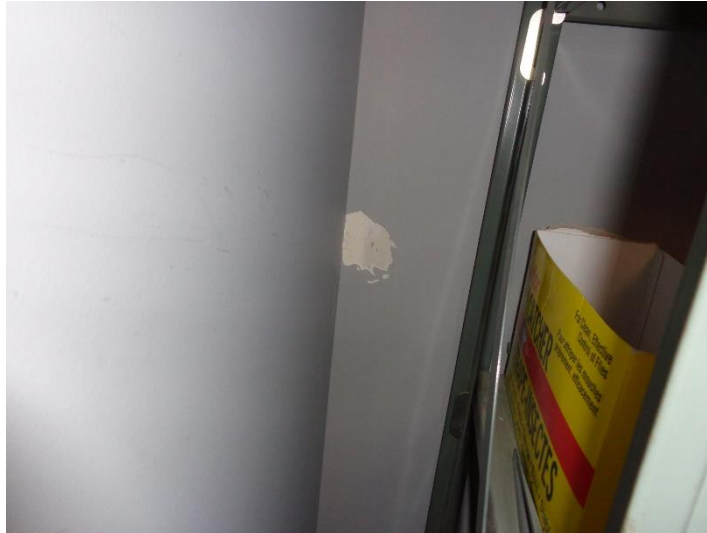
**PHOTO 3 – INTERIOR 108 WOMEN’S WASHROOM STORAGE ROOM
DRYWALL MUD COMPOUND SAMPLE #1**

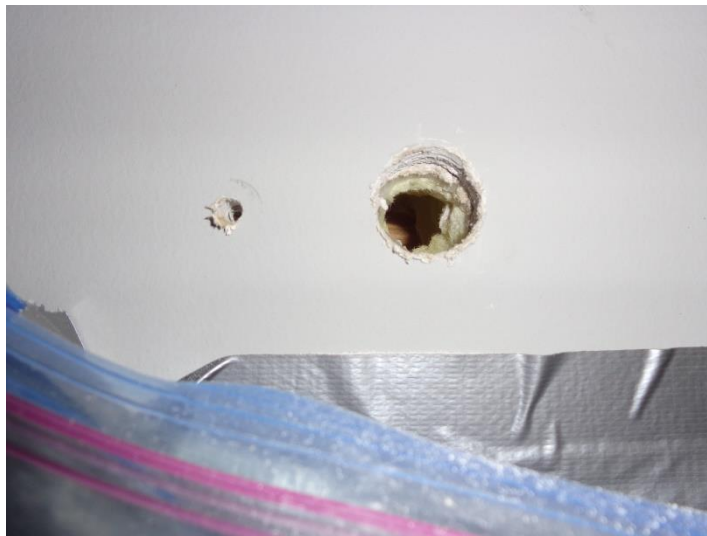
**PHOTO 4 – INTERIOR 108 WOMEN’S WASHROOM STORAGE ROOM
NORTH WALL COMPOSITION**
