CITY OF SASKATOON

Asbestos-Containing Building Materials Assessment Report - Lakewood Civic Centre and Cliff Wright Library

Report Number: 1667963

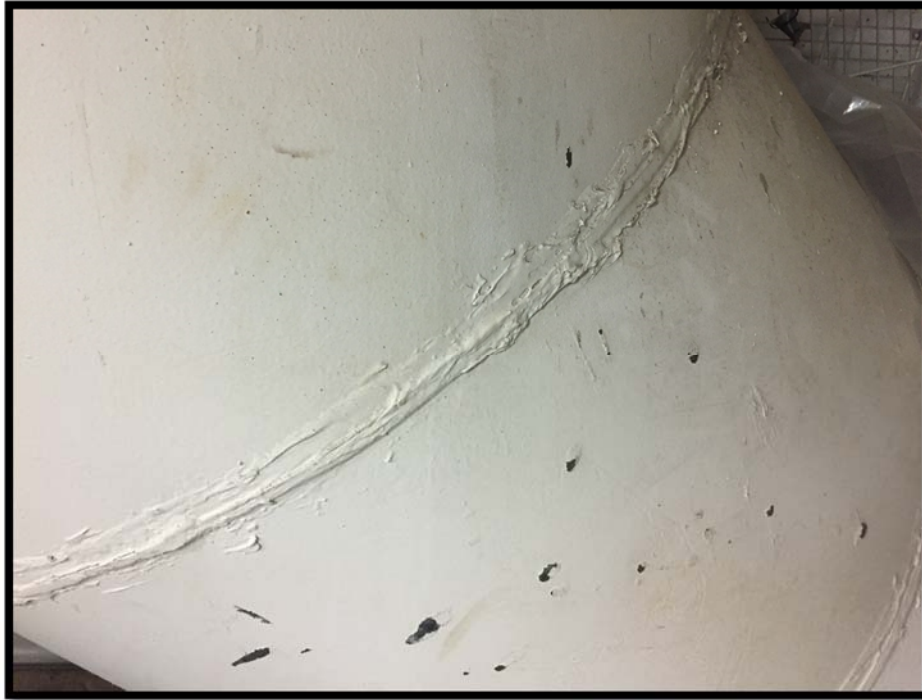
Three (3) samples of duct mastic painted white were collected during the assessment. One of the samples collected was found to contain 0.5% Chrysotile asbestos. Based upon observations on site and from the laboratory analysis report, the sample found to contain asbestos was observed to be white paint over tan mastic. The two remaining white duct mastic samples were observed to be white paint over brown mastic. Due to the white paint concealing the color of the duct mastic, all duct mastic painted white within the lower level should be treated as asbestos-containing until further sampling or historical information is provided. The duct mastic painted white sampled on the main floor (a separate functional space) was observed to be white paint over brown mastic, and other duct mastic painted white on the main floor was observed to be white paint over grey duct mastic, however consideration should be given to conduct further sampling to evaluate if asbestos-containing tan mastic is present below the white paint on the main floor.

Asbestos-containing tan duct mastic (painted white) (see Photograph 1 in Appendix B) was observed in the following locations:

- Room B01 (approximately 40 ft);
- Room B02 (approximately 400 ft); and
- Room B03 (approximately 500 ft).

Photograph 1: Asbestos-Containing Tan Duct Mastic (Painted White).

If scheduled for impact, asbestos-containing tan duct mastic (painted white) should be abated following low-risk abatement work procedures as outlined in the *Saskatchewan Asbestos Abatement Manual* (2017). Alternatively, as the tan duct mastic (painted white) was observed in good condition, and with a priority rating of 5 (please see the room by room spreadsheet provided in Appendix C for a description of the priority ratings), it can be managed in place if not scheduled for impact.

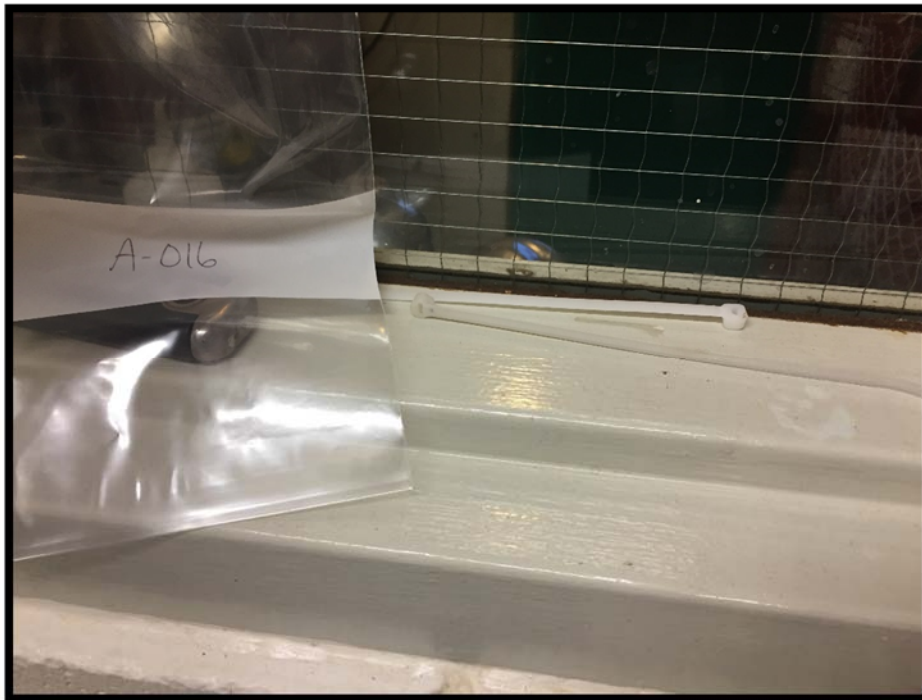
Three (3) samples of interior black window caulking were collected during the assessment. Two of the samples collected were found to contain 4.7% to 5.7% Chrysotile asbestos.

Asbestos-containing interior black window caulking (see Photograph 2 in Appendix B) was observed in the following locations:

- Room 112 (approximately 20 linear feet);
- Vestibule adjacent to Room 122 (approximately 120 linear feet);
- Room 122 (approximately 10 linear feet);
- Corridor 128 (approximately 100 linear feet);
- Room 175 (approximately 65 linear feet);
- Room 187 (approximately 65 linear feet); and
- Room 188 (approximately 200 linear feet).

Photograph 2: Asbestos-Containing Black Window Caulking.

If scheduled for impact, asbestos-containing black interior window caulking should be abated following low-risk abatement work procedures as outlined in the *Saskatchewan Asbestos Abatement Manual* (2017). Alternatively, as the black interior window caulking was observed in good condition, and with a priority rating of 5 (please see the room by room spreadsheet provided in Appendix C for a description of the priority ratings), it can be managed in place if not scheduled for impact.

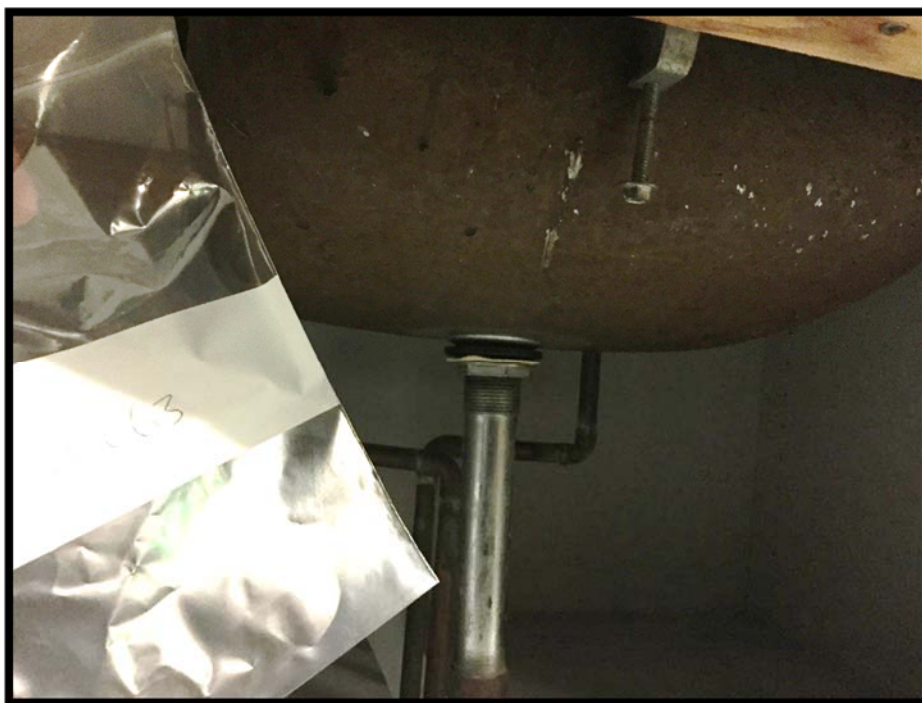
One (1) sample of gold sink undercoat was collected during the assessment. The sample collected was found to contain 0.25% Chrysotile asbestos.

Asbestos-containing gold sink undercoat (see Photograph 3 in Appendix B) was observed in the following location:

- Room 103 (approximately 1 sink).

Photograph 3: Asbestos-Containing Gold Sink Undercoat.

If scheduled for impact, asbestos-containing gold sink undercoat should be abated following low-risk abatement work procedures as outlined in the *Saskatchewan Asbestos Abatement Manual* (2017). Alternatively, as the gold sink undercoat was observed in good condition, and with a priority rating of 5 (please see the room by room spreadsheet provided in Appendix C for a description of the priority ratings), it can be managed in place if not scheduled for impact.

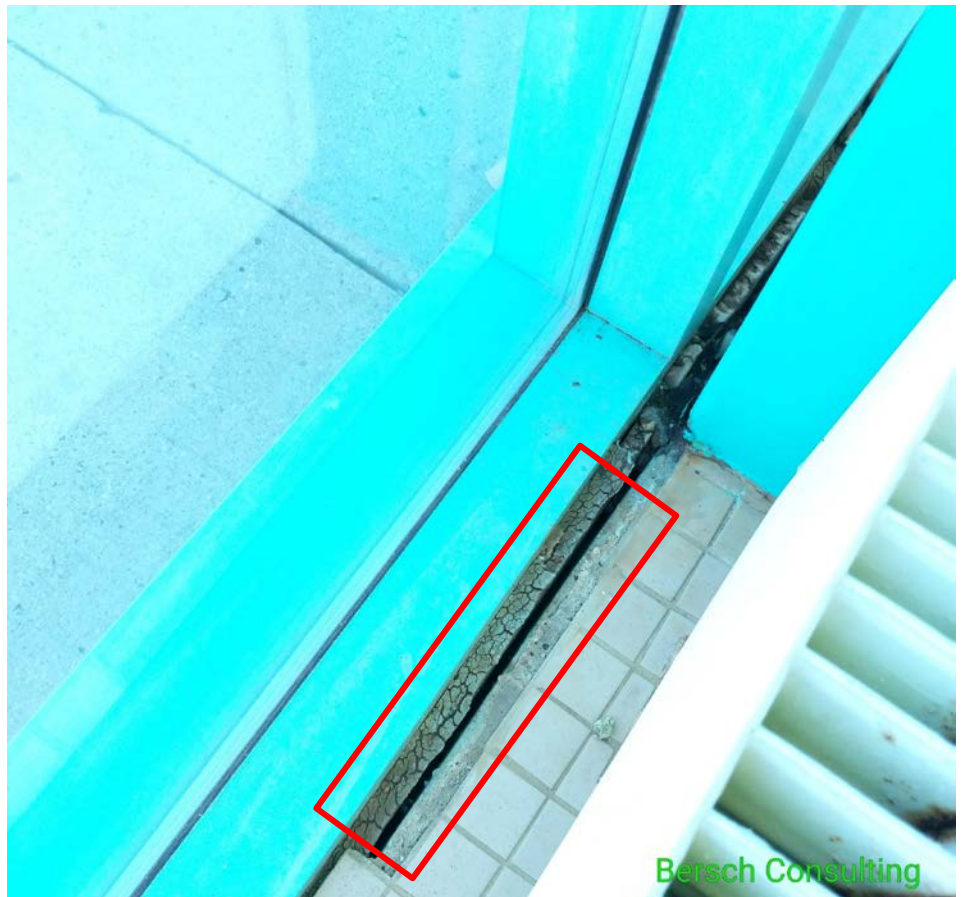
B67BLH20I - 002

Backing Board.
Between South Windows & Floor.

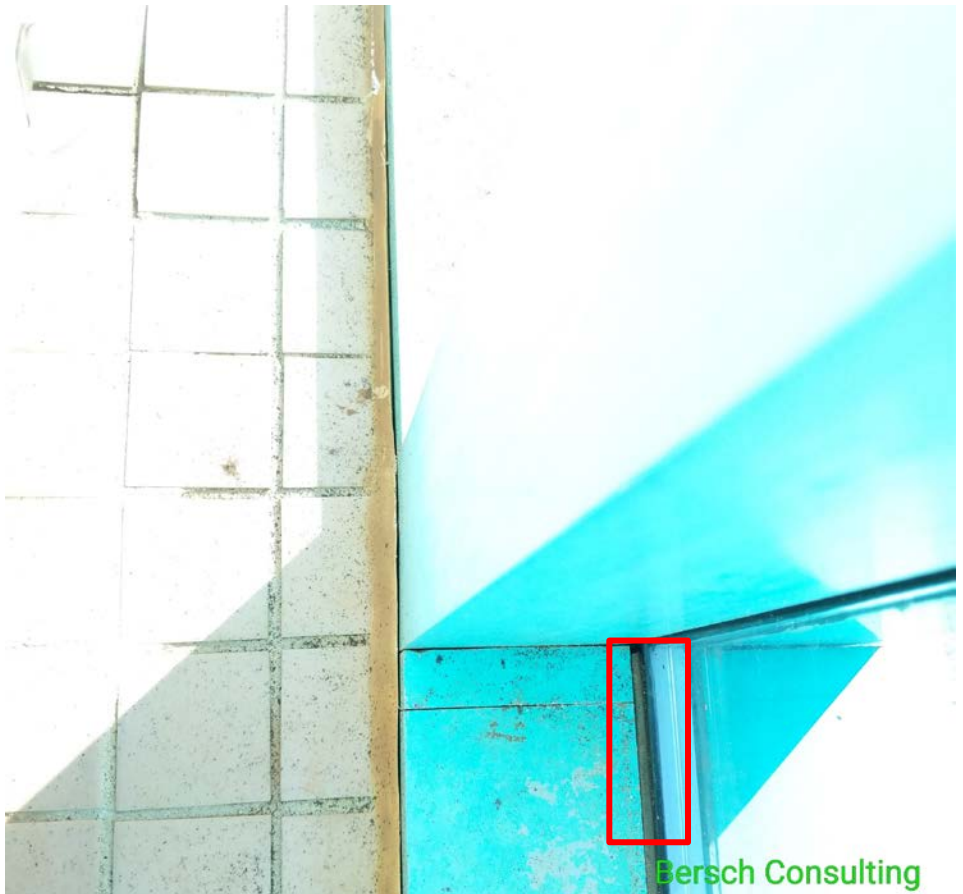
B67BLH20I – 003

Window caulking.
SW interior window.

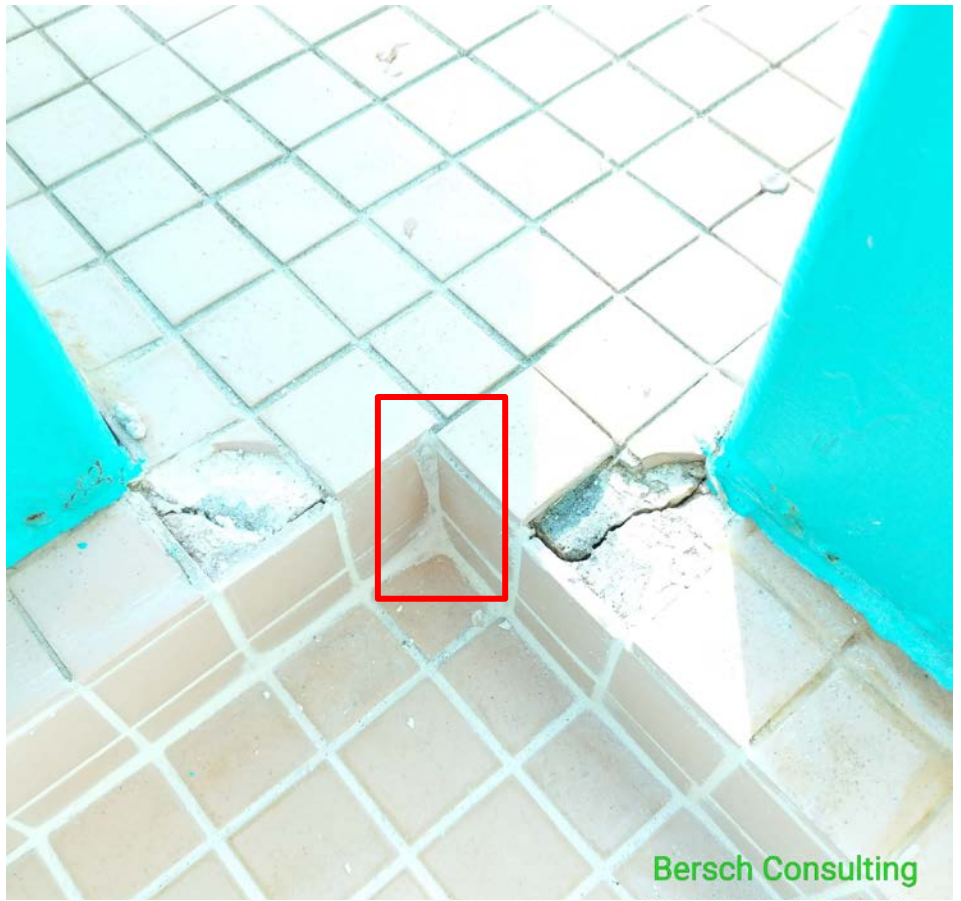
B67BLH20I – 004

White tile grout.

SW corner near pool.

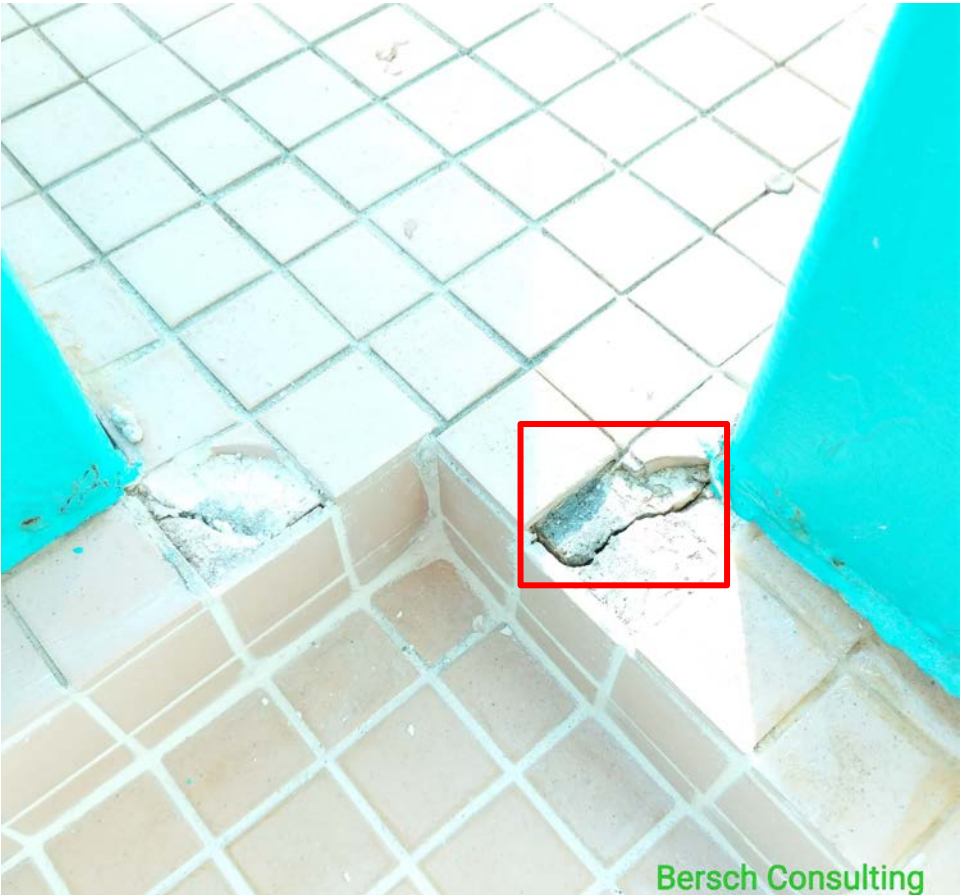
B67BLH20I - 005

Grey tile grout

SW corner near pool.

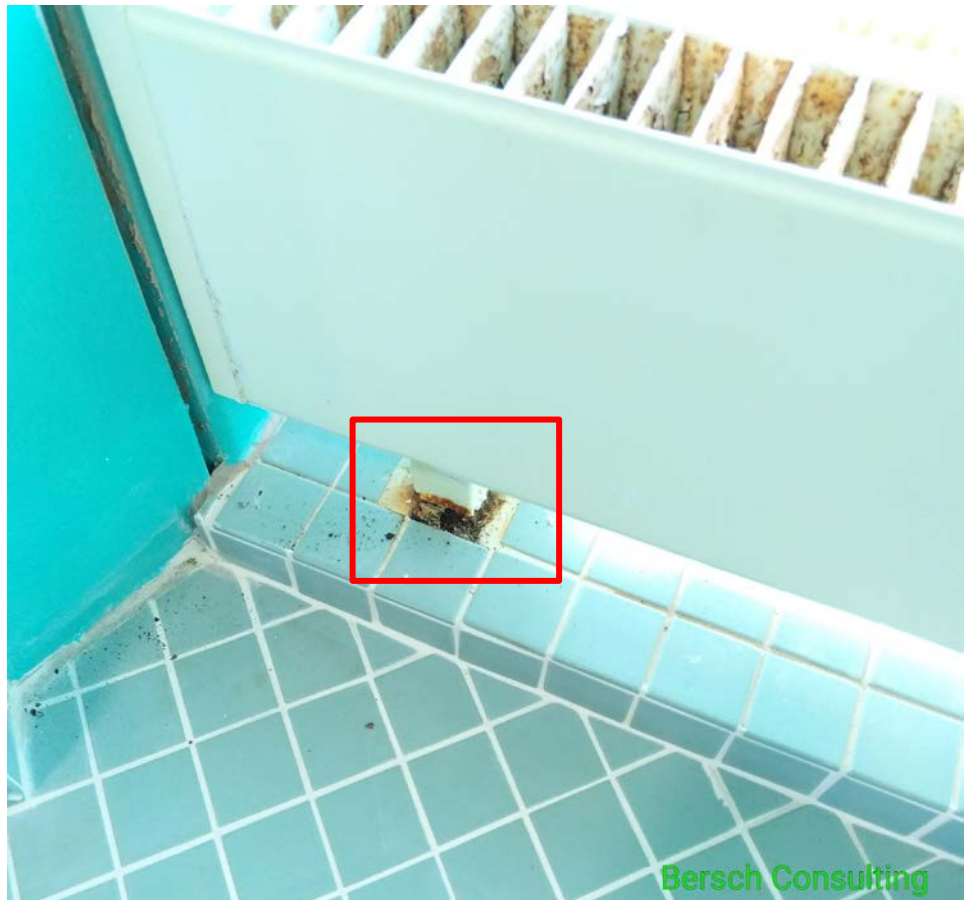
B67BLH20I - 006

White tile grout.

South radiator

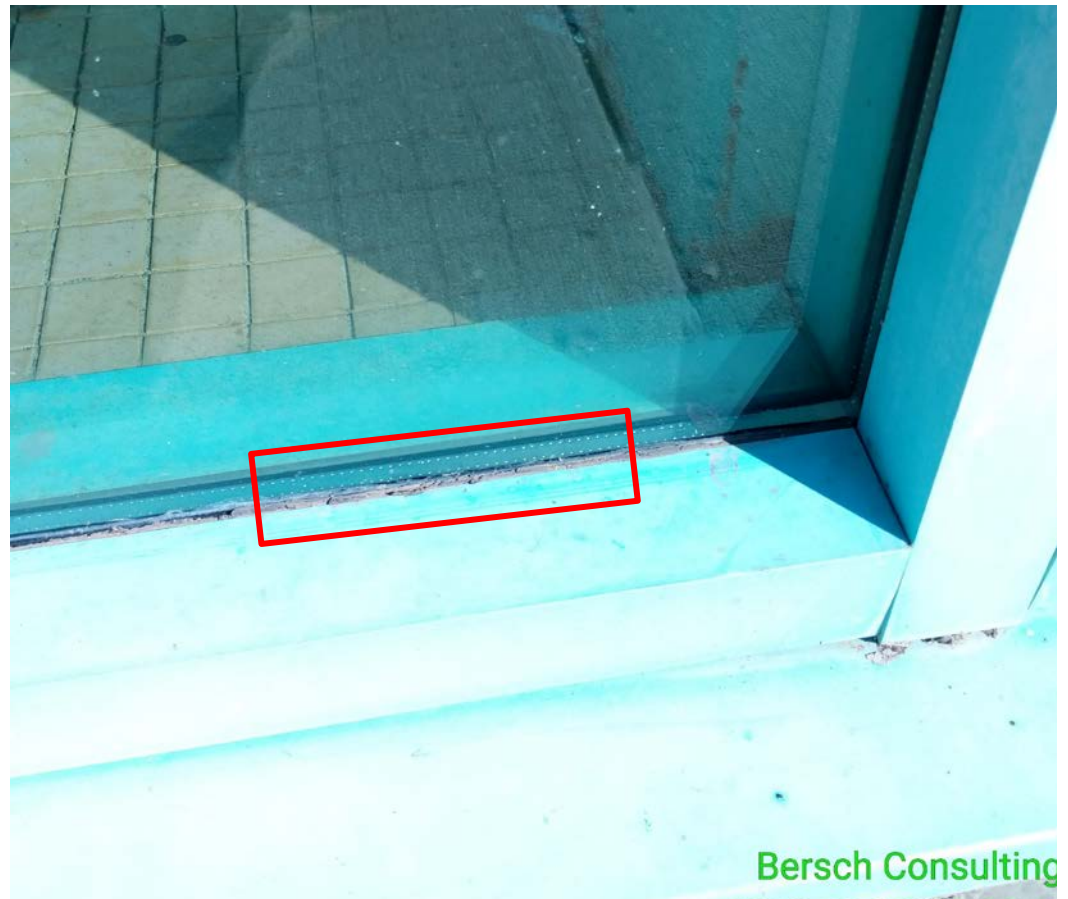
B67BLH20I - 007

Black window caulking.

SW exterior window.

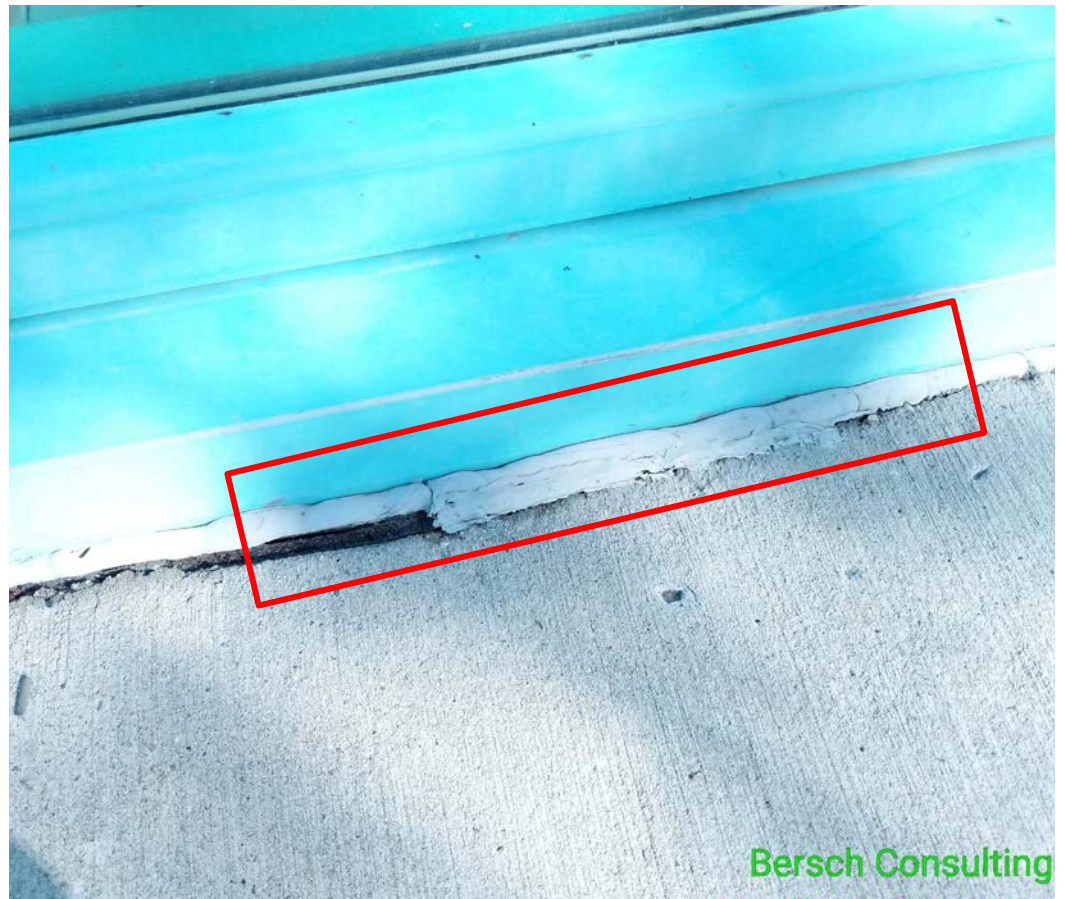
Grey caulking.

On sidewalk south exterior wall.
