**Building:** Mendel Art Gallery

**City of Saskatoon  
Mendel Art Gallery  
Asbestos Survey Report**

**December 2015**

**Prepared For: City of Saskatoon - Infrastructure Services – Facilities Branch  
Mendel Art Gallery  
950 Spadina Crescent East, Saskatoon, SK.  
Attn: Brent Anderson**

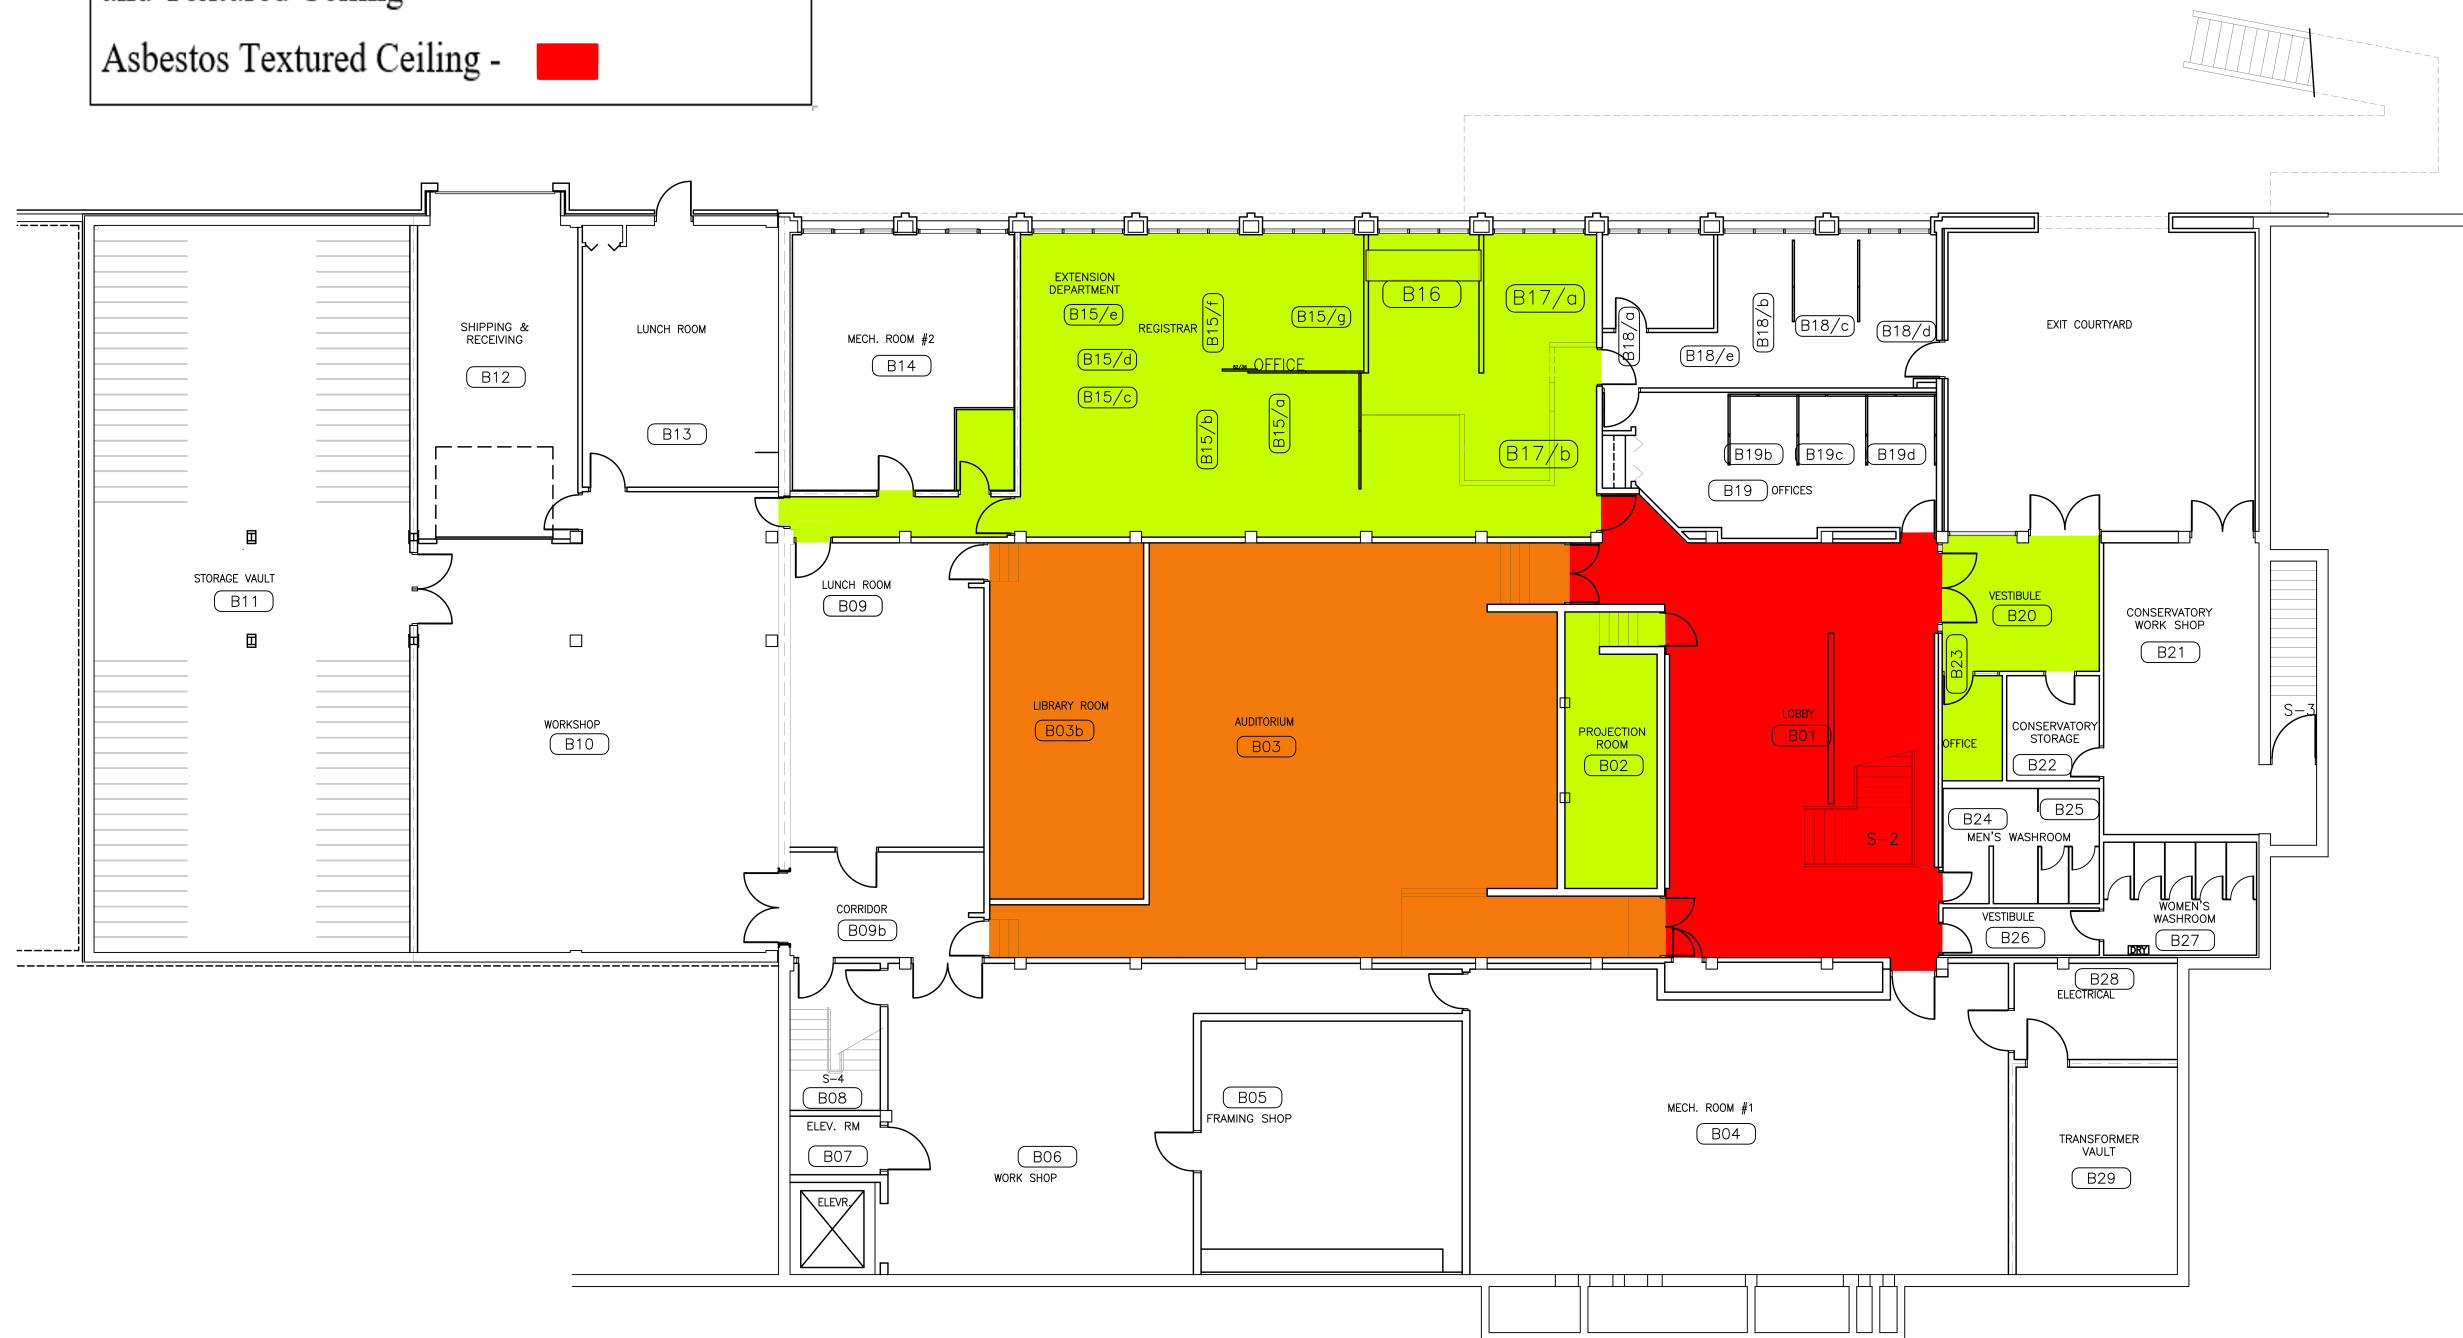
and Textured Ceiling -

Asbestos Textured Ceiling -

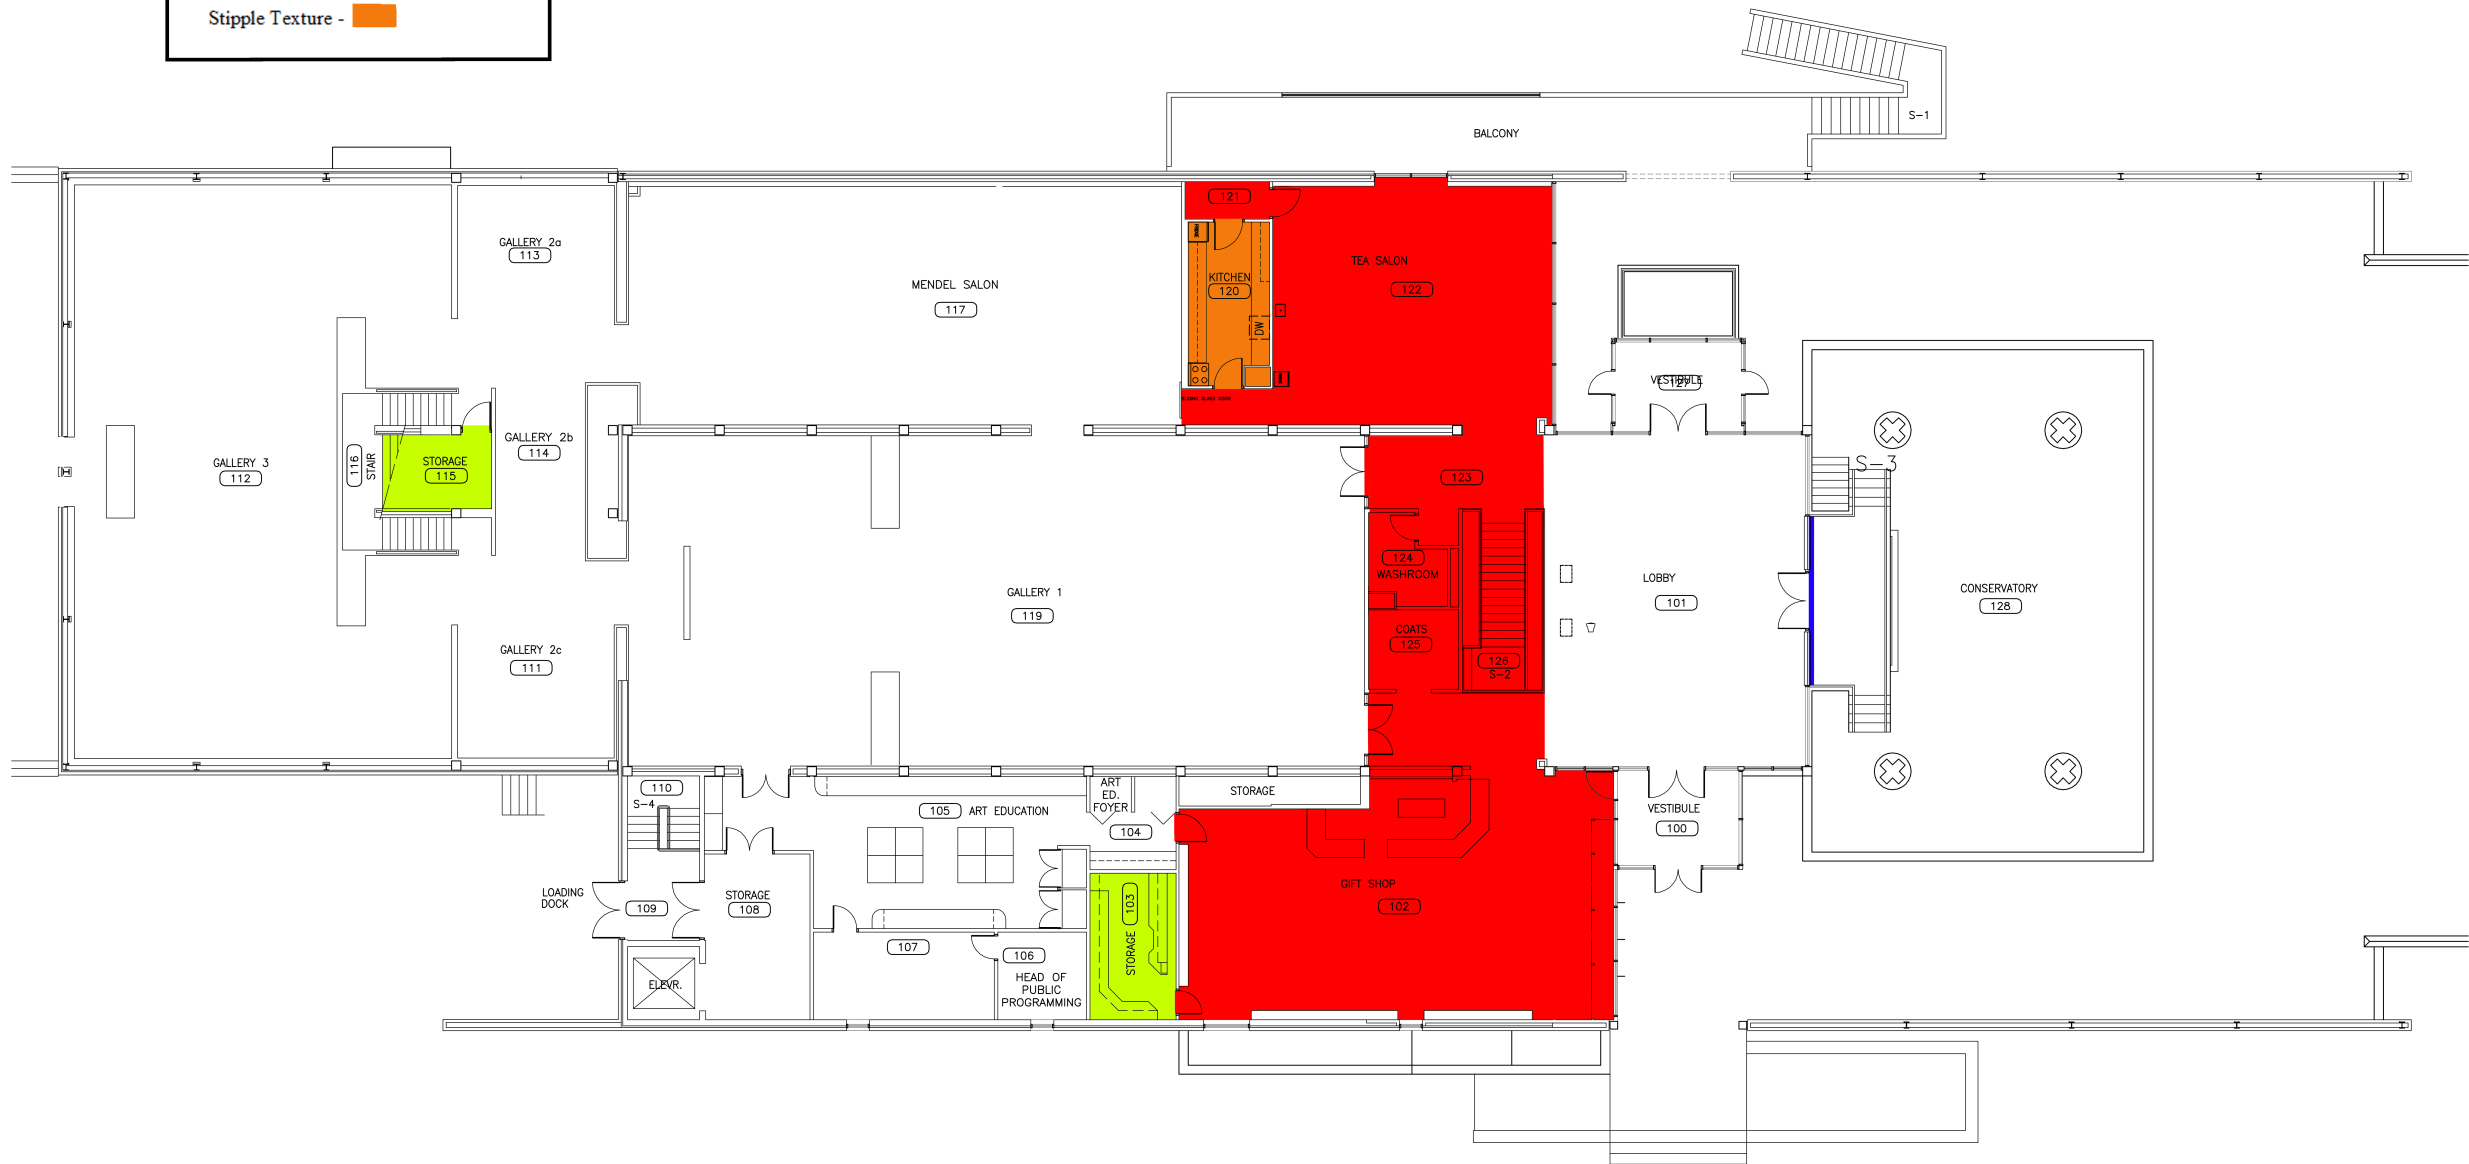
- Asbestos Floor Tile &  
Stipple Texture -
