CITY OF SASKATOON

Asbestos-Containing Building Materials Assessment Report - Marr Residence

Report Number: 1667963

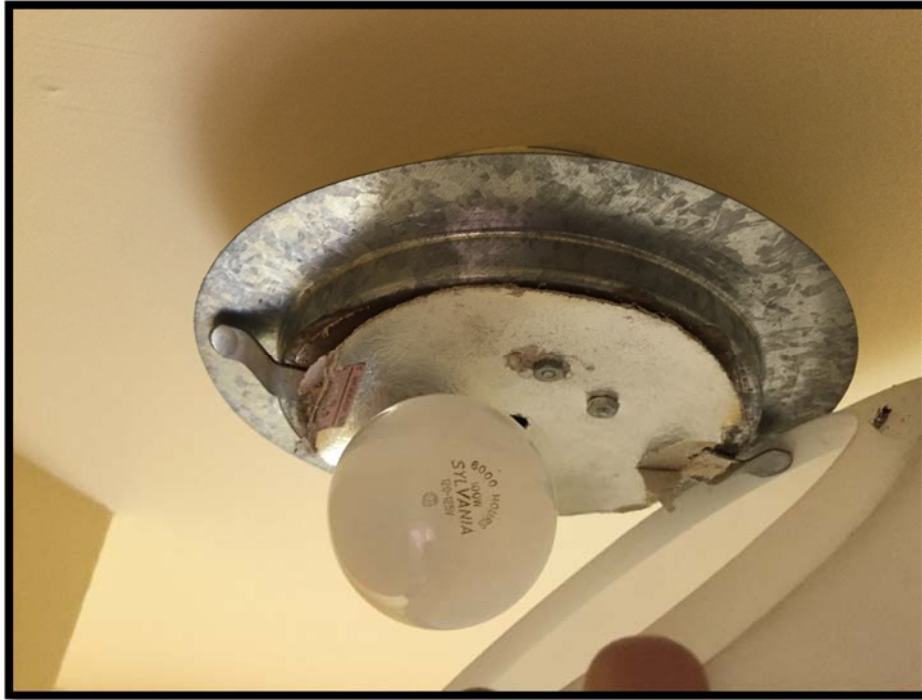
One (1) sample of incandescent light fixture paper was collected during the assessment. The sample collected was found to contain 80% Chrysotile asbestos. Asbestos-containing incandescent light fixture paper (see Photograph 3 in Appendix B) was observed in the following locations:

- Room 104 (approximately 1 light).

Photograph 3: Asbestos-Containing Incandescent Light Fixture Paper.

If scheduled for impact, asbestos-containing incandescent light fixture paper should be abated following low-risk abatement work procedures as outlined in the *Saskatchewan Asbestos Abatement Manual* (2017). Alternatively, as the duct paper wrap was observed in good condition, and with a priority rating of 4 (please see the room by

room spreadsheet provided in Appendix C for a description of the priority ratings), it can be managed in place if not scheduled for impact however removal should be conducted in a reasonable timeframe.
