December 4, 2017

CITY OF SASKATOON

Asbestos-Containing Building Materials Assessment Report - Mayfair Lawn Bowling Clubhouse

Report Number: 1667963

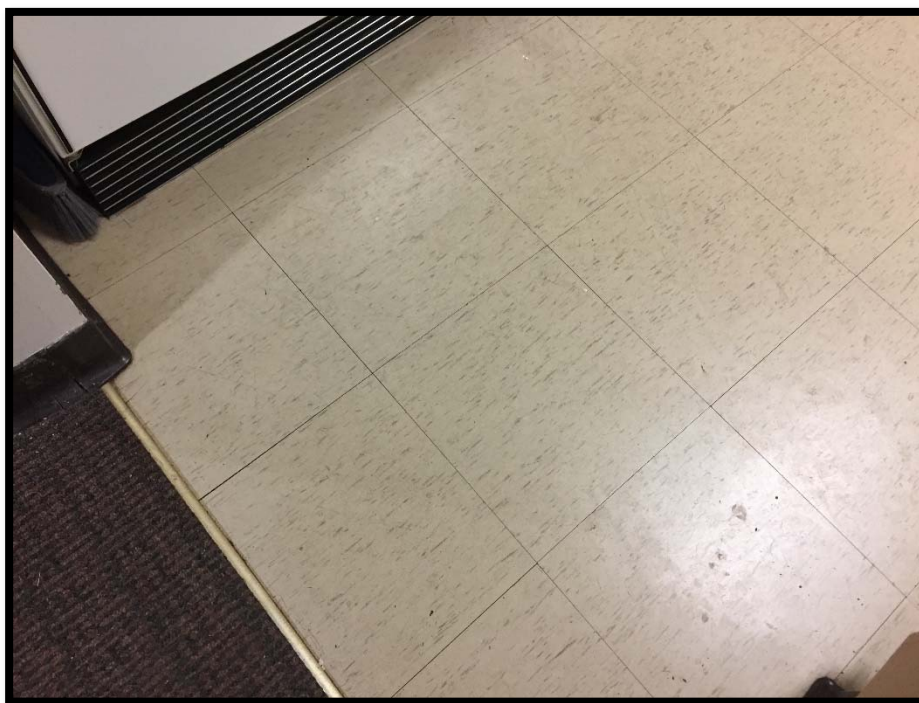
12"x12" Beige Floor Tile with Brown Streaks

One (1) sample of 12"x12" beige floor tile with brown streaks was collected during the assessment. The sample collected was found to contain 2.3% Chrysotile asbestos. Asbestos-containing 12"x12" beige floor tile with brown streaks (see Photograph 1 in Appendix B) was observed in the following locations:

- Room 102 (approximately 230 ft²);
- Room 103 (approximately 35 ft²);
- Room 104 (approximately 150 ft²);
- Room 106 (approximately 40 ft²);
- Room 107 (approximately 150 ft²); and
- Room 108 (approximately 10 ft²).

Additional asbestos-containing 12"x12" beige floor tile with brown streaks may be located below the carpet in other areas of the Site.

Photograph 1: Asbestos-Containing 12"x12" Beige Floor Tile with Brown Streaks.

12"x12" Beige Floor Tile with Brown Streaks

If scheduled for impact, asbestos-containing 12"x12" beige floor tile with brown streaks should be abated following low-risk abatement work procedures as outlined in the *Saskatchewan Asbestos Abatement Manual* (2017). Alternatively, as the 12"x12" beige floor tile with brown streaks was observed in good condition, and with a priority rating of 5 (please see the room by room spreadsheet provided in Appendix C for a description of the priority ratings), it can be managed in place if not scheduled for impact.

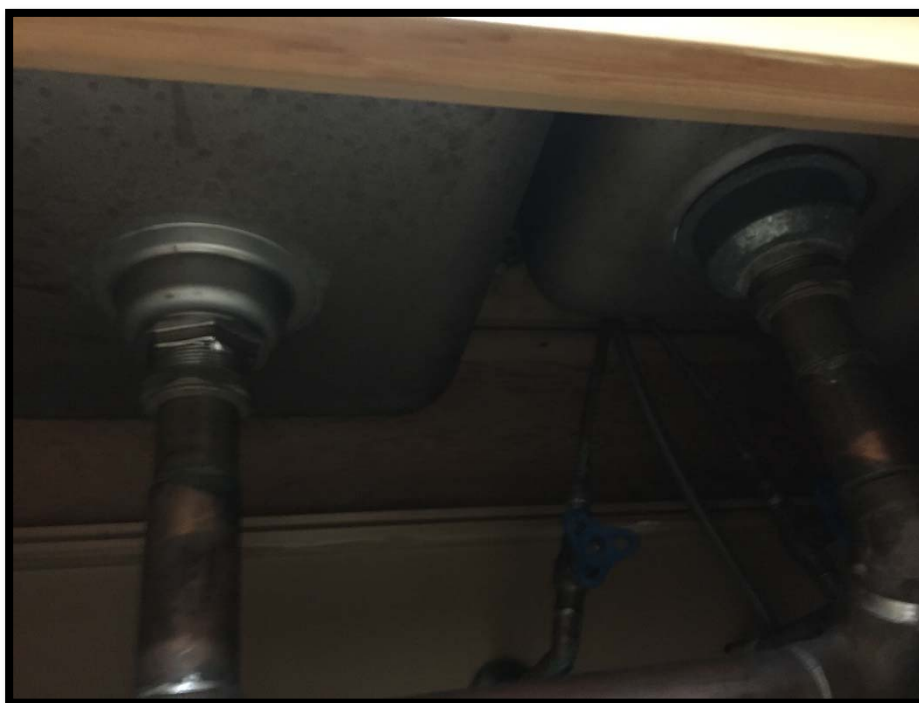
Silver Sink Undercoat

One (1) sample of silver sink undercoat was collected during the assessment. The sample collected was found to contain 1.7% Chrysotile asbestos. Asbestos-containing silver sink undercoat (see Photograph 2 in Appendix B) was observed in the following location:

- Room 102 (approximately 3 sinks).

Photograph 2: Asbestos-Containing Silver Sink Undercoat.

Silver Sink Undercoat

If scheduled for impact, asbestos-containing silver sink undercoat should be abated following low-risk abatement work procedures as outlined in the *Saskatchewan Asbestos Abatement Manual* (2017). Alternatively, as the silver sink undercoat was observed in good condition, and with a priority rating of 5 (please see the room by room spreadsheet provided in Appendix C for a description of the priority ratings), it can be managed in place if not scheduled for impact.
