## CITY OF SASKATOON

# Asbestos-Containing Building Materials Assessment Report - Mendel Park Site Washrooms

**Report Number: 1667963**

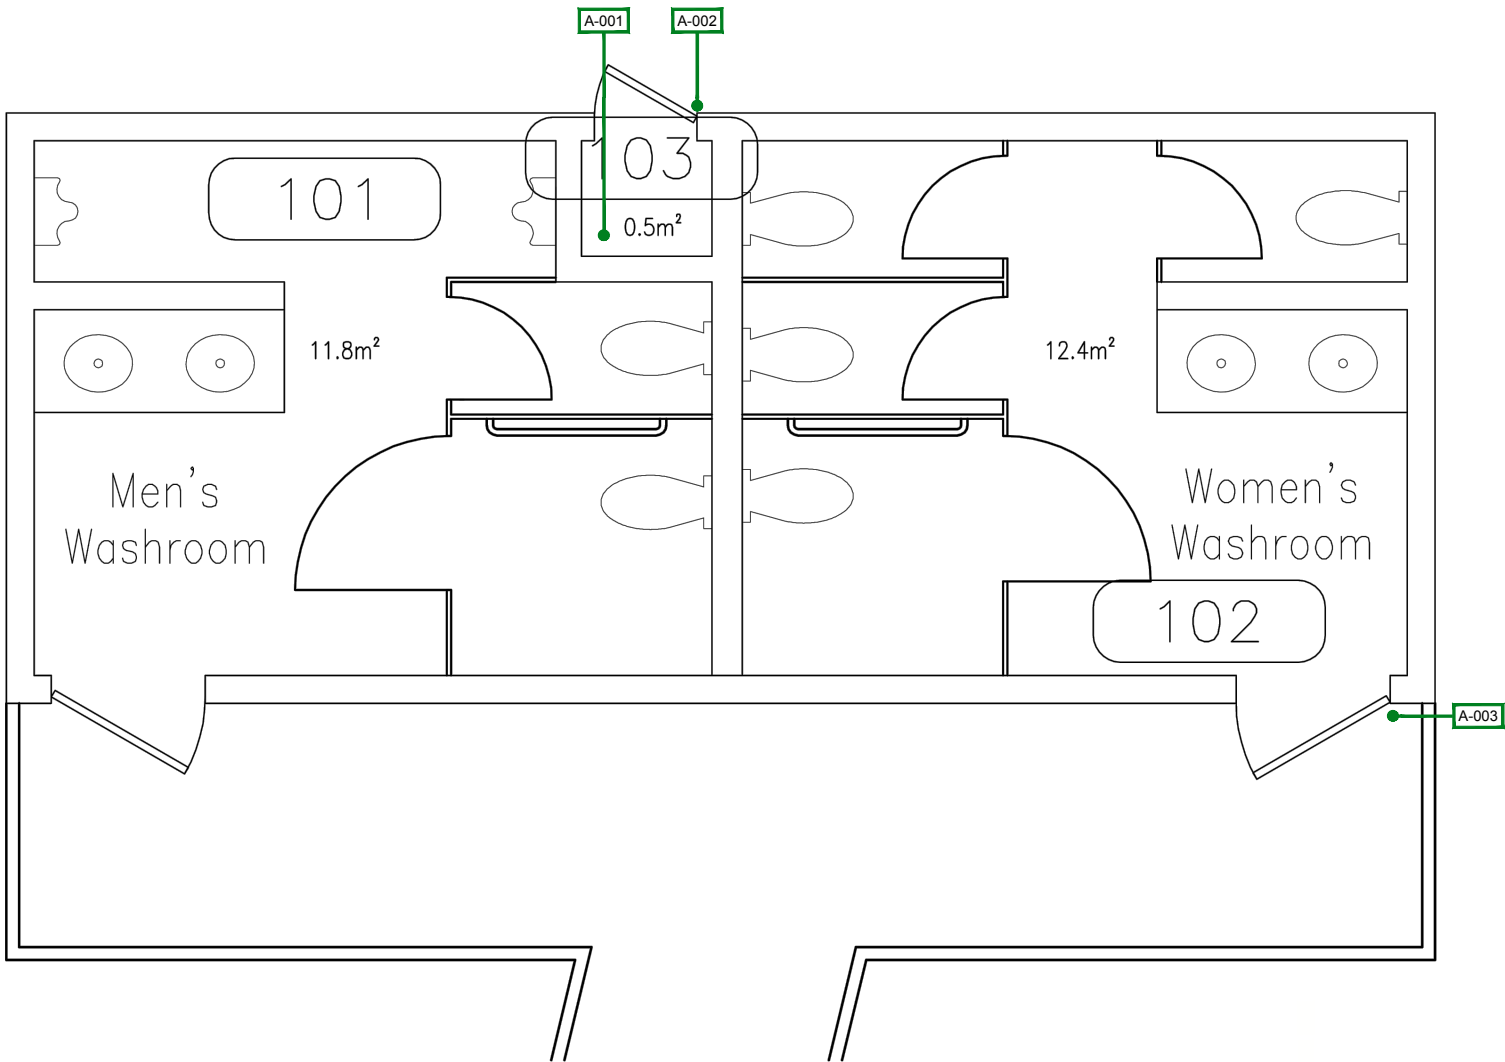
**TITLE**  
MAIN FLOOR

1. ASBESTOS IS A CARCINOGEN. DO NOT BREATHE ASBESTOS DUST.  
2. ASBESTOS-CONTAINING MATERIALS WERE NOT OBSERVED WITHIN THE WASHROOMS AT THE TIME OF THE ASSESSMENT.
