Asbestos-Containing Building Materials Assessment Report - Nutana Lawn Bowling Storage Garage

Report Number: 1667963

PROJECT
ASBESTOS ASSESSMENT
NUTANA LAWN BOWLING STORAGE GARAGE
310 - 7TH STREET EAST

Asbestos-Containing Building Materials Assessment Report - Nutana Lawn Bowling Storage Shed

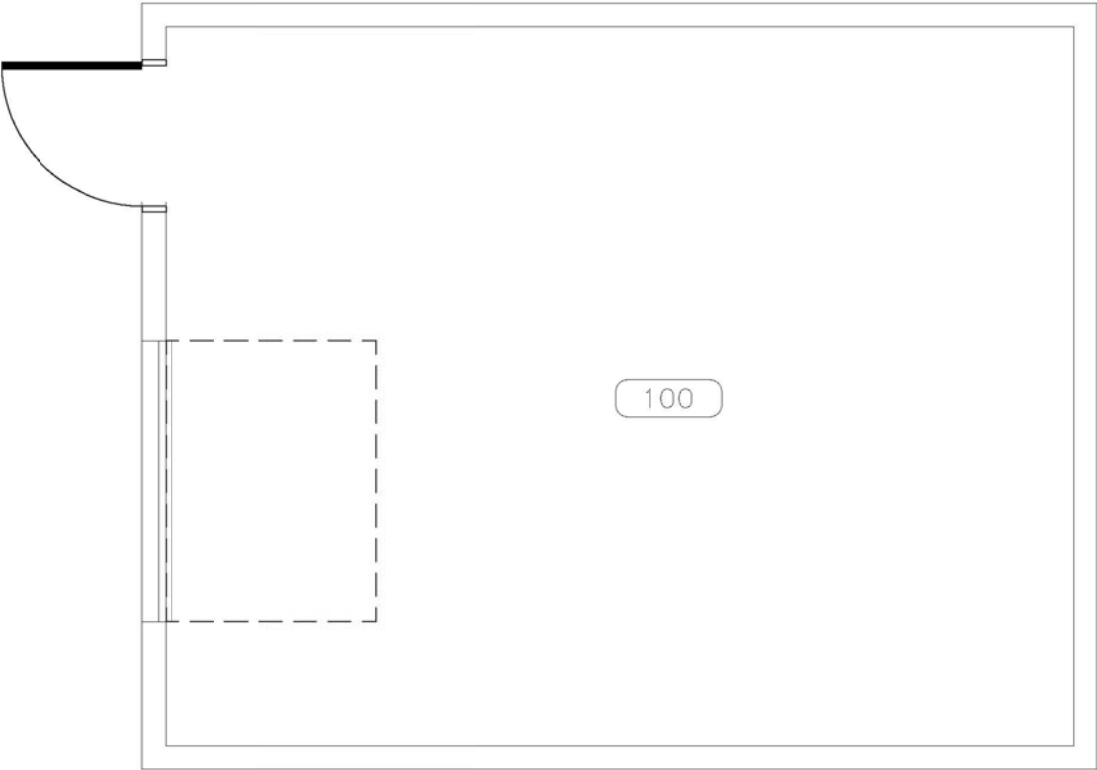
TITLE
STORAGE GARAGE

NOTE(S)
1. ASBESTOS IS A CARCINOGEN. DO NOT BREATHE ASBESTOS DUST.
2. ASBESTOS-CONTAINING MATERIALS WERE NOT OBSERVED WITHIN THE GARAGE AT THE TIME OF THE ASSESSMENT.

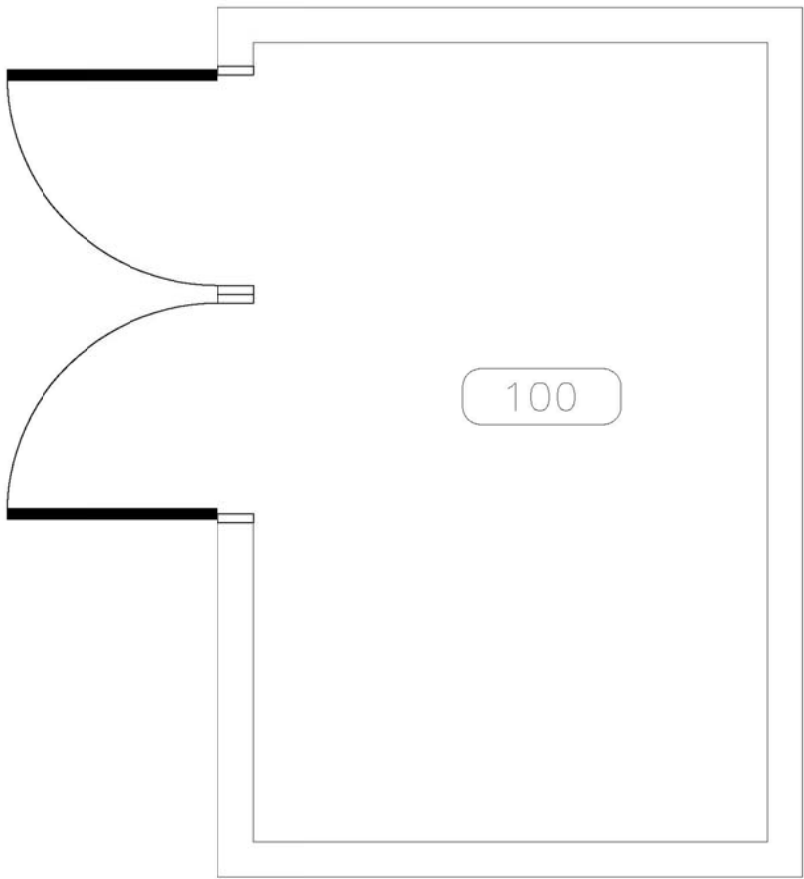
TITLE
STORAGE SHED

1. ASBESTOS IS A CARCINOGEN. DO NOT BREATHE ASBESTOS DUST.
2. ASBESTOS-CONTAINING MATERIALS WERE NOT OBSERVED WITHIN THE SHED AT THE TIME OF THE ASSESSMENT.

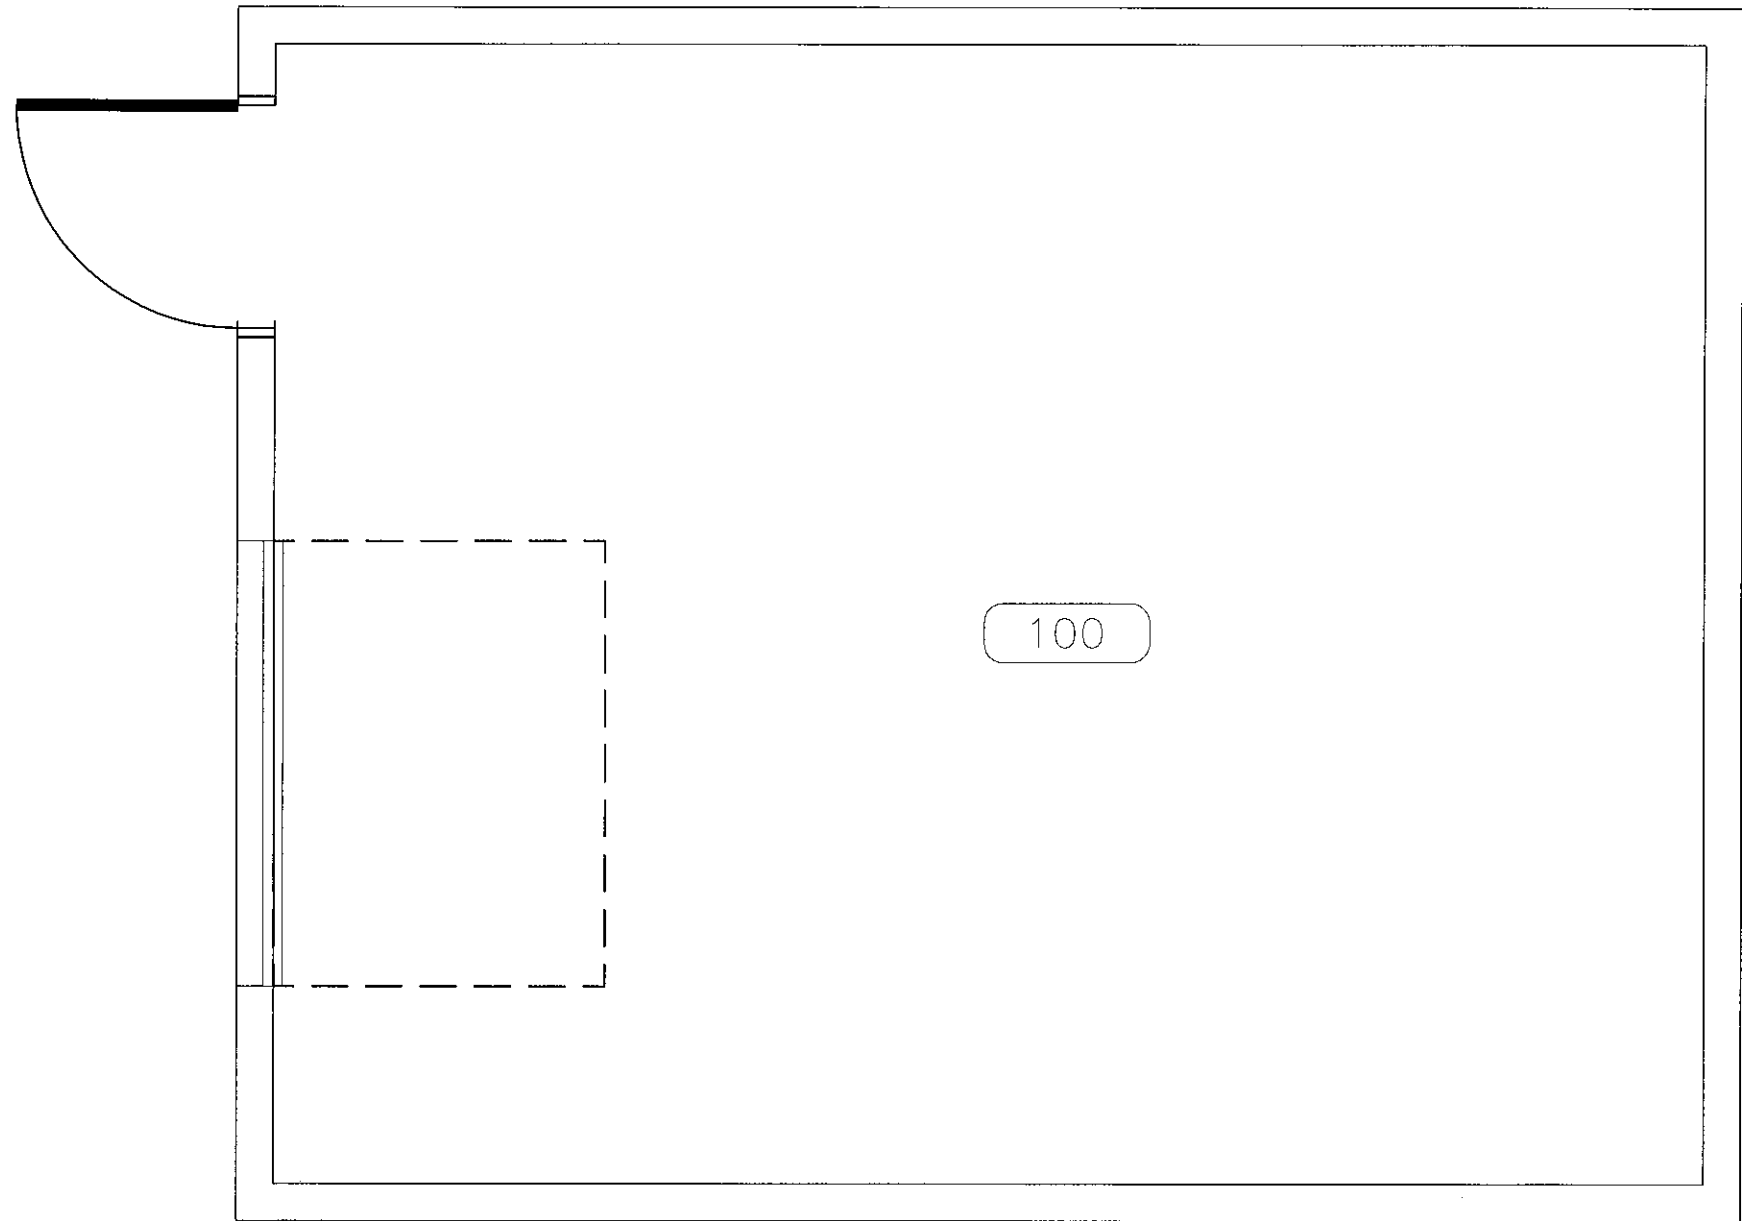
SHEET NAME
Storage Garage Base Plan

Notes: 1) Asbestos is a carcinogen. Avoid
breathing dust.
2) No suspect asbestos-containing
materials were observed on
site during the assessment.
