December 1, 2017

CITY OF SASKATOON

Asbestos-Containing Building Materials Assessment Report - Nutana Lawn Bowling Clubhouse

Report Number: 1667963

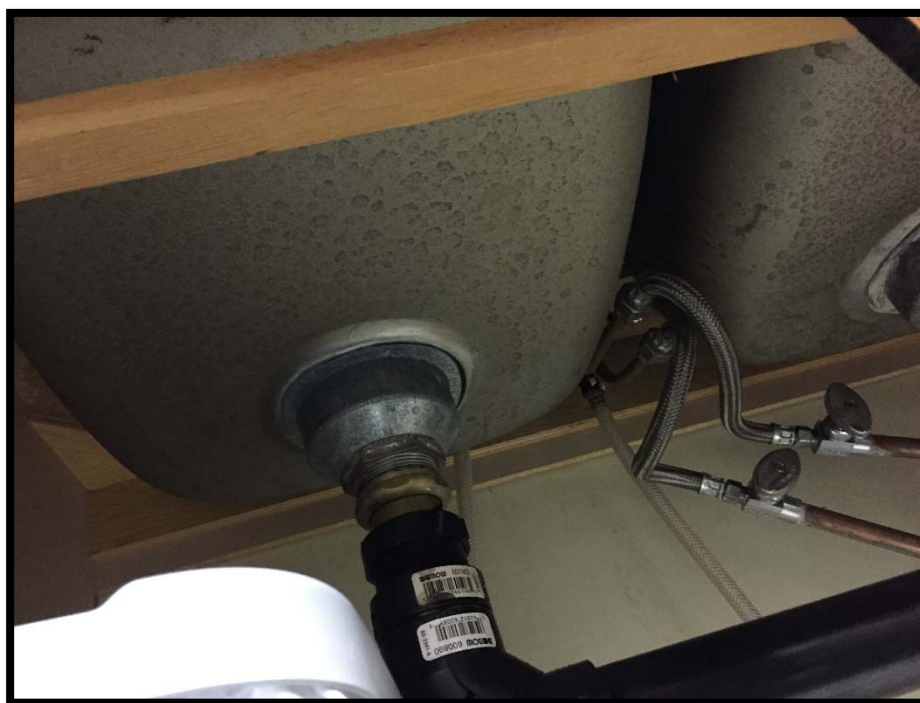
One (1) sample of silver sink undercoat was collected during the assessment. The sample collected was found to contain 1.6% Chrysotile asbestos. Asbestos-containing silver sink undercoat (see Photograph 2 in Appendix B) was observed in the following location:

- Room 106 (approximately 2 sinks).

Photograph 2: Asbestos-Containing Silver Sink Undercoat.

If scheduled for impact, asbestos-containing silver sink undercoat should be abated following low-risk abatement work procedures as outlined in the *Saskatchewan Asbestos Abatement Manual* (2017). Alternatively, as the silver sink undercoat was observed in good condition, and with a priority rating of 5 (please see the room by room spreadsheet provided in Appendix C for a description of the priority ratings), they can be managed in place if not scheduled for impact.
