**City of Saskatoon
Nutana Kiwanis Maintenance / Office Buildings
Asbestos Survey Report**

December 2015

**Prepared By: Bersch & Associates Ltd.
Project No. : B67SRL17**

Project: Nutana Kiwanis Maintenance Office – 2235 McEown Ave – Installation of Central Vacuum System

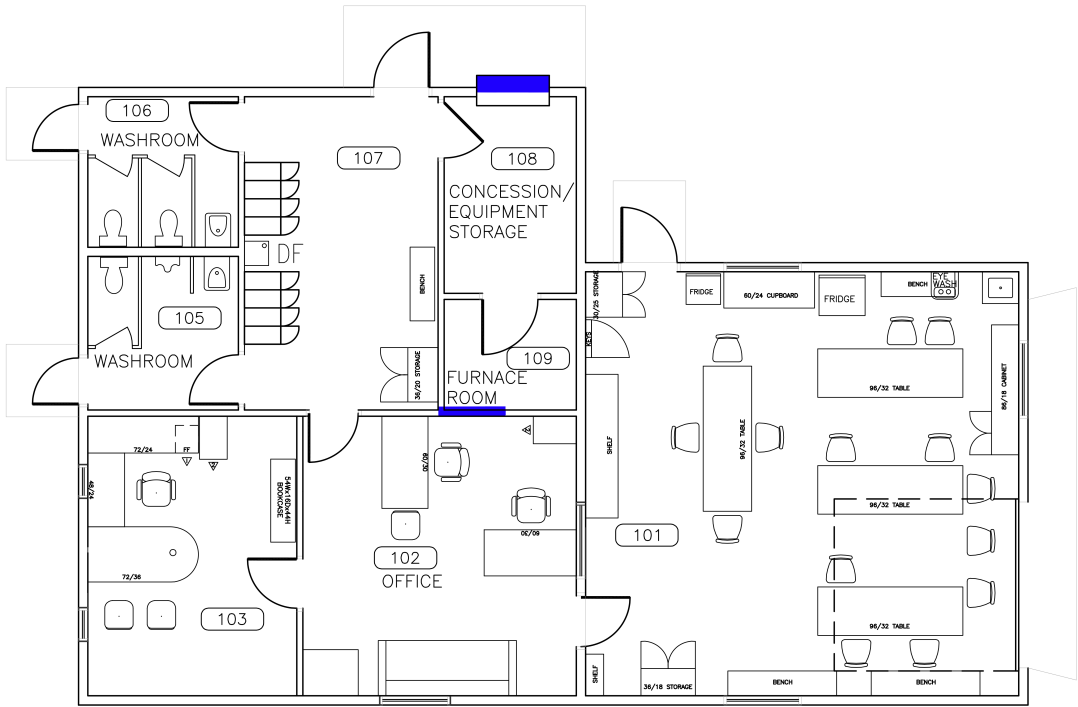
FACILITY #904.002

- **Transite Board** has been identified within the Nutana Kiwanis Maintenance Office Building. The samples were collected from the 109 Furnace Room and the sill on the exterior west wall of 108 Concession Equipment Storage.

Transite Board -

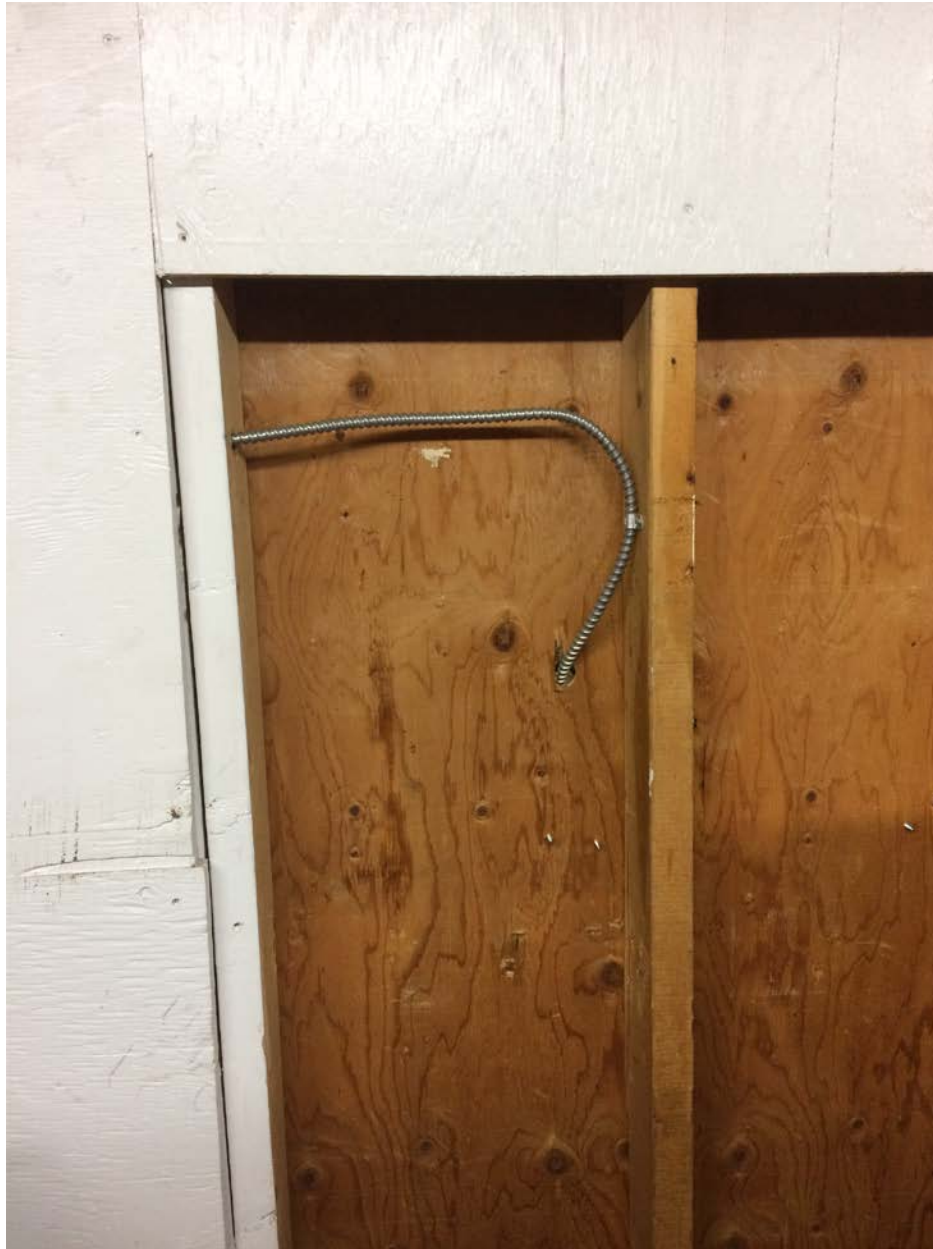
The scope of the project involves the installation of a central vacuum system in the storage room on the northeast side of the building. The central vacuum will be mounted on the south wall. This wall is composed of wood framing with plywood sheeting on both sides. The wall cavity is empty as observed from several uncovered sections of the wall in the storage room. The vacuum will be plumbed into the shop area through the plywood wall of the storage room. The vacuum will be exhausted overhead to the exterior east wall where an existing vent in the exterior wall will be used to exhaust the unit outside.

Figure 1- Wall adjoining storage room and maintenance shop where vacuum is to be mounted.

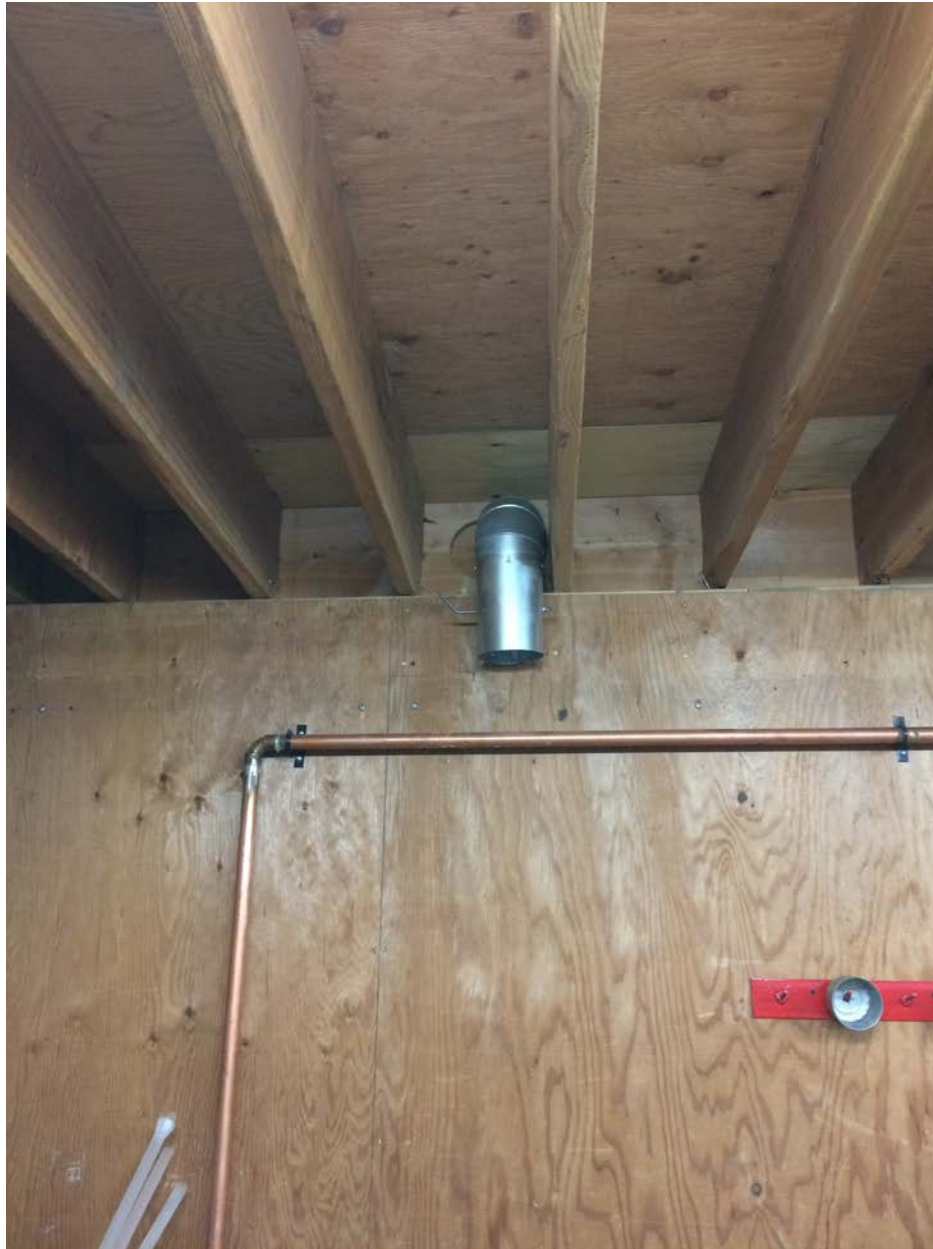
Figure 2- Exterior wall of storage room showing existing vent to be used.

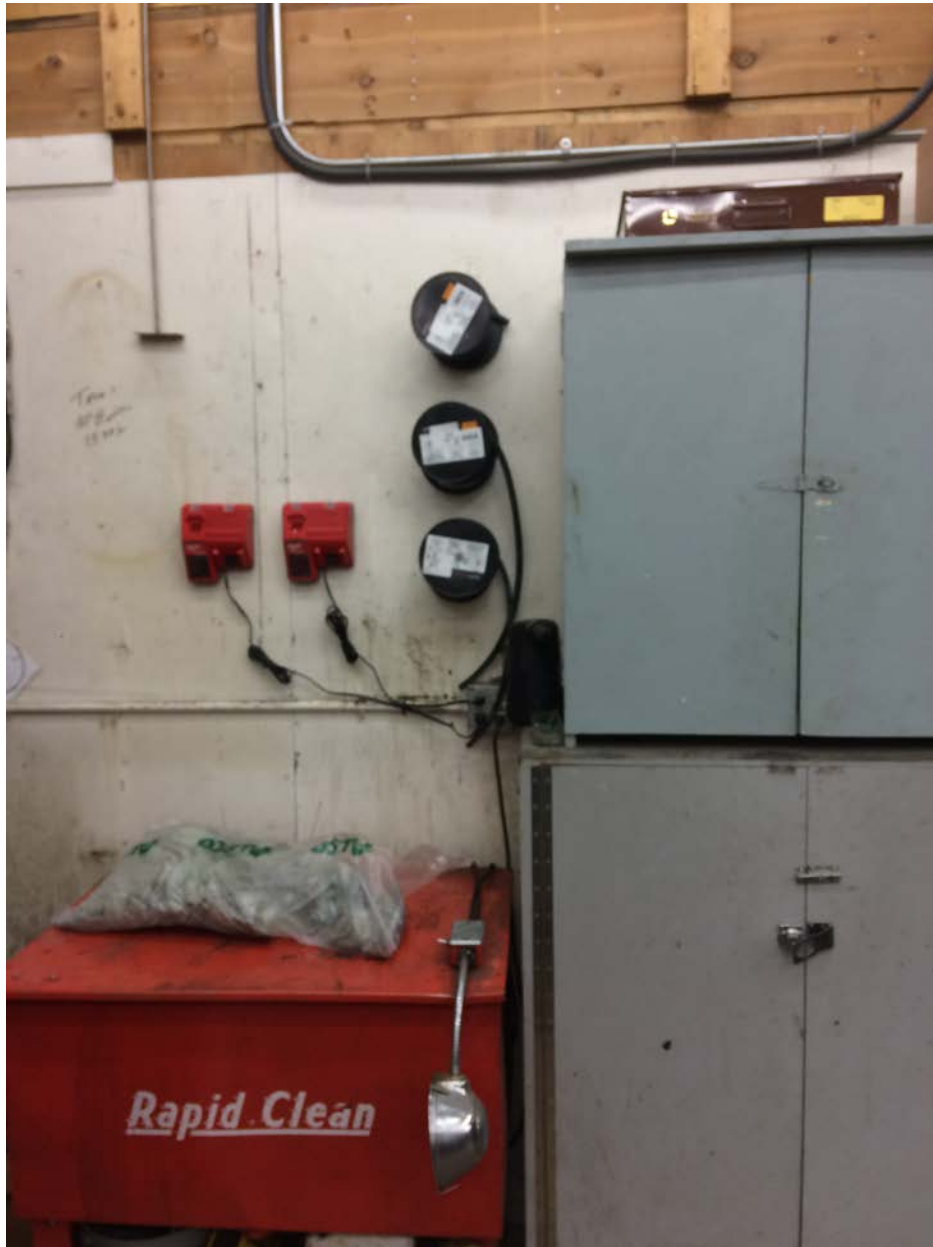
Figure 3- Wall adjoining maintenance shop and storage room.
