## CITY OF SASKATOON

# Asbestos-Containing Building Materials Assessment Report - Nicholson Yards Lunch Trailer

**Report Number: 1667963**

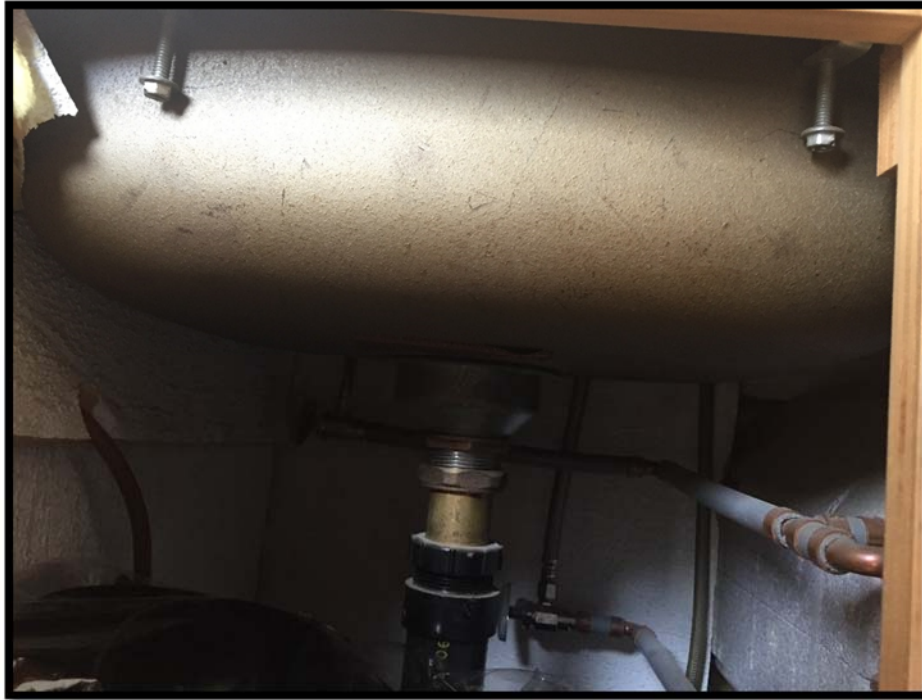
One (1) sample of gold sink undercoat was collected during the assessment. The sample collected was found to contain 4.1% Chrysotile asbestos. Asbestos-containing gold sink undercoat (see Photograph 1 in Appendix B) was observed in the following location:

- Room 100 (approximately 1 sink); and
- Room 101 (approximately 1 sink).

**Photograph 1: Asbestos-Containing Gold Sink Undercoat.**

If scheduled for impact, sinks with asbestos-containing gold undercoat should be abated following low-risk abatement work procedures as outlined in the *Saskatchewan Asbestos Abatement Manual* (2017). Alternatively, as the gold sink undercoat was observed in good condition, and with a priority rating of 5 (please see the room by room spreadsheet provided in Appendix C for a description of the priority ratings), it can be managed in place if not scheduled for impact.

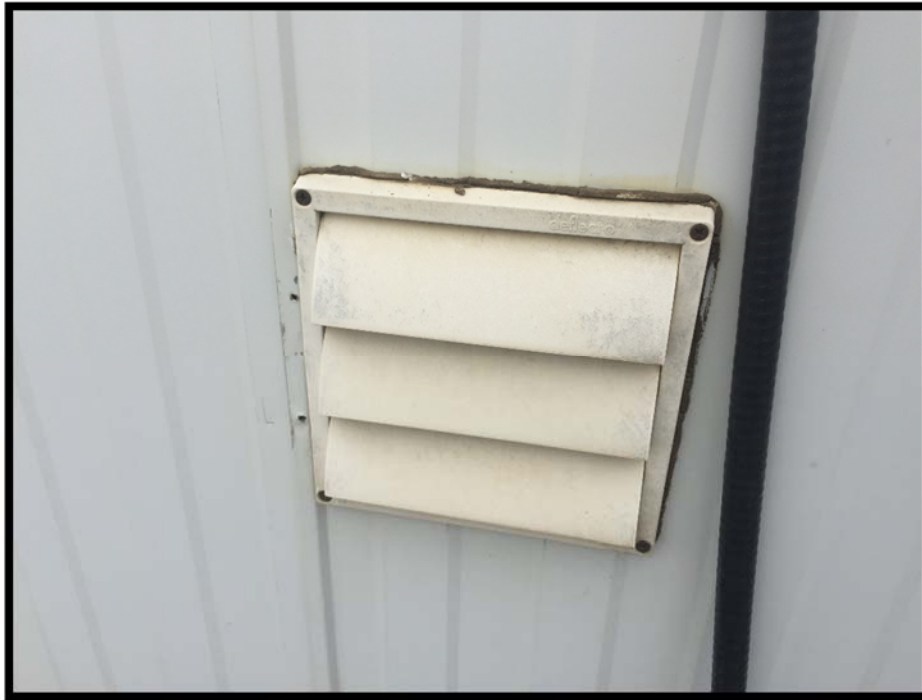
One (1) sample of brown building caulking was collected during the assessment. The sample collected was found to contain 6.7% Chrysotile asbestos. Asbestos-containing brown building caulking (see Photograph 2 in Appendix B) was observed in the following location:

- Exterior (approximately 24 linear ft).

**Photograph 2: Asbestos-Containing Brown Building Caulking.**

If scheduled for impact, asbestos-containing brown building caulking should be abated following low-risk abatement work procedures as outlined in the *Saskatchewan Asbestos Abatement Manual* (2017). Alternatively, as the brown building caulking was observed in good condition, and with a priority rating of 5 (please see the room by room spreadsheet provided in Appendix C for a description of the priority ratings), it can be managed in place if not scheduled for impact.

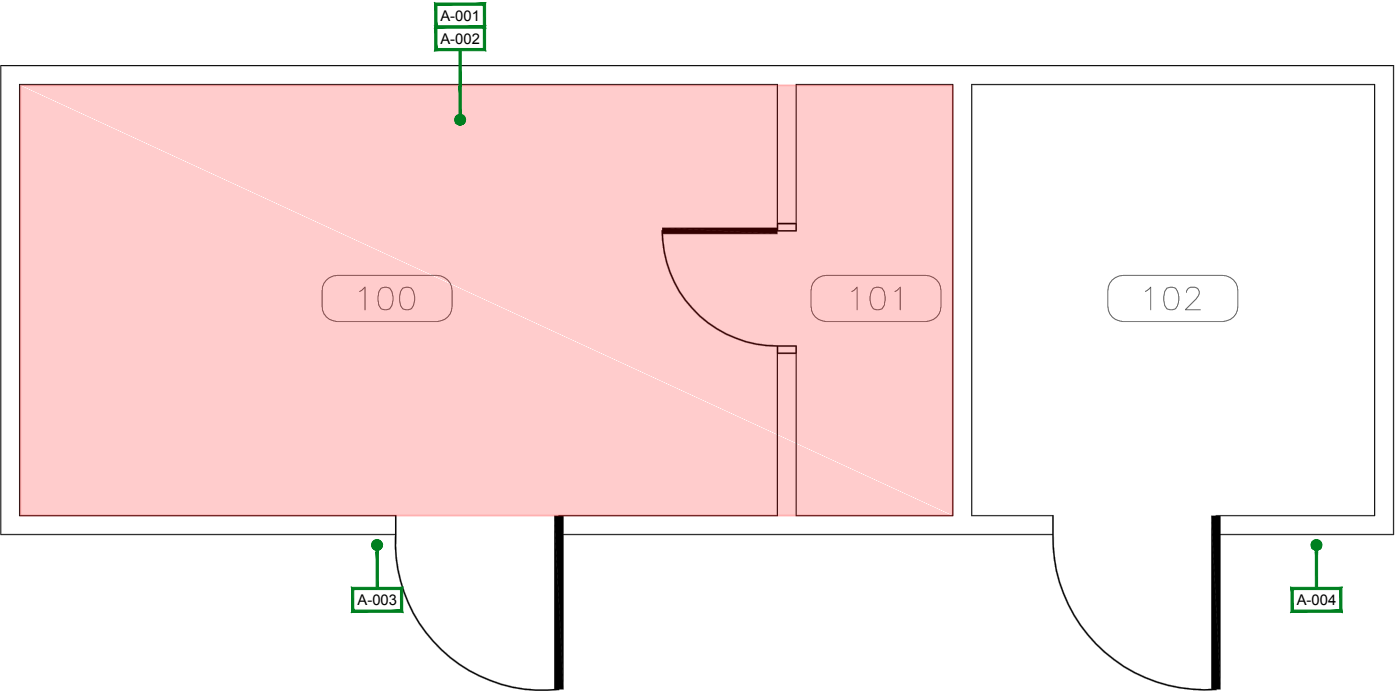
TITLE  
MAIN FLOOR

1. ASBESTOS IS A CARCINOGEN. DO NOT BREATHE ASBESTOS DUST.
2. ASBESTOS-CONTAINING BROWN BUILDING CAULKING IS LOCATED ALONG THE EXTERIOR OF THE BUILDING.
