August 8, 2017

## CITY OF SASKATOON

# Asbestos-Containing Building Materials Assessment Report - City Yards Patrol Shed

**Report Number: 1667963**

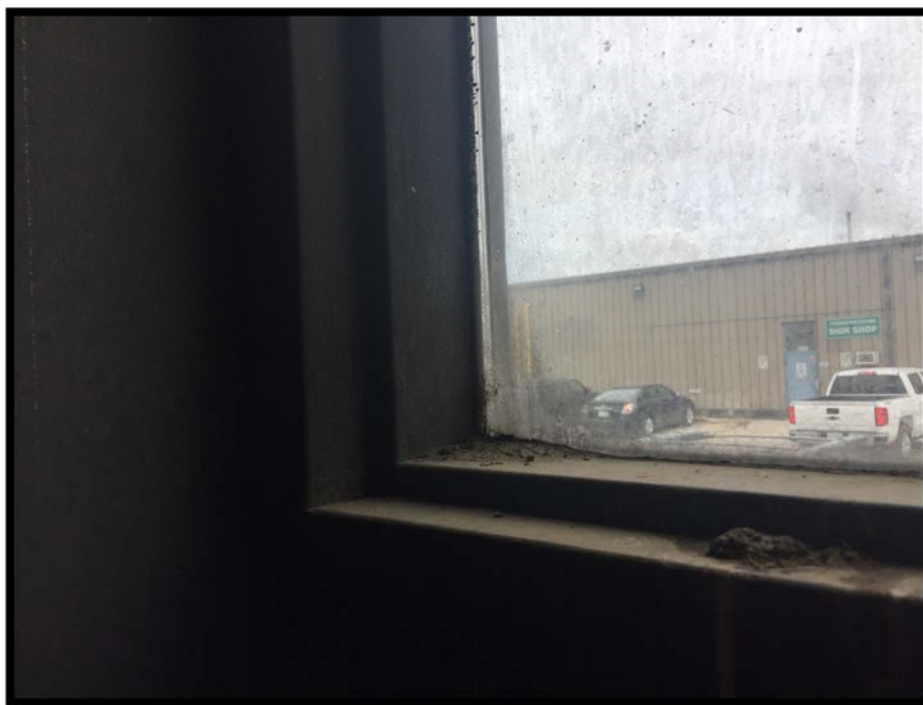
One (1) sample of black window caulking was collected during the assessment. The sample collected was found to contain 3.3% Chrysotile asbestos. Asbestos-containing black window caulking (see Photograph 1 in Appendix B) was observed in the following locations:

- Door Windows (approximately 32 linear ft).

**Photograph 1: Asbestos-Containing Black Window Caulking.**

| Included/<br>Excluded | Floor | Room # | Area Description | Elements | Subelements | Material Description | Accessibility | Suspect? | Sampled? | Asbestos<br>Containing<br>Material? | Condition | Field Notes | Sample<br>Type | Sample ID | Sample<br>Date | Asbestos<br>Type | ACM Product | % of asbestos | Friable | Sprayed-on | Maintenance | Inspection | Priority | Potential for<br>Disturbance | Recommended<br>Action | Quantity | Photograph ID | Labelling Type |
|---|---|---|---|---|---|---|---|---|---|---|---|---|---|---|---|---|---|---|---|---|---|---|---|---|---|---|---|---|
| Included | M | 101 | Open Area | Windows | Caulking | Black Window Caulking | High | Yes | Yes | Yes | Good | | Bulk | A-001 | 15-Jun-17 | Chrysotile | Window Caulking | 3.3% | No | No | N/A | Annually | 5 | Moderate | Manage in Place | 32 ft | Photograph 1 | Door Jamb |

If scheduled for impact, asbestos-containing black window caulking should be abated following low-risk abatement work procedures as outlined in the *Saskatchewan Asbestos Abatement Manual* (2017). Alternatively, as the black window caulking was observed in good condition, and with a priority rating of 5 (please see the room by room spreadsheet provided in Appendix C for a description of the priority ratings), it can be managed in place if not scheduled for impact.
