Subject: Pre-Renovation Assessment – Forestry Farm Pump House

SUBJECT: Bulk Sample Analysis Report – Forestry Farm – Header Building

Project: Saskatoon Forestry Farm – Investigation of Maintenance Building & Pump House

SUBJECT: Bulk Sample Analysis Report – Forest Farm Park and Zoo

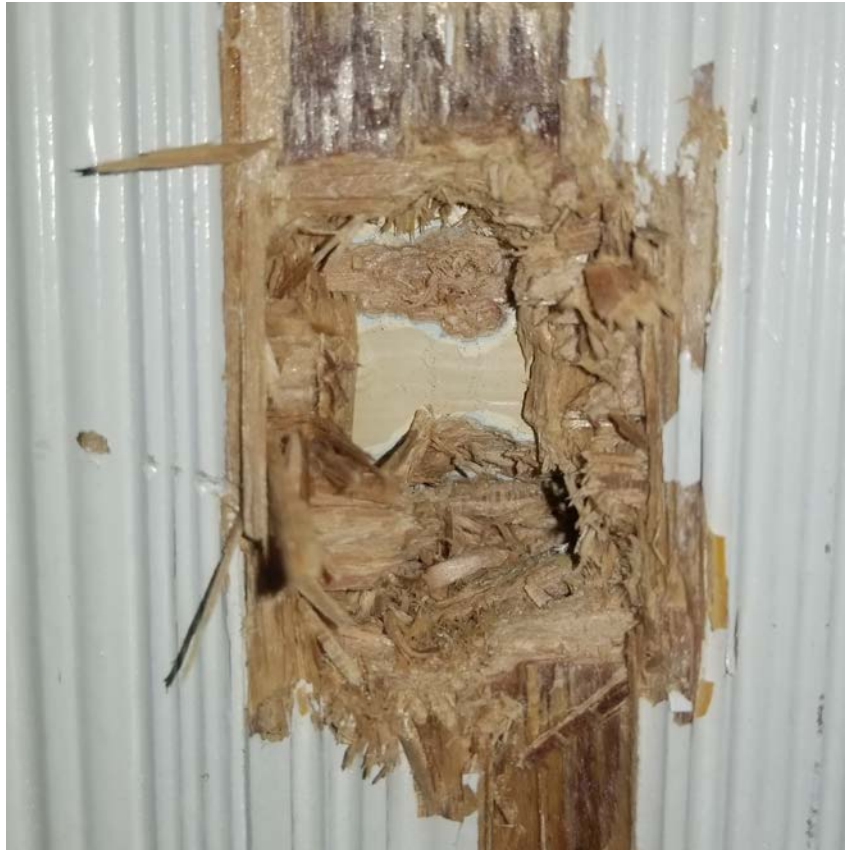
B67PRB13J - 001

The wall paneling consisted of wood panels on top of wood walls. Since the panels and wall are remaining in place there are no concerns regarding asbestos within these materials. Please reference to **Appendix I** for the **Site Photos**.

Wall panel cored into wood wall behind.

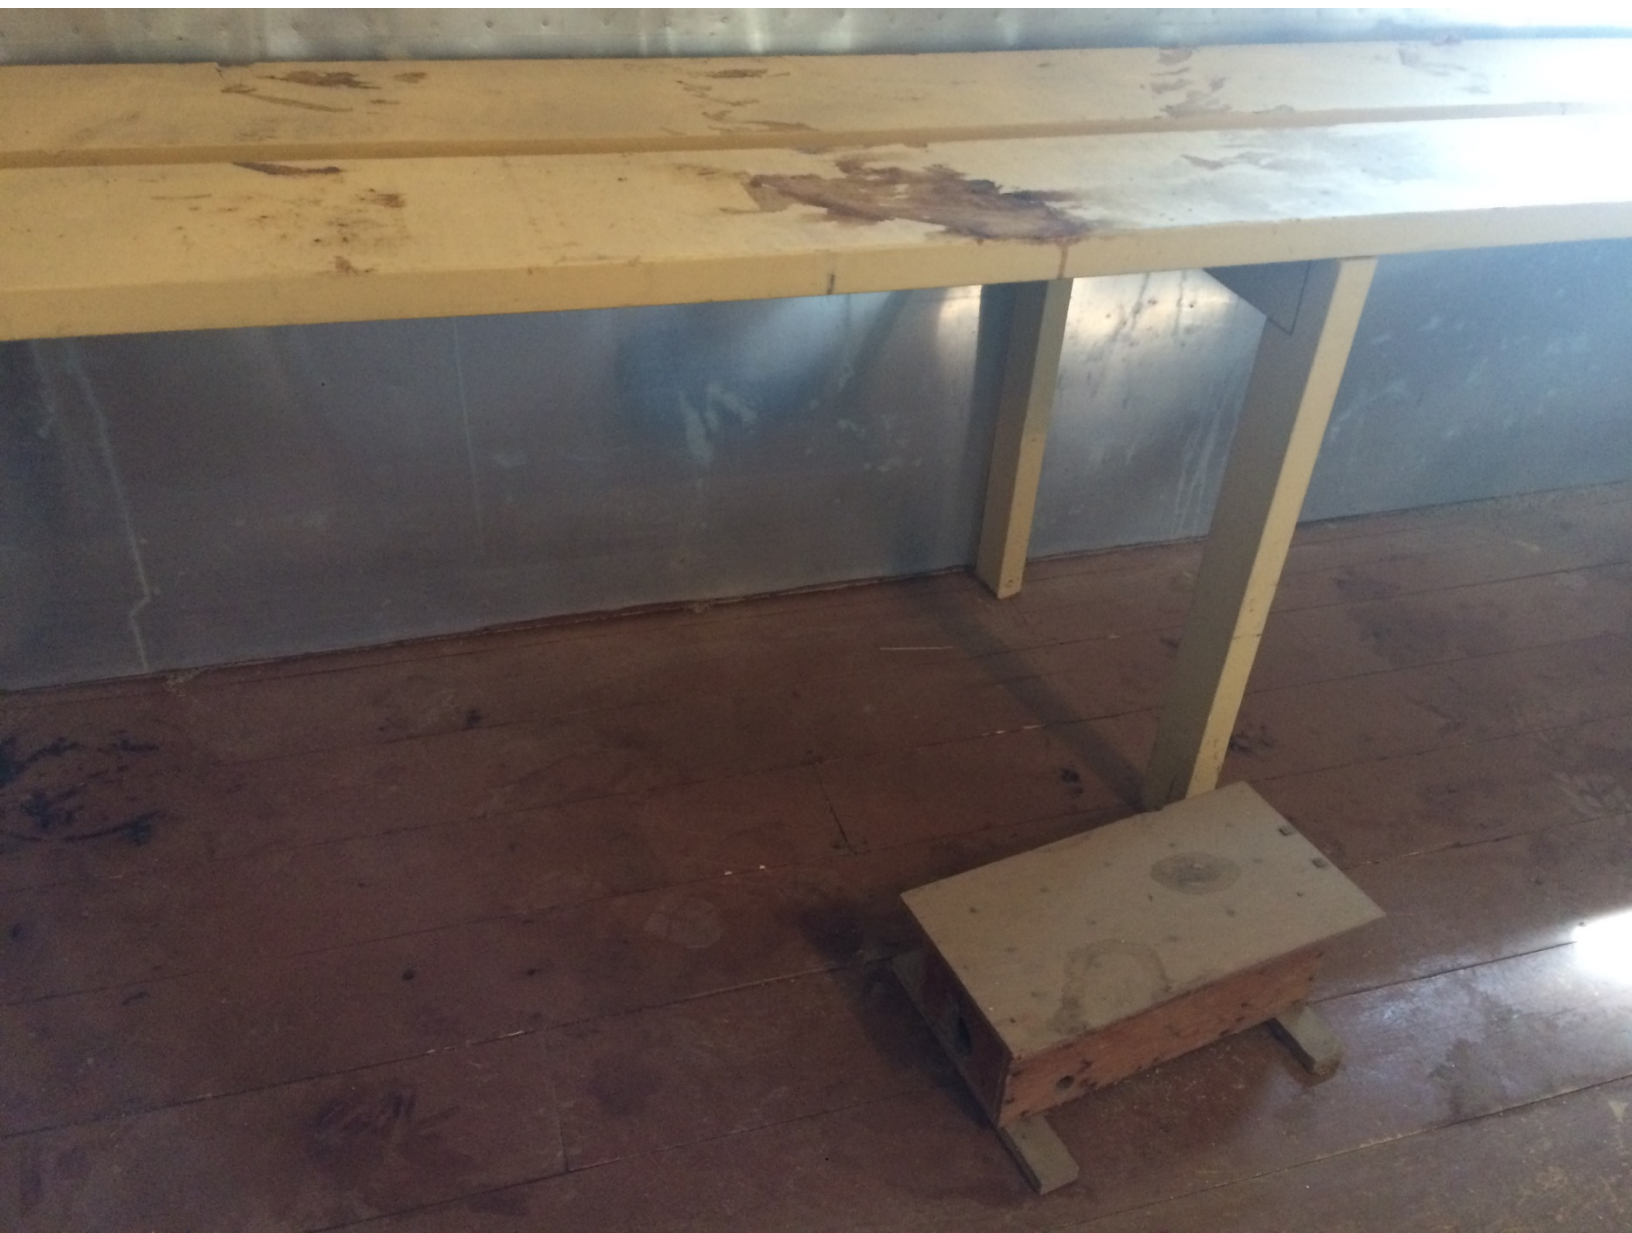
Photo 001- Seed Storage Room

The scope of this investigation included the Maintenance Building and Old Pump House on the Saskatoon Forestry Farm site. Vermiculite was identified within the seed storage room in the northwest corner of the Maintenance Building, the second-floor loft and “Burlap and Twine Storage Room”. Vermiculite in the seed storage room is leaking from the east and west wall cavities onto the floor in minor amounts. In the second-floor loft vermiculite is leaking from a penetration in the north wall. In the “Burlap and Twine Storage Room” vermiculite is leaking through joints in the ceiling tin in the north half of the room. Vermiculite was not identified in any other areas of the Maintenance Building or Pump House.

The vermiculite may be cleaned under following low-risk procedures by HEPA vacuuming and caulking penetrations to prevent further contamination. Following this step areas containing or suspected to contain vermiculite should be inspected regularly and staff be alerted to its presence. See **Appendix II** for site photos.
