CITY OF SASKATOON

Asbestos-Containing Building Materials Assessment Report - Victoria Park Riversdale Badminton and Tennis Club

Report Number: 1667963

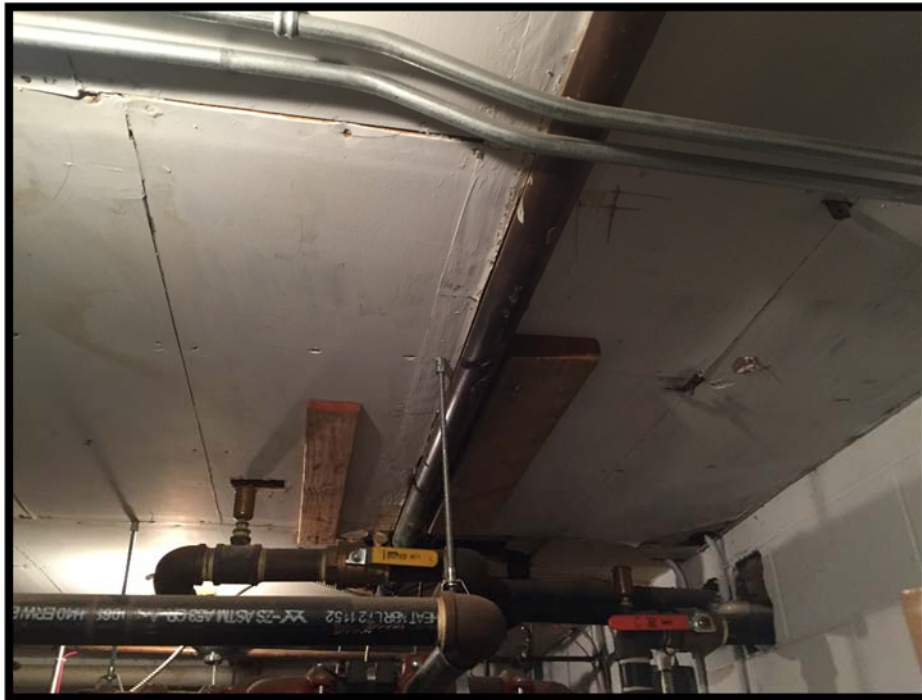
Seven (7) samples of drywall joint compound were collected during the assessment. Three of the samples collected were found to contain 2.1% to 2.8% Chrysotile asbestos. Asbestos-containing drywall joint compound (see Photograph 1 in Appendix B) was observed in the following location:

Photograph 1: Asbestos-Containing Drywall Joint Compound.

If scheduled for impact, asbestos-containing drywall joint compound should be abated following low-risk abatement work procedures as outlined in the *Saskatchewan Asbestos Abatement Manual* (2017). Alternatively, as the drywall joint compound was observed in good condition, and with a priority rating of 5 (please see the room by room spreadsheet provided in Appendix C for a description of the priority ratings), it can be managed in place if not scheduled for impact.

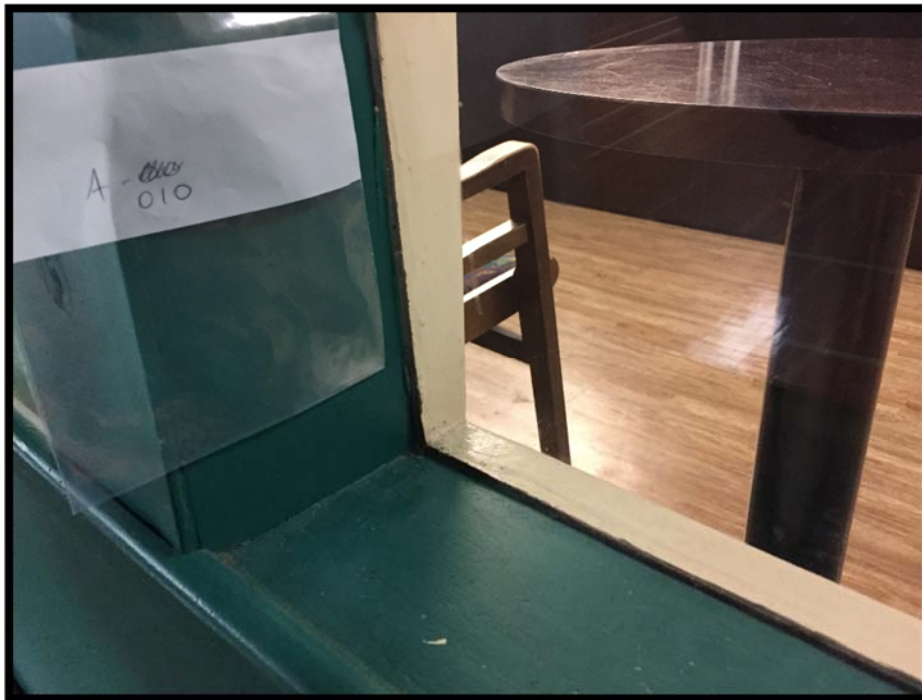
Two (2) samples of black window caulking were collected during the assessment. One of the samples collected was found to contain 1.6% Chrysotile asbestos. Asbestos-containing black window caulking (see Photograph 2 in Appendix B) was observed in the following location:

- Room 101 (approximately 10 linear ft).

Photograph 2: Asbestos-Containing Black Window Caulking.

If scheduled for impact, asbestos-containing black window caulking should be abated following low-risk abatement work procedures as outlined in the *Saskatchewan Asbestos Abatement Manual* (2017). Alternatively, as the black window caulking was observed in good condition, and with a priority rating of 5 (please see the room by room spreadsheet provided in Appendix C for a description of the priority ratings), it can be managed in place if not scheduled for impact.
