December 1, 2017

CITY OF SASKATOON

Asbestos-Containing Building Materials Assessment Report - Riversdale Pool

Report Number: 1667963

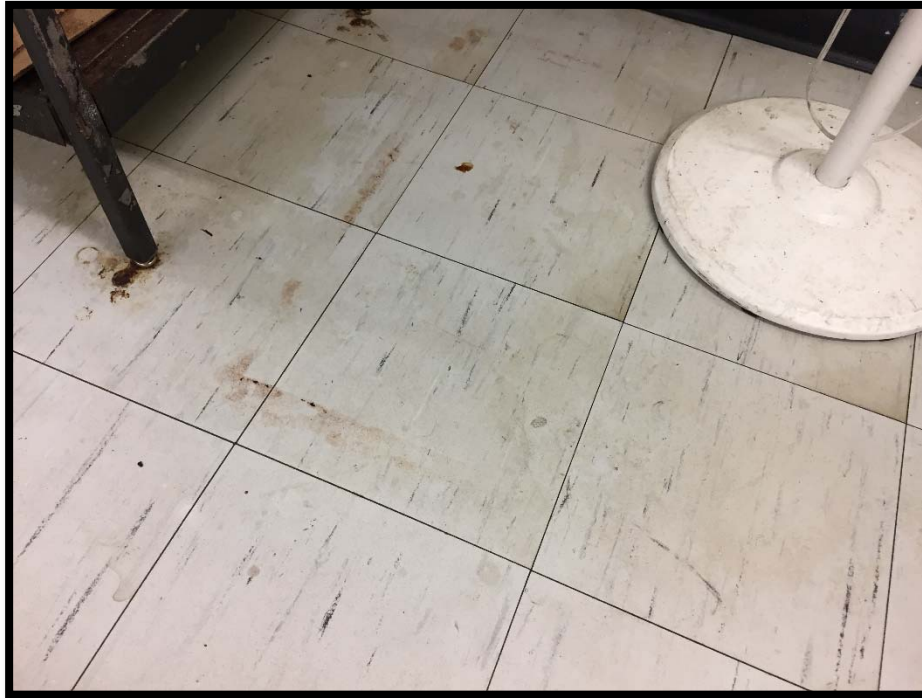
One (1) sample of 12"x12" off-white floor tile with black streaks was collected during the assessment. The sample collected was found to contain 1.3% Chrysotile asbestos. Asbestos-containing 12"x12" off-white floor tile with black streaks (see Photograph 1 in Appendix B) was observed in the following locations:

- Room 127/130 (approximately 550 ft²);
- Room 128 (approximately 90 ft²); and
- Room 129 (approximately 190 ft²).

Photograph 1: Asbestos-Containing 12"x12" Off-White Floor Tile with Black Streaks.

If scheduled for impact, asbestos-containing 12"x12" off-white floor tile with black streaks should be abated following low-risk abatement work procedures as outlined in the *Saskatchewan Asbestos Abatement Manual* (2017). Alternatively, as the 12"x12" off-white floor tile with black streaks was observed in good condition, and with a priority rating of 5 (please see the room by room spreadsheet provided in Appendix C for a description of the priority ratings), it can be managed in place if not scheduled for impact.

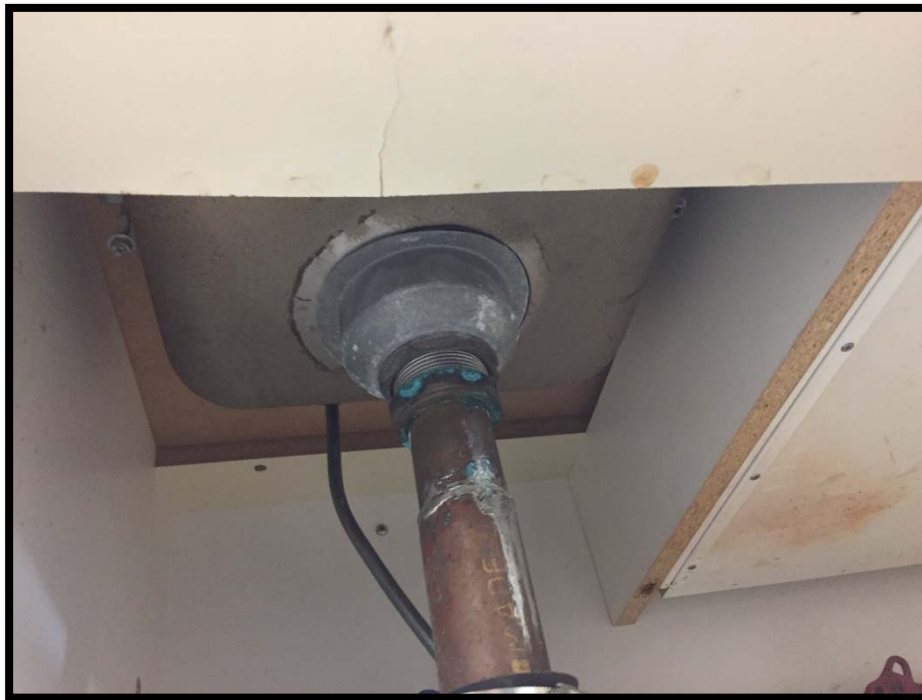
One (1) sample of gold sink undercoat was collected during the assessment. The sample collected was found to contain 12% Chrysotile asbestos. Asbestos-containing gold sink undercoat (see Photograph 2 in Appendix B) was observed in the following locations:

- Room 112 (approximately 1 sink); and
- Room 117 (approximately 2 sinks).

Photograph 2: Asbestos-Containing Gold Sink Undercoat.

If scheduled for impact, asbestos-containing gold sink undercoat should be abated following low-risk abatement work procedures as outlined in the *Saskatchewan Asbestos Abatement Manual* (2017). Alternatively, as the gold sink undercoat was observed in good condition, and with a priority rating of 5 (please see the room by room spreadsheet provided in Appendix C for a description of the priority ratings), it can be managed in place if not scheduled for impact.

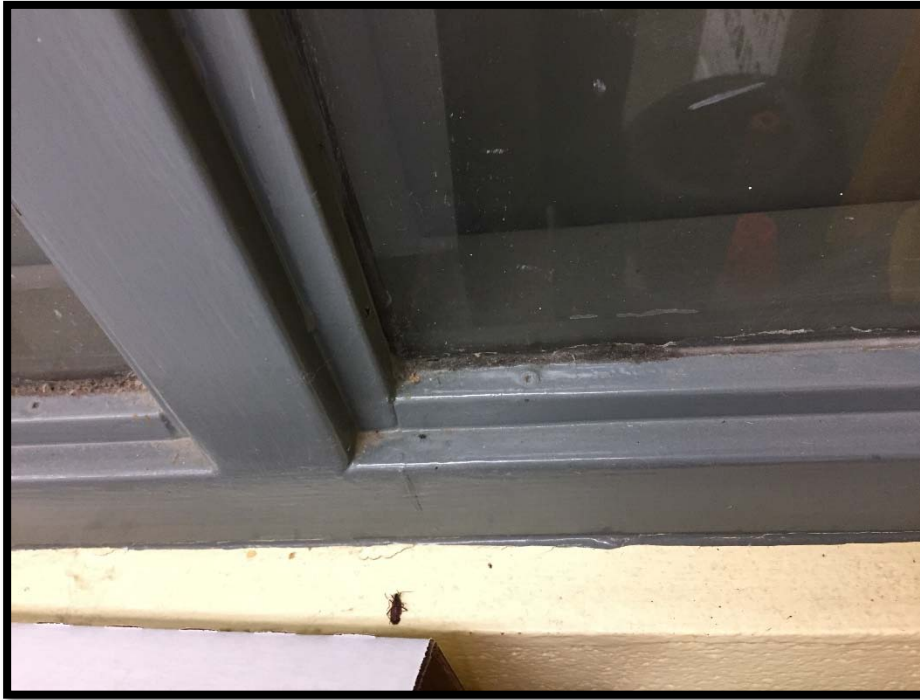
One (1) sample of grey window caulking was collected during the assessment. The sample collected was found to contain 15% Chrysotile asbestos. Asbestos-containing grey window caulking (see Photograph 3 in Appendix B) was observed in the following locations:

- Room 112 (approximately 32 linear feet); and
- Room 118 (approximately 48 linear feet).

Photograph 3: Asbestos-Containing Grey Window Caulking.

If scheduled for impact, asbestos-containing grey window caulking should be abated following low-risk abatement work procedures as outlined in the *Saskatchewan Asbestos Abatement Manual* (2017). Alternatively, as the grey window caulking was observed in good condition, and with a priority rating of 5 (please see the room by room spreadsheet provided in Appendix C for a description of the priority ratings), it can be managed in place if not scheduled for impact.

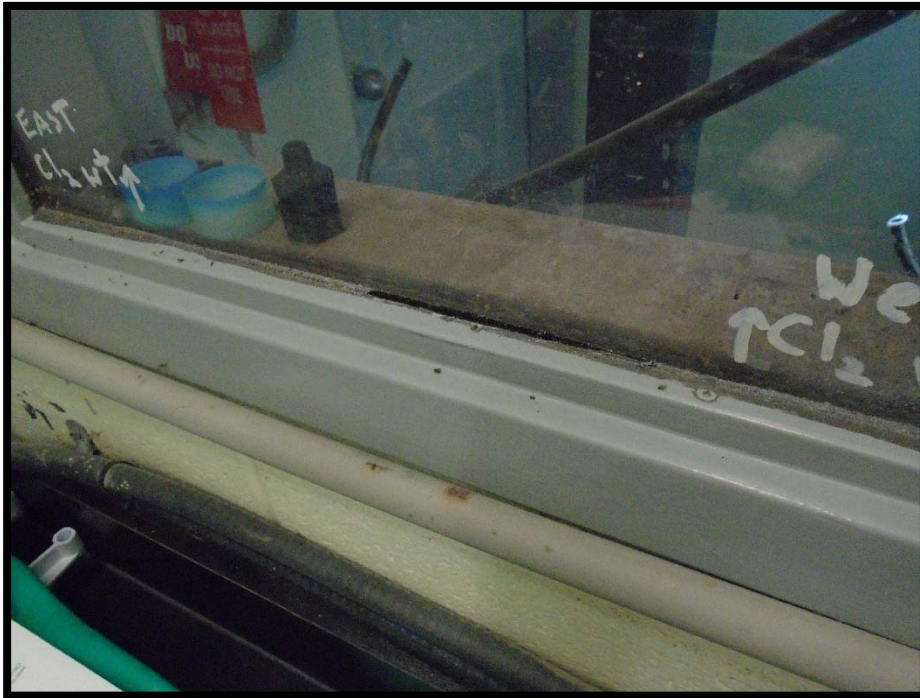
One (1) sample of black window putty was collected during the assessment. The sample collected was found to contain 15% Chrysotile asbestos. Asbestos-containing black window putty (see Photograph 4 in Appendix B) was observed in the following location:

- Room 103 (approximately 5 linear feet).

Photograph 4: Asbestos-Containing Black Window Putty.

If scheduled for impact, asbestos-containing black window putty should be abated following low-risk abatement work procedures as outlined in the *Saskatchewan Asbestos Abatement Manual* (2017). Alternatively, as the black window putty was observed in good condition, and with a priority rating of 5 (please see the room by room spreadsheet provided in Appendix C for a description of the priority ratings), it can be managed in place if not scheduled for impact.

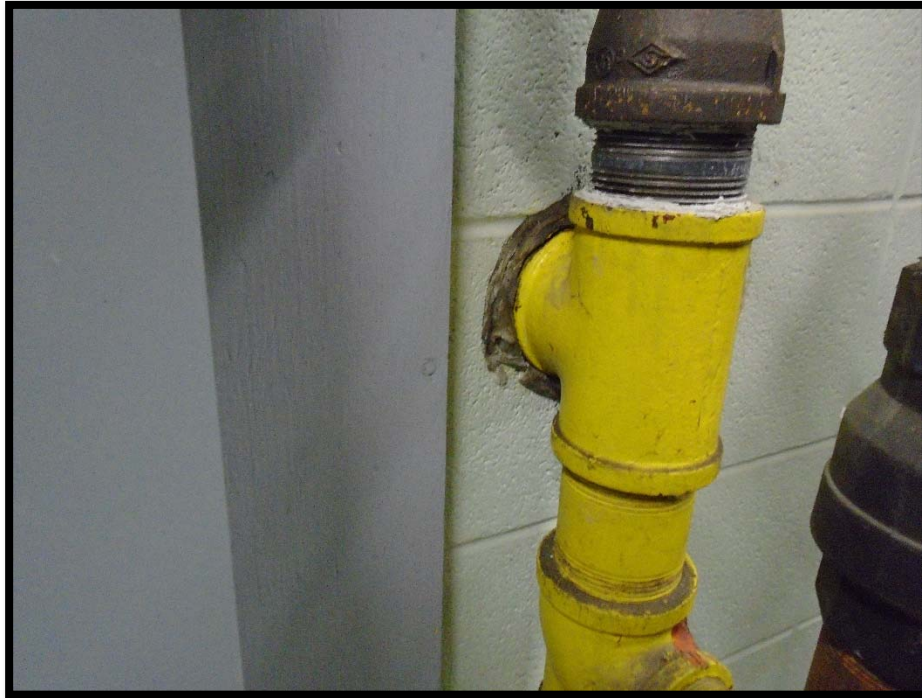
One (1) sample of light grey firestop was collected during the assessment. The sample collected was found to contain 2.2% Chrysotile asbestos. Asbestos-containing light grey firestop (see Photograph 5 in Appendix B) was observed in the following location:

- Room 104 (approximately 1 linear foot).

Photograph 5: Asbestos-Containing Light Grey Firestop.

If scheduled for impact, asbestos-containing light grey firestop should be abated following low-risk abatement work procedures as outlined in the *Saskatchewan Asbestos Abatement Manual* (2017). Alternatively, as the light grey firestop was observed in good condition, and with a priority rating of 5 (please see the room by room spreadsheet provided in Appendix C for a description of the priority ratings), it can be managed in place if not scheduled for impact.

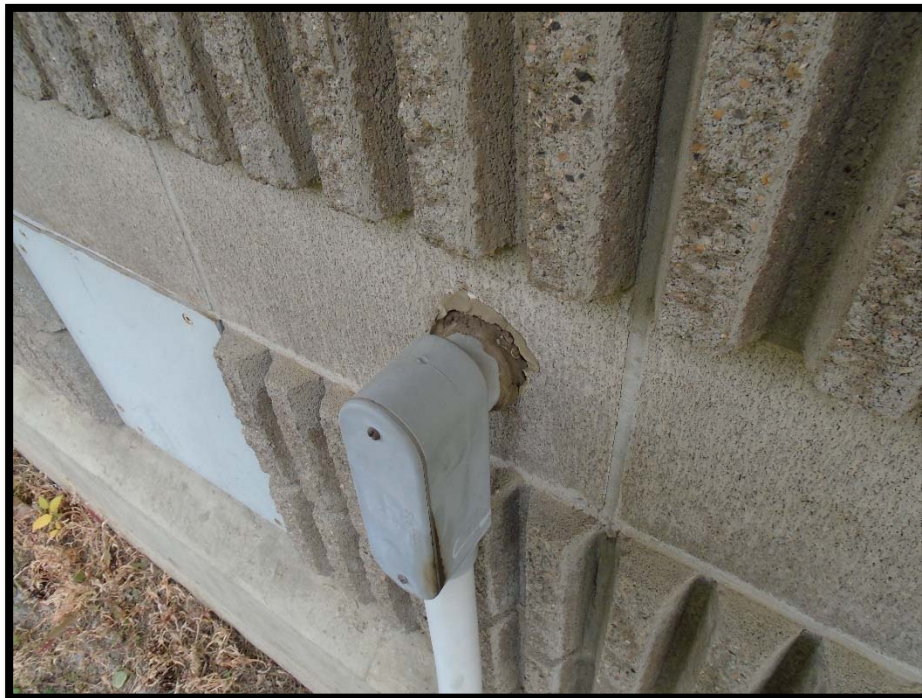
One (1) sample of light grey building caulking was collected during the assessment. The sample collected was found to contain 10% Chrysotile asbestos. Asbestos-containing light grey building caulking (see Photograph 6 in Appendix B) was observed in the following location:

- Exterior (approximately 1 linear foot).

Photograph 6: Asbestos-Containing Light Grey Building Caulking.

If scheduled for impact, asbestos-containing light grey building caulking should be abated following low-risk abatement work procedures as outlined in the *Saskatchewan Asbestos Abatement Manual* (2017). Alternatively, as the light grey building caulking was observed in good condition, and with a priority rating of 5 (please see the room by room spreadsheet provided in Appendix C for a description of the priority ratings), it can be managed in place if not scheduled for impact.

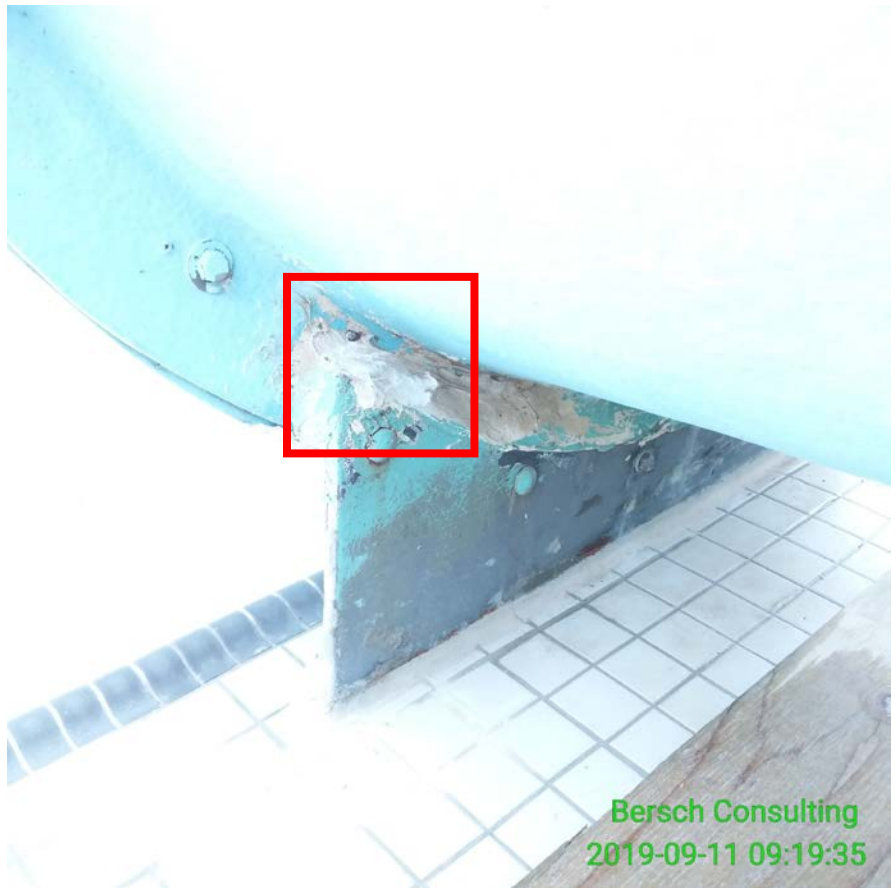
B67PRI11I - 002

White Caulking

Waterslide Section Joint

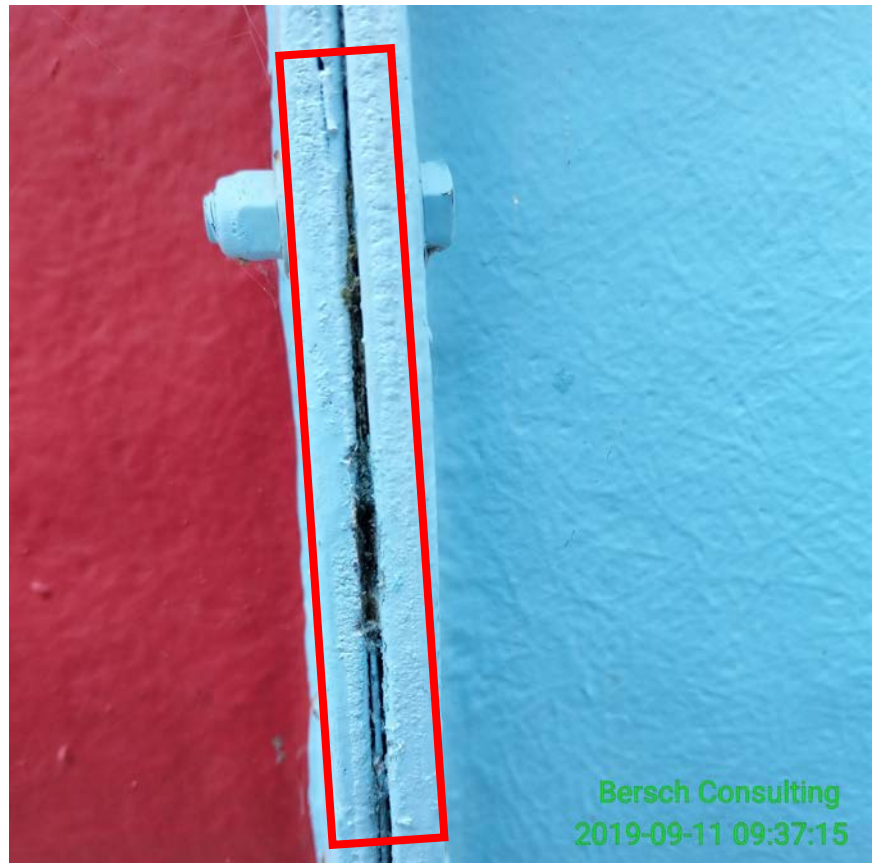
B67PRI11I - 003

Gasket Material

Waterslide Section Joint

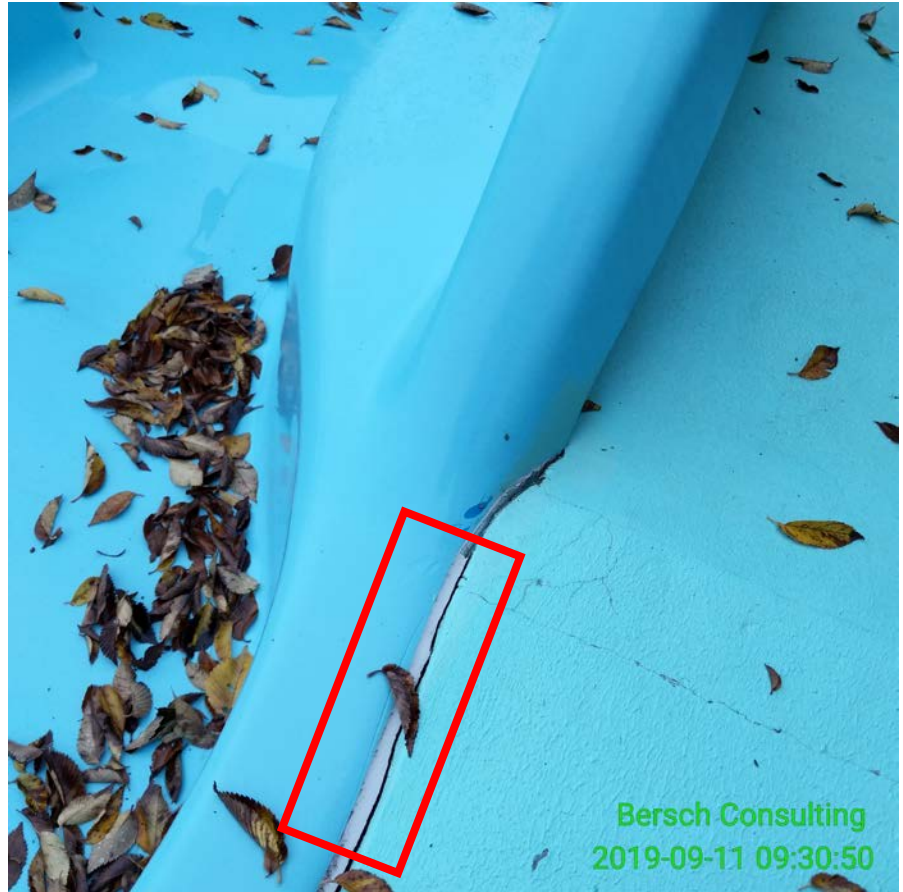
B67PRI11I - 004

Gray Caulking

Top of Waterslide

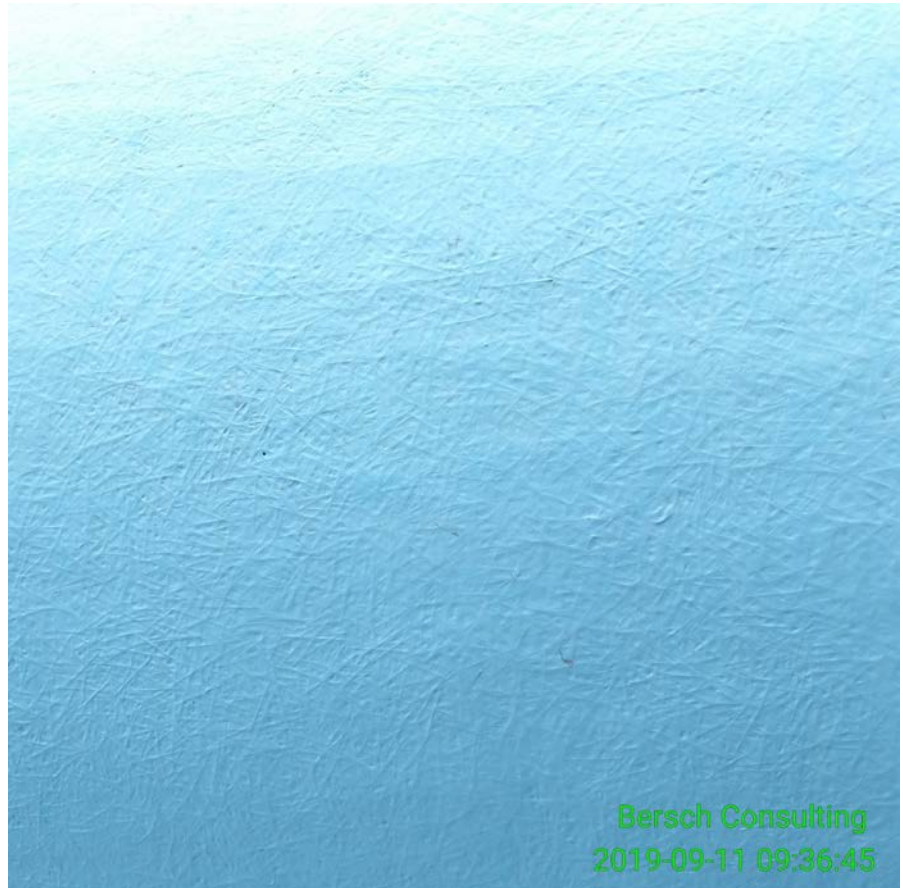
B67PRI11I - 005

Waterslide Material
