August 8, 2017

CITY OF SASKATOON

Asbestos-Containing Building Materials Assessment Report - Victoria Park Lawn Bowling Clubhouse

Report Number: 1667963

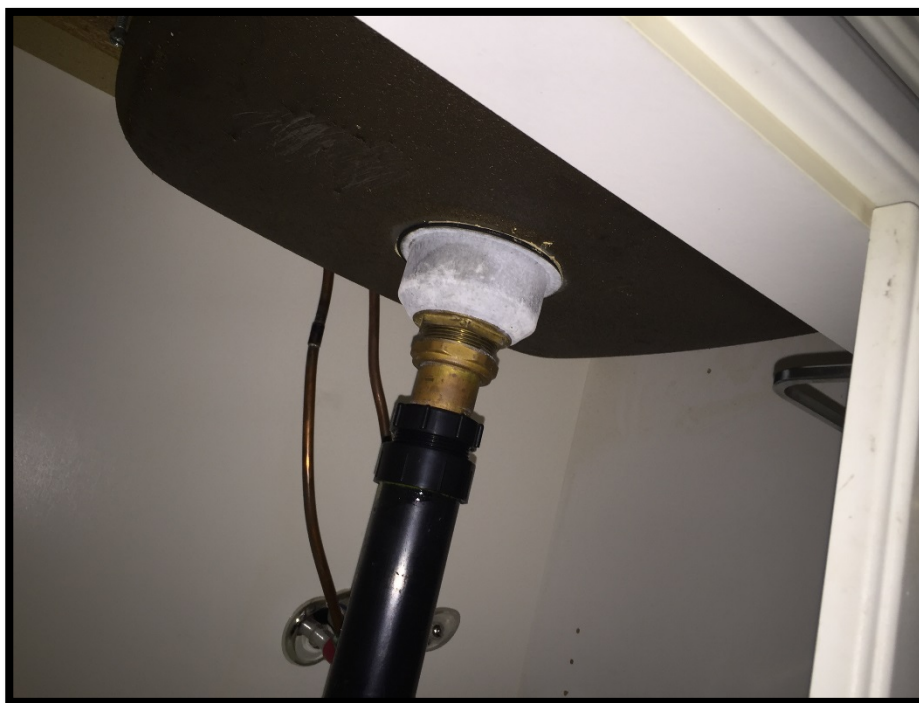
One (1) sample of gold sink undercoat was collected during the assessment. The sample collected was found to contain 2.3% Chrysotile asbestos. Asbestos-containing gold sink undercoat (see Photograph 1 in Appendix B) was observed in the following location:

- Room 102 (approximately 1 sink).

Asbestos was positively identified within the gold sink undercoat on Site. Asbestos was not identified in the remaining samples collected and analyzed.

Lab No.: 6271474 Client No.: A-007	Description: Gold Fibrous Facility:	Location: Room 102
<u>Percent Asbestos:</u> <i>PC 2.3 Chrysotile</i>	<u>Percent Non-Asbestos Fibrous Material:</u> None Detected	<u>Percent Non-Fibrous Material:</u> 97.7
Lab No.: 6271475 Client No.: A-008	Description: White Joint Compound Facility:	Location: Room 104
<u>Percent Asbestos:</u> <i>None Detected</i>	<u>Percent Non-Asbestos Fibrous Material:</u> None Detected	<u>Percent Non-Fibrous Material:</u> 100
Lab No.: 6271476 Client No.: A-009	Description: Lt Grey Vinyl Sheet Flooring Facility:	Location: Room 104
<u>Percent Asbestos:</u> <i>None Detected</i>	<u>Percent Non-Asbestos Fibrous Material:</u> 20 Cellulose 2 Fibrous Glass	<u>Percent Non-Fibrous Material:</u> 78
Lab No.: 6271476(L2) Client No.: A-009	Description: Tan Mastic Facility:	Location: Room 104
<u>Percent Asbestos:</u> <i>None Detected</i>	<u>Percent Non-Asbestos Fibrous Material:</u> 1 Cellulose	<u>Percent Non-Fibrous Material:</u> 99

Photograph 1: Asbestos-Containing Gold Sink Undercoat.

If scheduled for impact, asbestos-containing gold sink undercoat should be abated following low-risk abatement work procedures as outlined in the *Saskatchewan Asbestos Abatement Manual* (2017). Alternatively, as the gold sink undercoat was observed in good condition, and with a priority rating of 5 (please see the room by room spreadsheet provided in Appendix C for a description of the priority ratings), it can be managed in place if not scheduled for impact.

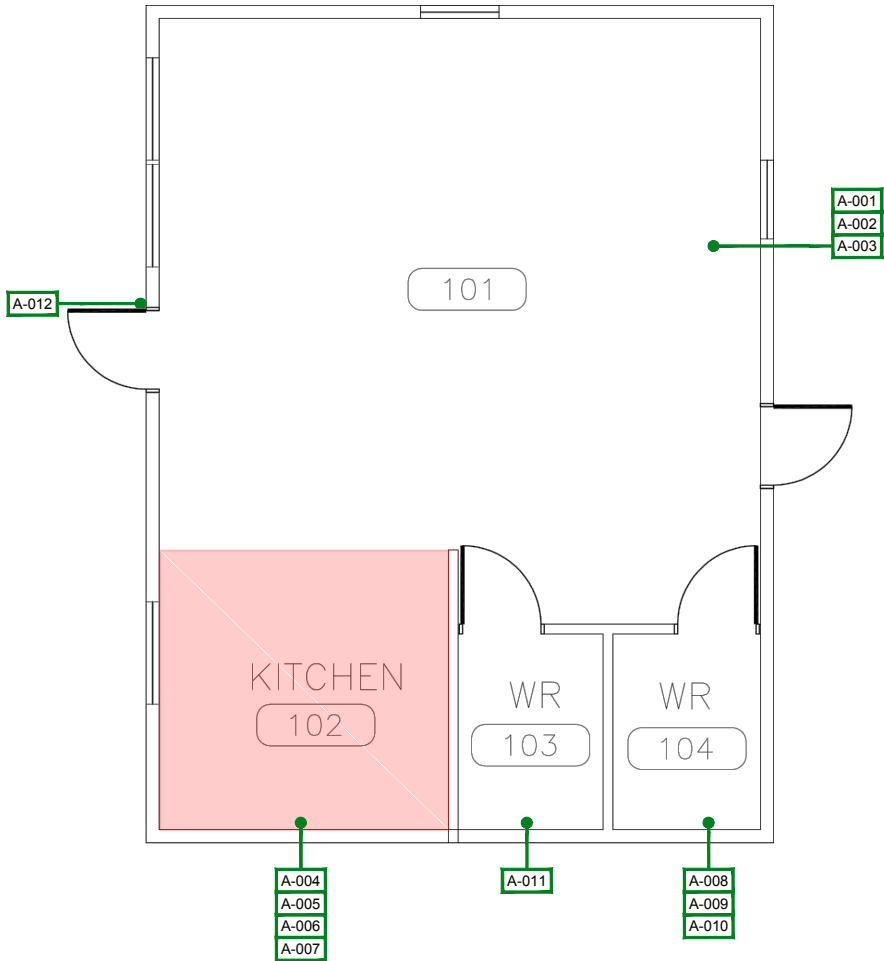
FIGURE 1

ASBESTOS - CONTAINING SINK UNDERCOAT
