CITY OF SASKATOON

Asbestos-Containing Building Materials Assessment Report - Rotary Park Washrooms

Report Number: 1667963

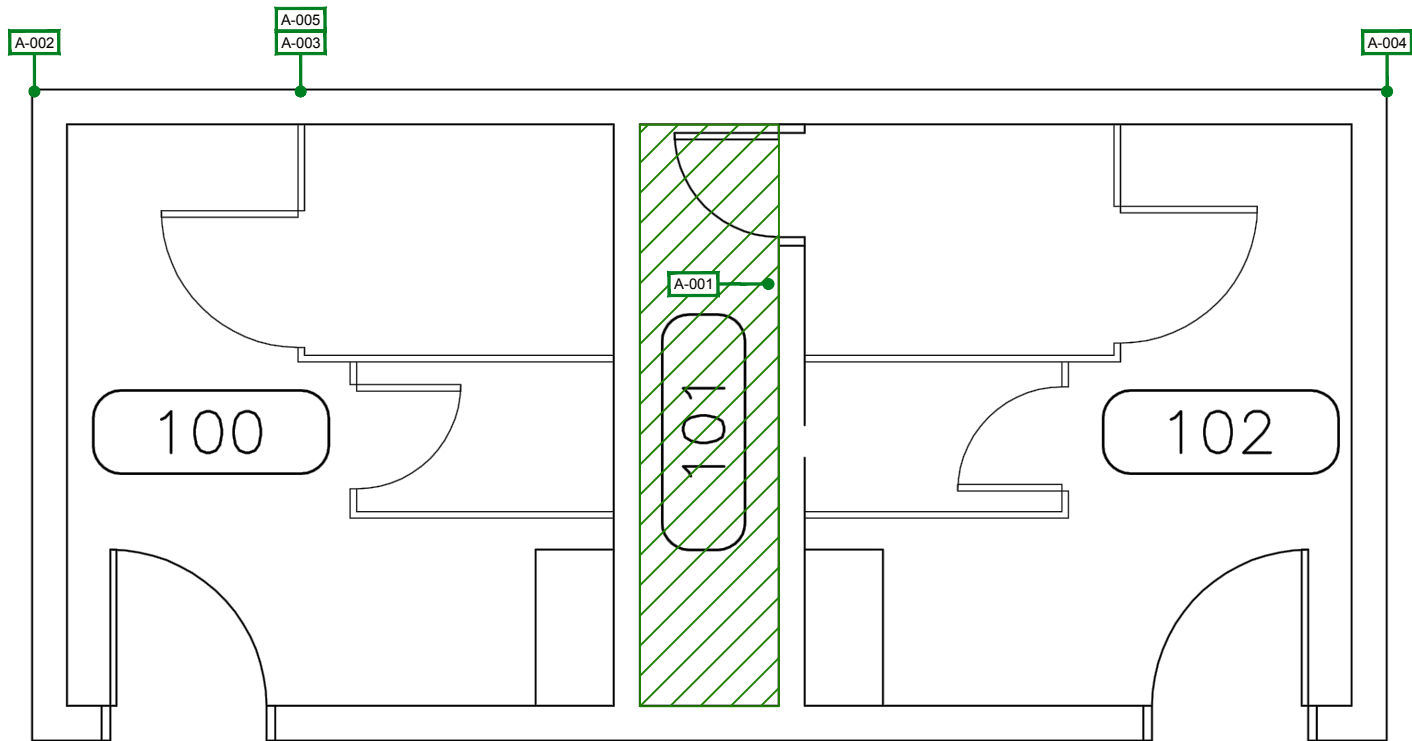
FIGURE
1

ASBESTOS-CONTAINING VERMICULITE DEBRIS (REMOVED 2017)
