July 11, 2017

CITY OF SASKATOON

Asbestos-Containing Building Materials Assessment Report - Sasktel Centre

Report Number: 1667963

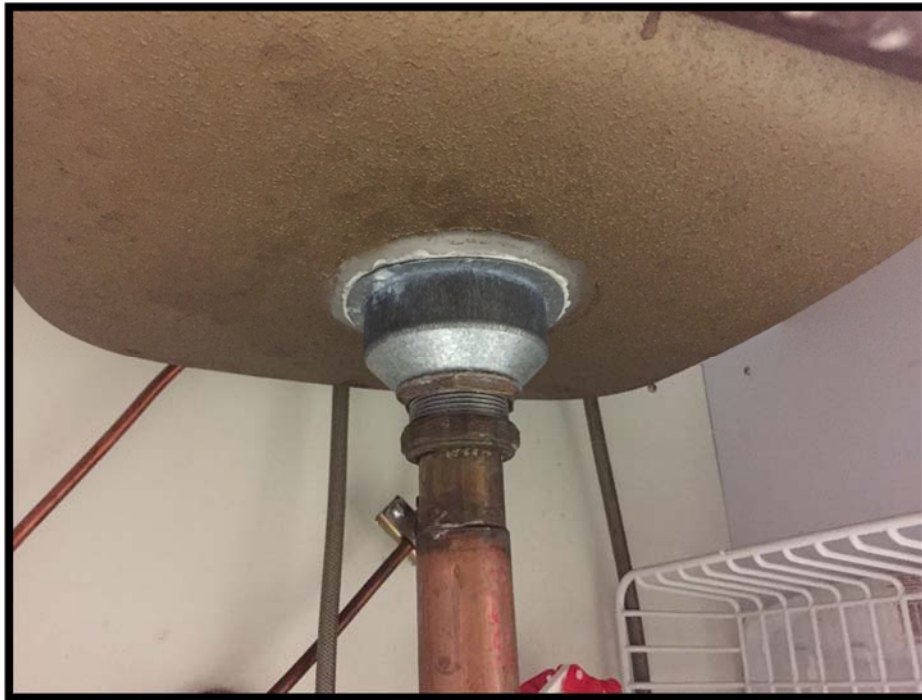
One (1) sample of gold/silver sink undercoat was collected during the assessment. The sample collected was found to contain 0.5% Chrysotile asbestos. Asbestos-containing gold/silver sink undercoat (see Photograph 1 in Appendix B) was observed in the following locations:

- Room 119 (approximately 1 sink);
- Room 122 (approximately 1 sink);
- Room 154/155/156 (approximately 1 sink);
- Room 177 (approximately 1 sink);

- Room 206 (approximately 2 sinks); and
- Room 304E (approximately 1 sink).

Photograph 1: Asbestos-Containing Gold/Silver Sink Undercoat.

If scheduled for impact, asbestos-containing gold/silver sink undercoat should be abated following low-risk abatement work procedures as outlined in the *Saskatchewan Asbestos Abatement Manual* (2017). Alternatively, as the gold/silver sink undercoat was observed in good condition, and with a priority rating of 5 (please see the room by room spreadsheet provided in Appendix C for a description of the priority ratings), it can be managed in place if not scheduled for impact.

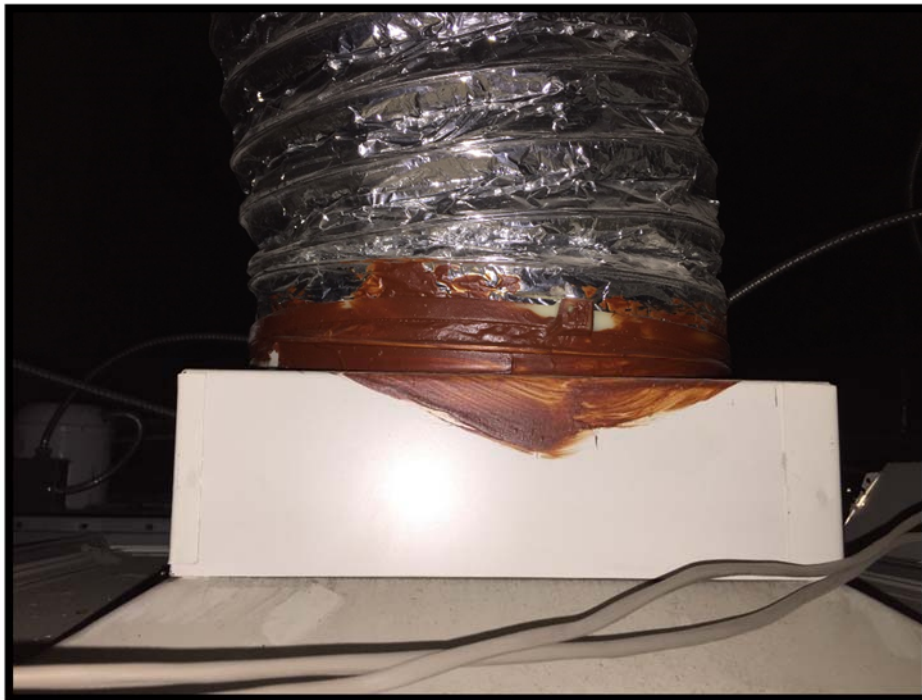
Two (2) samples of red/brown duct mastic were collected during the assessment. Both of the samples collected were found to contain 0.75% to 1.3% Chrysotile asbestos. Asbestos-containing red/brown duct mastic (see Photograph 2 in Appendix B) was observed in the following locations:

- Room 154/155/156 (approximately 15 ft);
- Room 153 (approximately 25 ft);
- Room 130 (approximately 5 ft);
- Room 125 (approximately 30 ft);
- Room 130 (approximately 5 ft);
- Arena Level Ceiling Space Mechanical Room (approximately 600 ft);
- Room 214 (approximately 5 ft);
- Room 210 (approximately 5 ft);
- Room 208 (approximately 5 ft);
- Mezzanine Level Mechanical Room Adjacent S5 (approximately 10 ft);
- Room 324 (approximately 20 ft); and
- Room 301 (approximately 50 ft).

Please note additional asbestos-containing red/brown duct mastic is suspected to be located behind fibreglass insulation and within concealed locations (wall cavities, ceiling spaces and cavities, mechanical shafts, etc.) throughout the Site.

Photograph 2: Asbestos-Containing Red/Brown Duct Mastic.

If scheduled for impact, asbestos-containing red/brown duct mastic should be abated following low-risk abatement work procedures as outlined in the *Saskatchewan Asbestos Abatement Manual* (2017). Alternatively, as the red/brown duct mastic was observed in good condition, and with a priority rating of 5 (please see the room by room spreadsheet provided in Appendix C for a description of the priority ratings), it can be managed in place if not scheduled for impact.

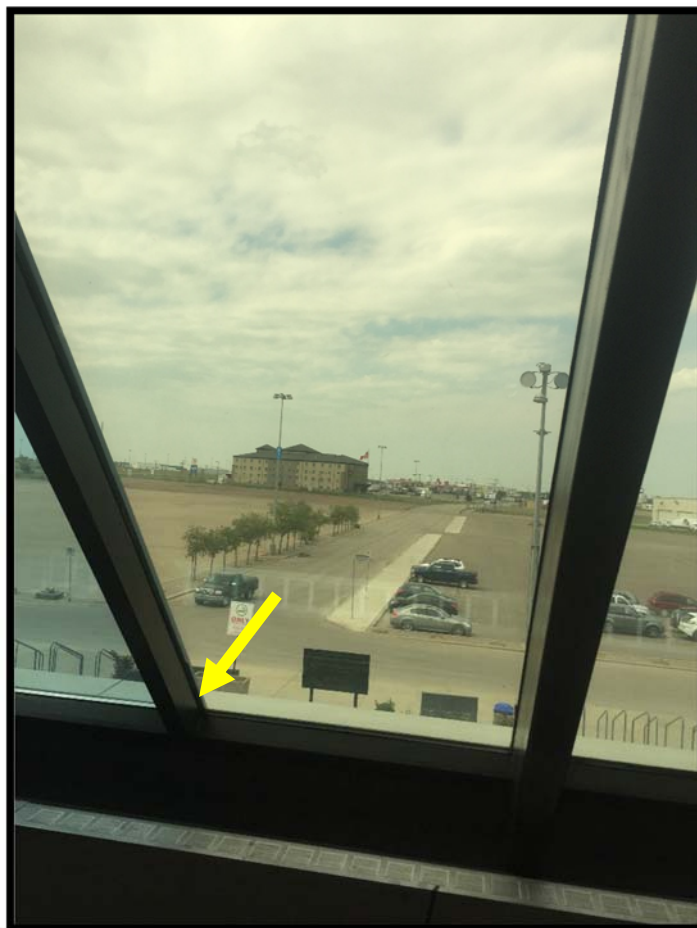
Five (5) samples of black interior window caulking were collected during the assessment. One of the samples collected was found to contain 1.8% Chrysotile asbestos. Asbestos-containing black interior window caulking (see Photograph 3 in Appendix B) was observed on the interior of the exterior windows in the following locations:

- Room 301 (approximately 600 ft);
- Room 304 (approximately 580 ft);
- Room 304A (approximately 200 ft);
- Room 304B (approximately 200 ft);
- Room 304C (approximately 200 ft);
- Room 305 (approximately 225 ft); and
- Room 308 (approximately 260 ft).

Photograph 3: Asbestos-Containing Black Interior Window Caulking.

If scheduled for impact, asbestos-containing black interior window caulking should be abated following low-risk abatement work procedures as outlined in the *Saskatchewan Asbestos Abatement Manual* (2017). Alternatively, as the black interior window caulking was observed in good condition, and with a priority rating of 5 (please see the room by room spreadsheet provided in Appendix C for a description of the priority ratings), it can be managed in place if not scheduled for impact.
