## **Field House Asbestos Survey Report**

**January 2015**

**Prepared For: City of Saskatoon Infrastructure Services - Facilities Branch**  
3130 Laurier Drive, Saskatoon, SK.  
Attn: Brent Anderson

**Prepared By: Bersch & Associates Ltd.**  
**Project No. : B67SRJ08**

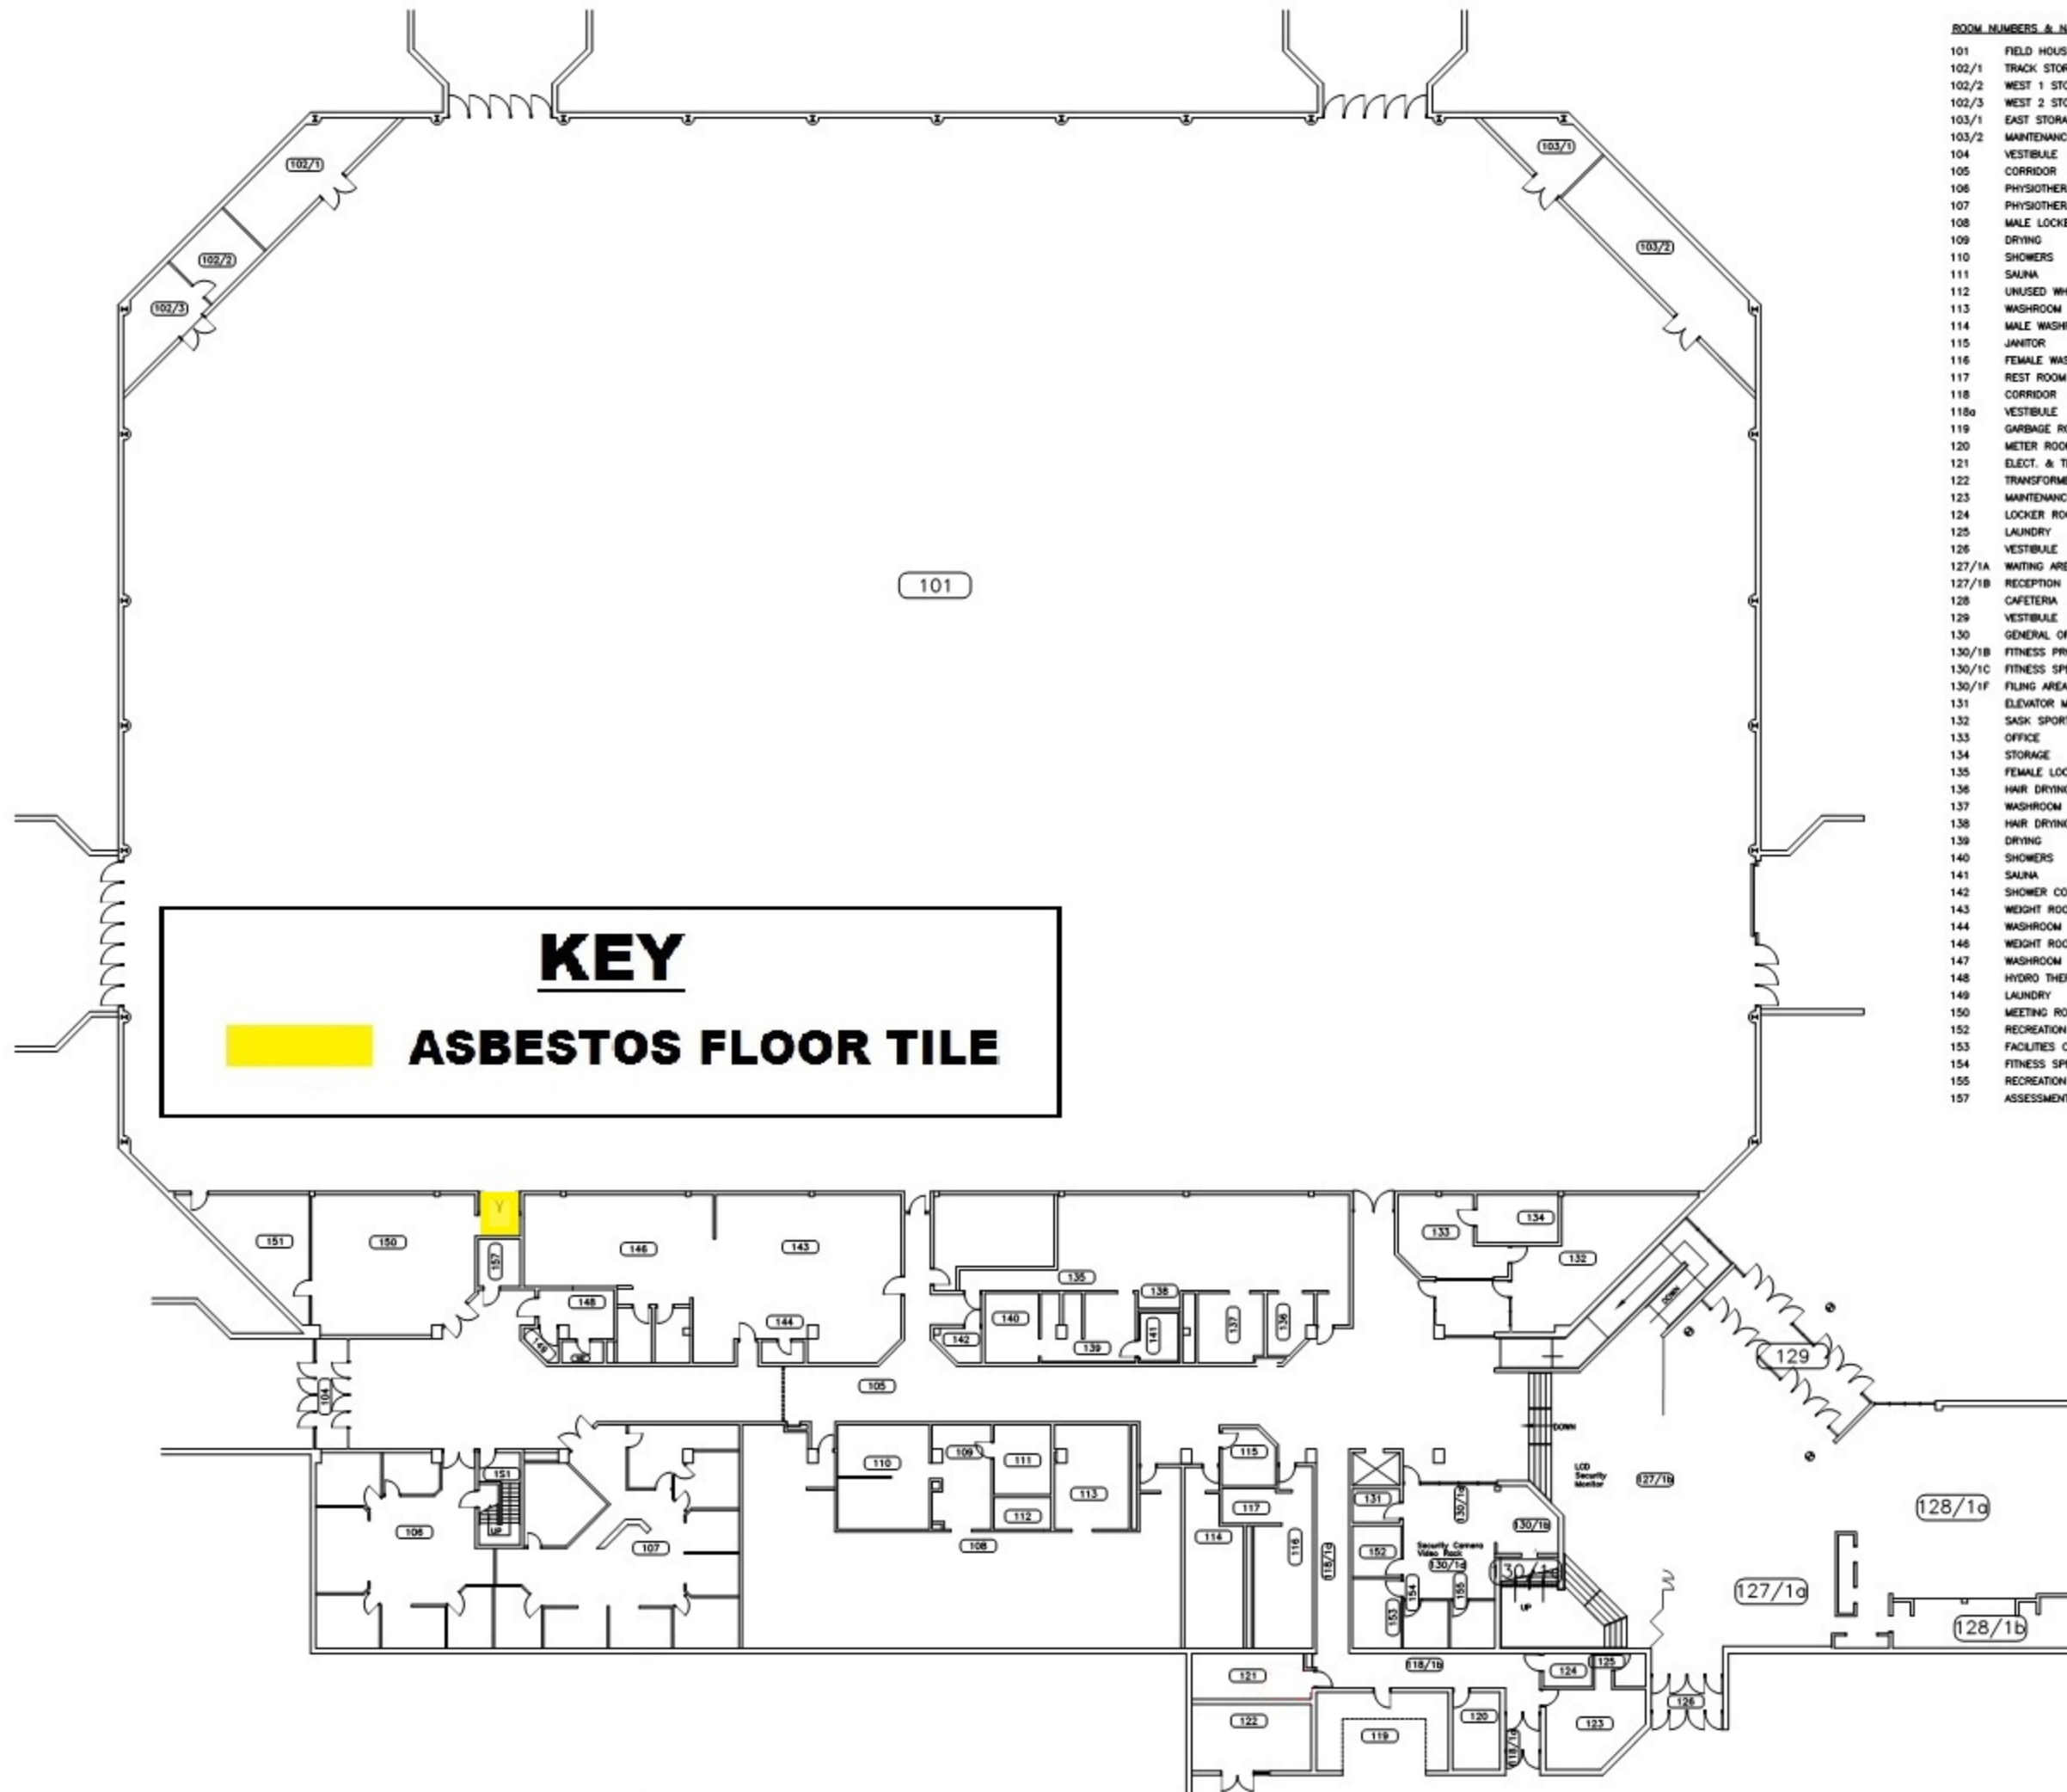
- **Vinyl Asbestos Floor Tile** is located in Meeting Room 151(walkway to track area) and Meeting Room 207. The Asbestos Floor Tile is identified on the **Floor Plans** in **Appendix III** of this report. It is suspected that the vinyl asbestos tile is present beneath the new layer of flooring throughout the facility. ***Further testing of any flooring beneath the top layer is recommended prior to renovations.***

**ASBESTOS FLOOR TILE**

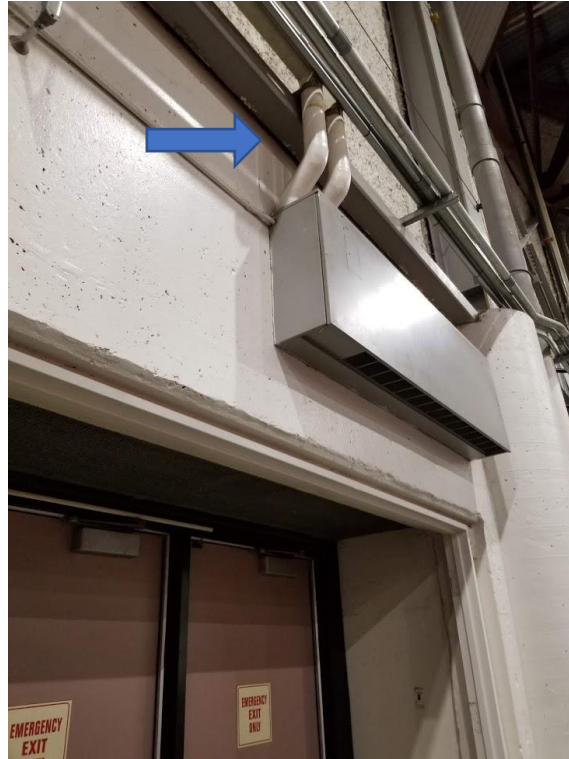
### 1) Pipeline Fittings Above Doorway (non-asbestos)

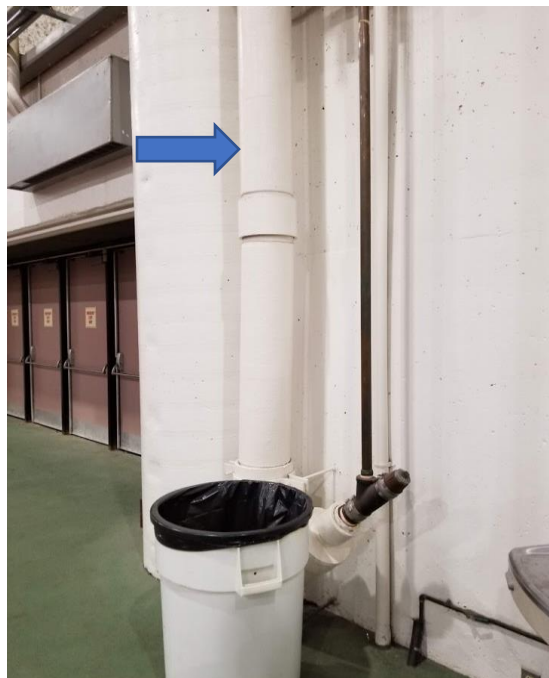
### 2) Transite Roof Drainpipe (Asbestos Containing) Adjacent Exit Doors on the North Wall

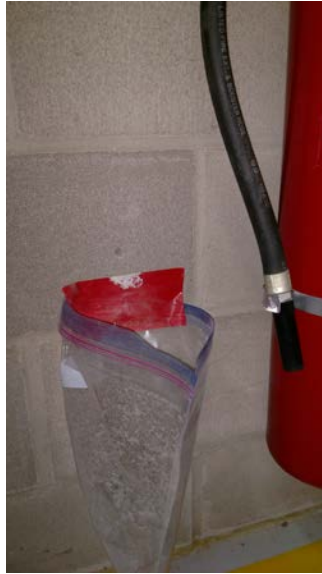
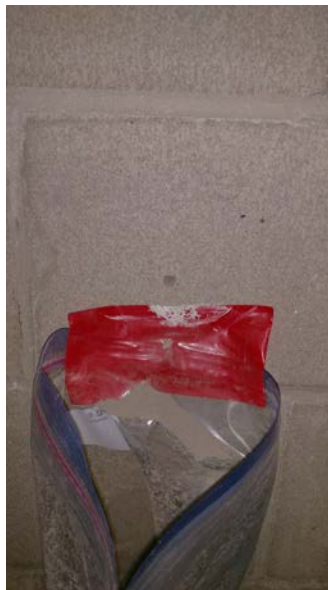
## ROOM 121 –BLOCK WALL – EMPTY CAVITIES
