**SPCA ANIMAL SHELTER
ASBESTOS SURVEY REPORT**

May 2013

Prepared By: Bersch & Associates Ltd.
Project No. : B67.13

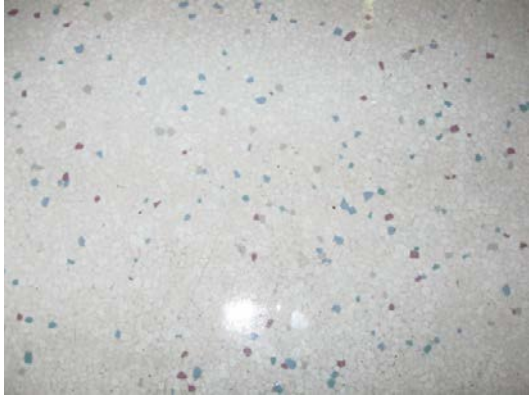
#1) Sheet Floor Covering

NO.	DATE	SAMPLE INFORMATION	ASBESTOS	%	ANALYST
1	2-May-13	128 - Sheet floor covering, gray stone pattern with blue, pink and green spec	None detected		WB
2	2-May-13	127 - Attic insulation	None detected		WB
3	2-May-13	B100 - Drywall tape/ mud	None detected		WB
4	2-May-13	B100 - Pipeline insulation	None detected		WB
5	2-May-13	119 - Ceiling board	None detected		WB
6	2-May-13	112 - 2' x 4' ceiling tile	None detected		WB
7	2-May-13	121 - Sheet floor covering, tan with white spec	None detected		WB

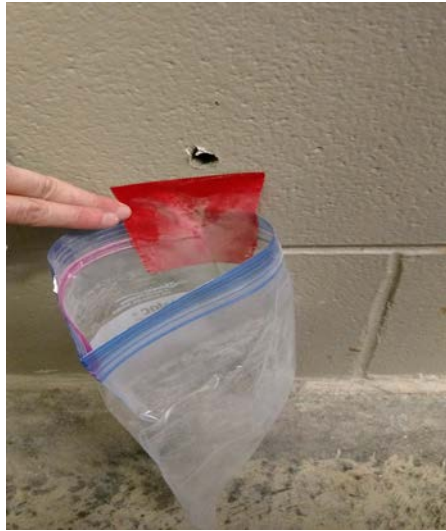
The SPCA building consists of block walls, drywall walls/ceilings and vinyl sheet flooring. The block walls were drilled into resulting in a hollow block cavity. No insulation was observed in the block wall. Please refer to ***Appendix II – Site Photo's***.

PHOTO 1 – Block Wall Cavity (Empty)

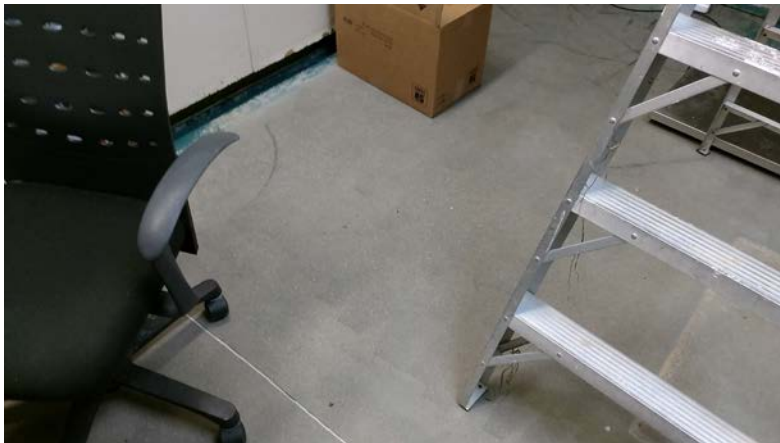
PHOTO 2 – Concrete Flooring

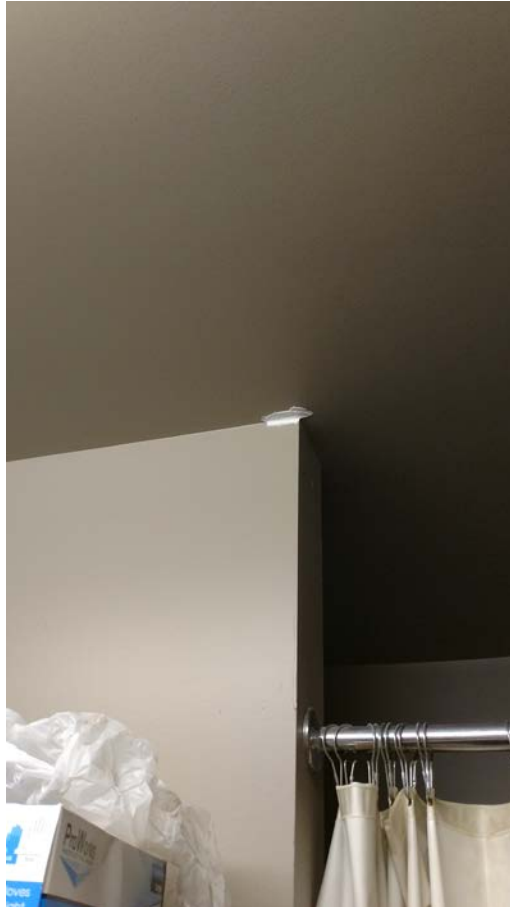
PHOTO 3 – Drywall Walls/Ceiling
