## CITY OF SASKATOON

# Asbestos-Containing Building Materials Assessment Report - 29th Street Substation

**Report Number: 1667963**

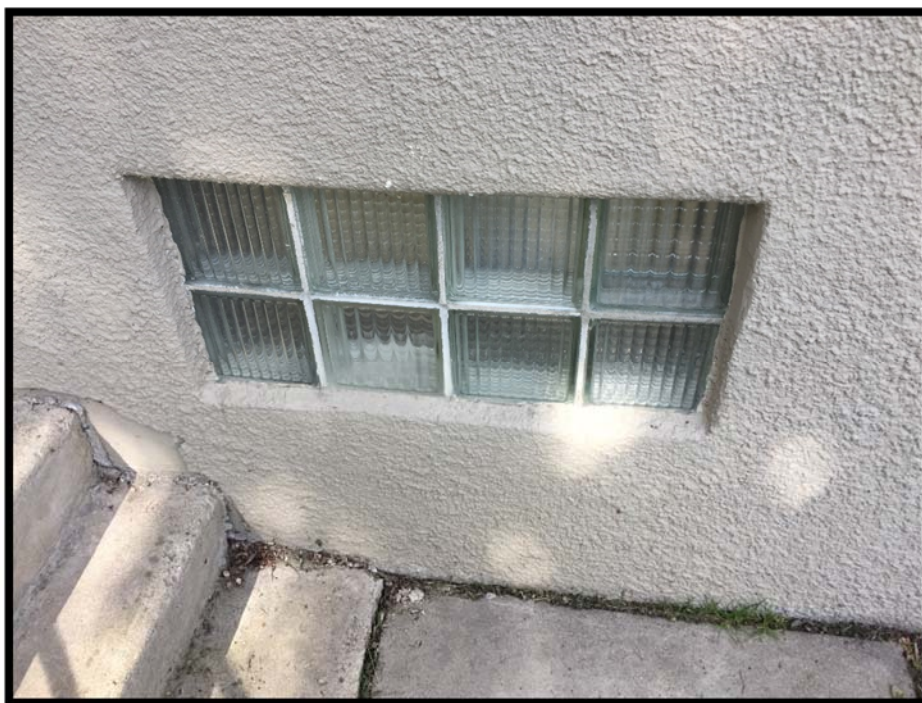
Five (5) samples of exterior stucco were collected during the assessment. One of the samples collected was found to contain 1.4% Chrysotile asbestos. Asbestos-containing exterior stucco (see Photograph 1 in Appendix B) was observed in the following locations:

- Exterior (approximately 2,175 ft<sup>2</sup>).

**Photograph 1: Asbestos-Containing Exterior Stucco.**

If scheduled for impact, asbestos-containing exterior stucco should be abated following the high-risk abatement work procedures as outlined in the *Saskatchewan Asbestos Abatement Manual* (2017). Alternatively, as the exterior stucco was observed in good condition, and with a priority rating of 4 (please see the room by room spreadsheet provided in Appendix C for a description of the priority ratings), it can be managed in place if not scheduled for impact. Due to the material being located on the exterior of the building being exposed to the elements, removal should be scheduled within a reasonable timeframe.

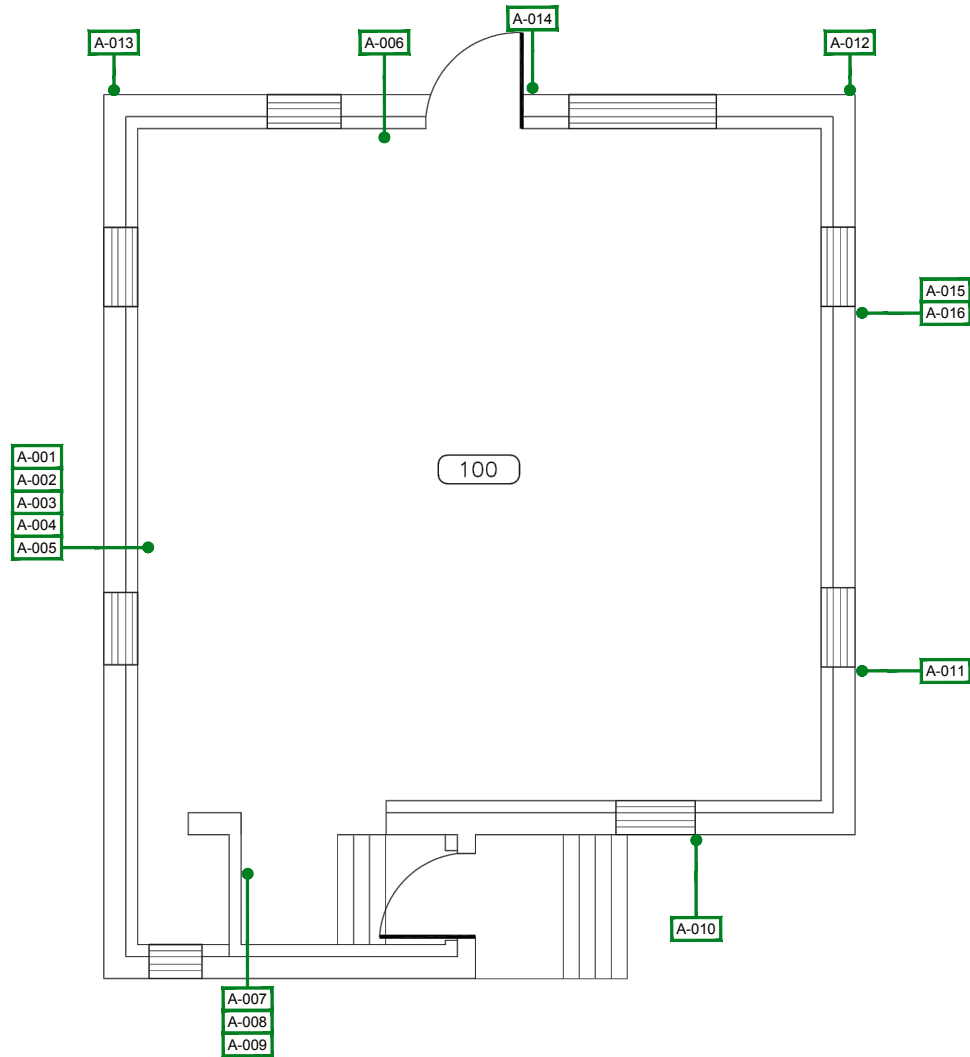
FIGURE 1

**NOTE(S)**  
1. ASBESTOS IS A CARCINOGEN. DO NOT BREATHE ASBESTOS DUST.  
2. ASBESTOS-CONTAINING STUCCO IS LOCATED ON THE EXTERIOR OF THE BUILDING.
