August 4, 2017

## CITY OF SASKATOON

# Asbestos-Containing Building Materials Assessment Report - Avenue W Substation

**Report Number: 1667963**

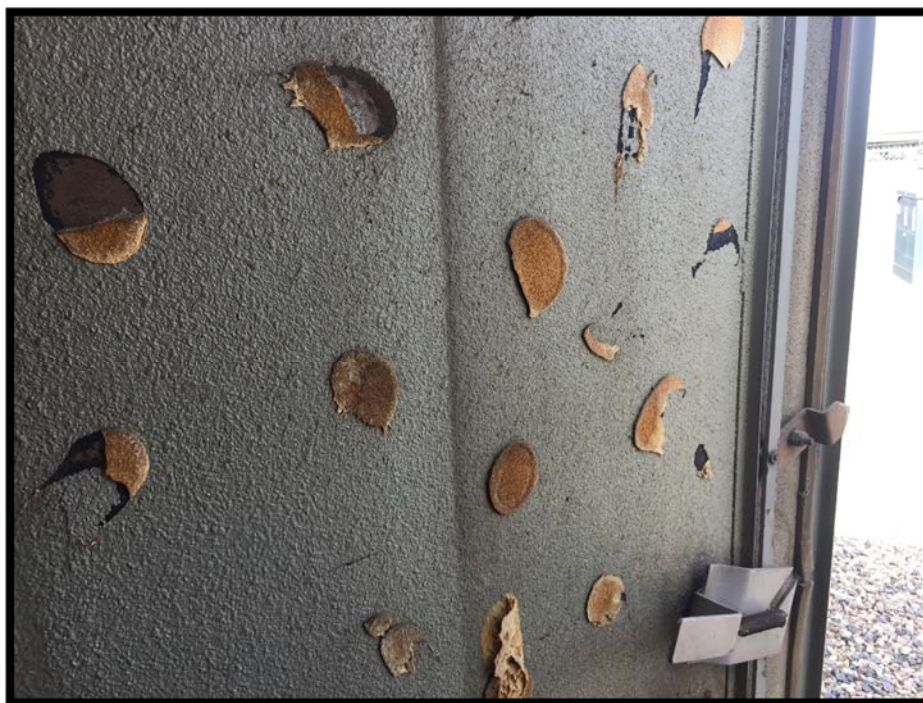
One (1) sample of wall and ceiling mastic was collected during the assessment. The sample collected was found to contain 10% Chrysotile asbestos. Asbestos-containing wall mastic (see Photograph 1 in Appendix B) was observed in the following locations:

- Room 100 (approximately 50 ft<sup>2</sup>).

Additional asbestos-containing mastic is suspected to be located sporadically below the fibreglass panels on the walls and ceilings and within the interior of the doors throughout Room 100.

**Photograph 1: Asbestos-Containing Wall and Ceiling Mastic.**

If scheduled for impact, asbestos-containing wall and ceiling mastic should be abated following low-risk abatement work procedures as outlined in the *Saskatchewan Asbestos Abatement Manual* (2017). Alternatively, as the wall and ceiling mastic was observed in good condition, and with a priority rating of 5 (please see the room by room spreadsheet provided in Appendix C for a description of the priority ratings), it can be managed in place if not scheduled for impact.

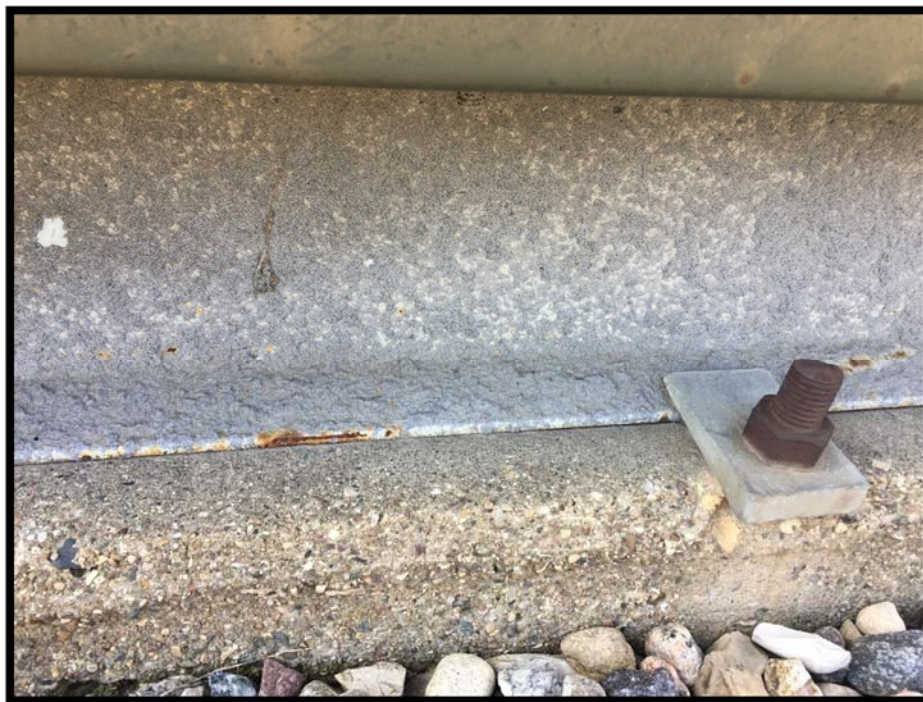
One (1) sample of texture coat was collected during the assessment. The sample collected was found to contain 20% Chrysotile asbestos. Asbestos-containing texture coat (see Photograph 2 in Appendix B) was observed in the following locations:

- Doors and Exterior Structural Steel (approximately 200 ft<sup>2</sup>).

**Photograph 2: Asbestos-Containing Texture Coat.**

If scheduled for impact, asbestos-containing texture coat should be abated following high-risk abatement work procedures as outlined in the *Saskatchewan Asbestos Abatement Manual* (2017). The texture coat was observed in good condition, however it is located along the exterior structural steel and within a half-dismantled door. Based upon the exposure to the exterior elements, as well as the intent of having the texture concealed behind the door, a priority rating of 4 (please see the room by room spreadsheet provided in Appendix C for a description of the priority ratings) was assigned to the texture. The texture should be managed in place until it can be scheduled for removal in a reasonable timeframe.

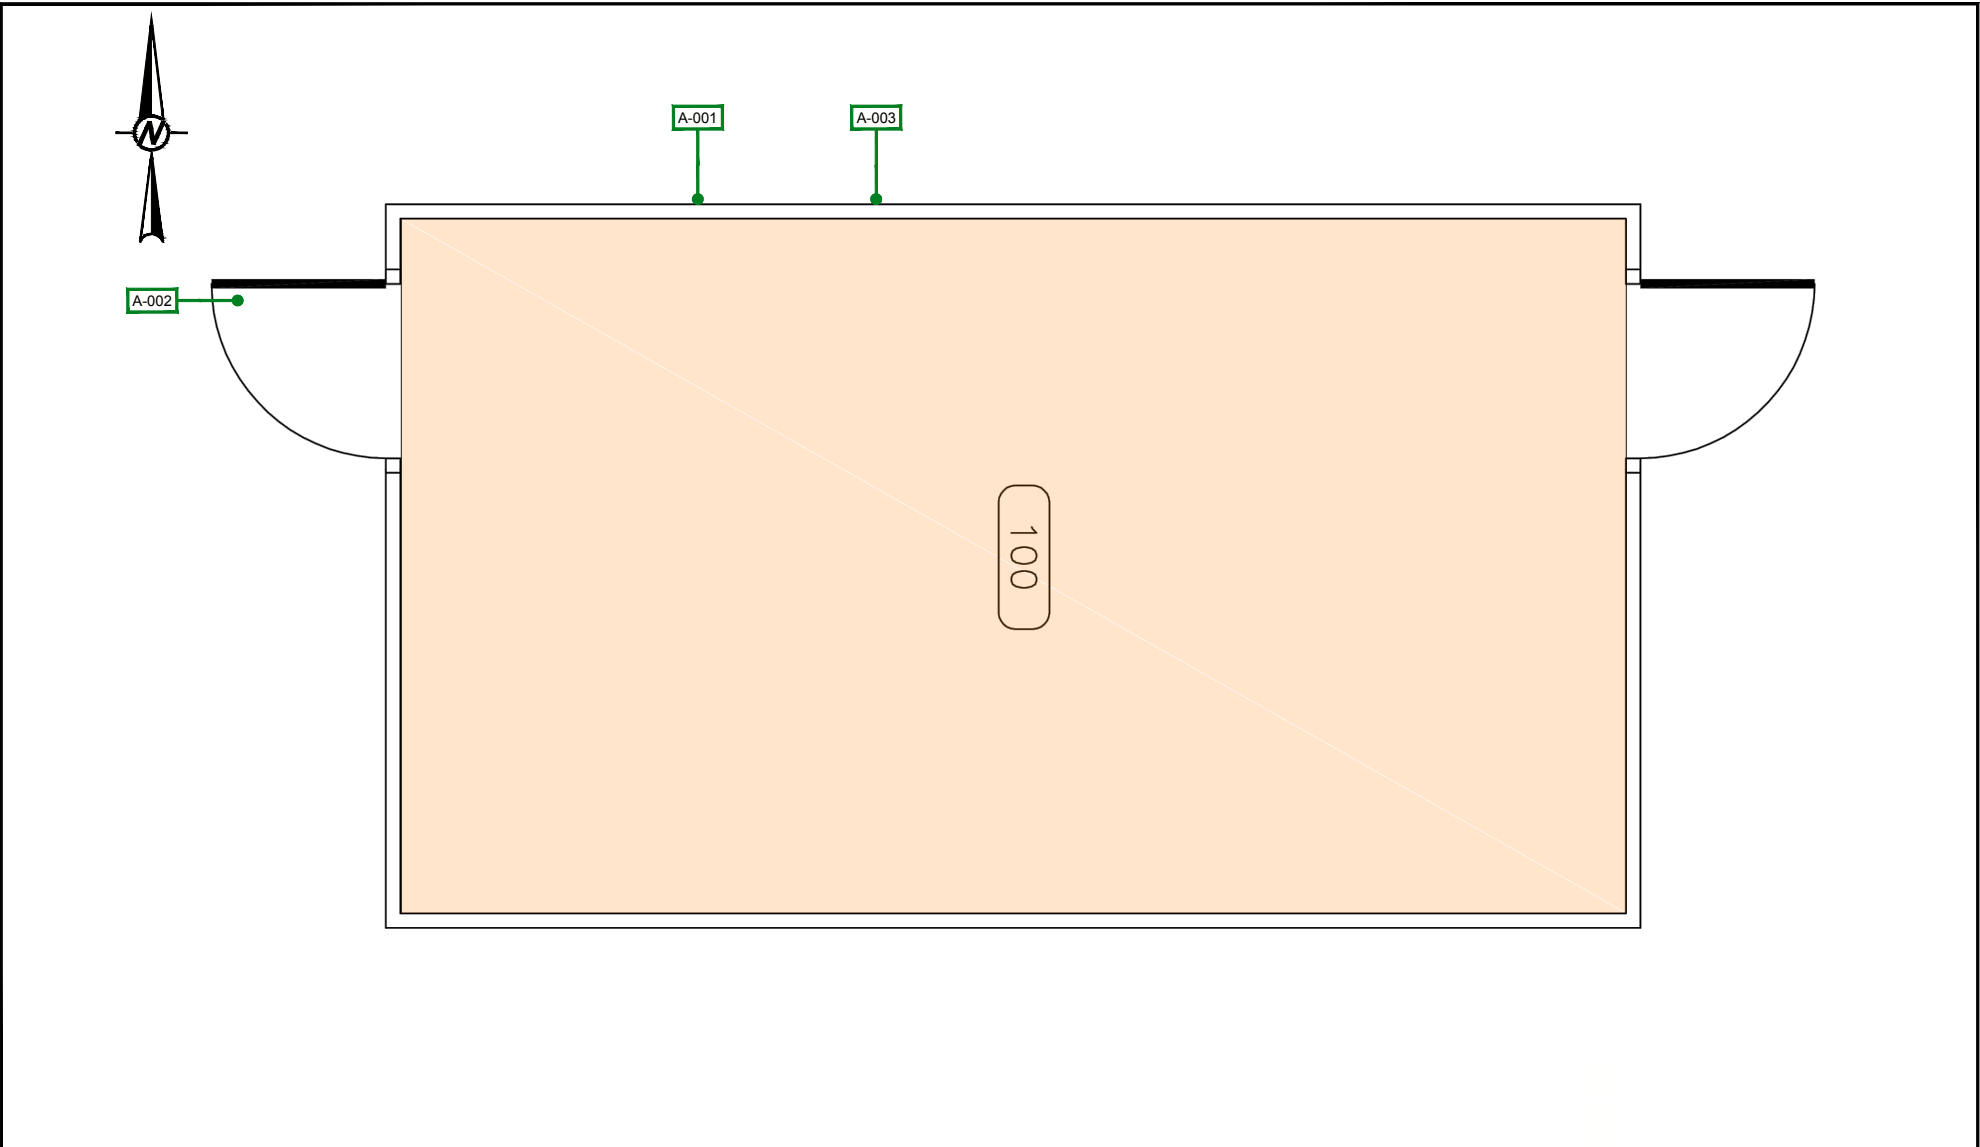
TITLE  
MAIN FLOOR

2. ASBESTOS-CONTAINING TEXTURE COAT IS LOCATED ON THE EXTERIOR STRUCTURAL STEEL OF THE SITE.
