## CITY OF SASKATOON

# Asbestos-Containing Building Materials Assessment Report - C D McGall Substation

**Report Number: 1667963**

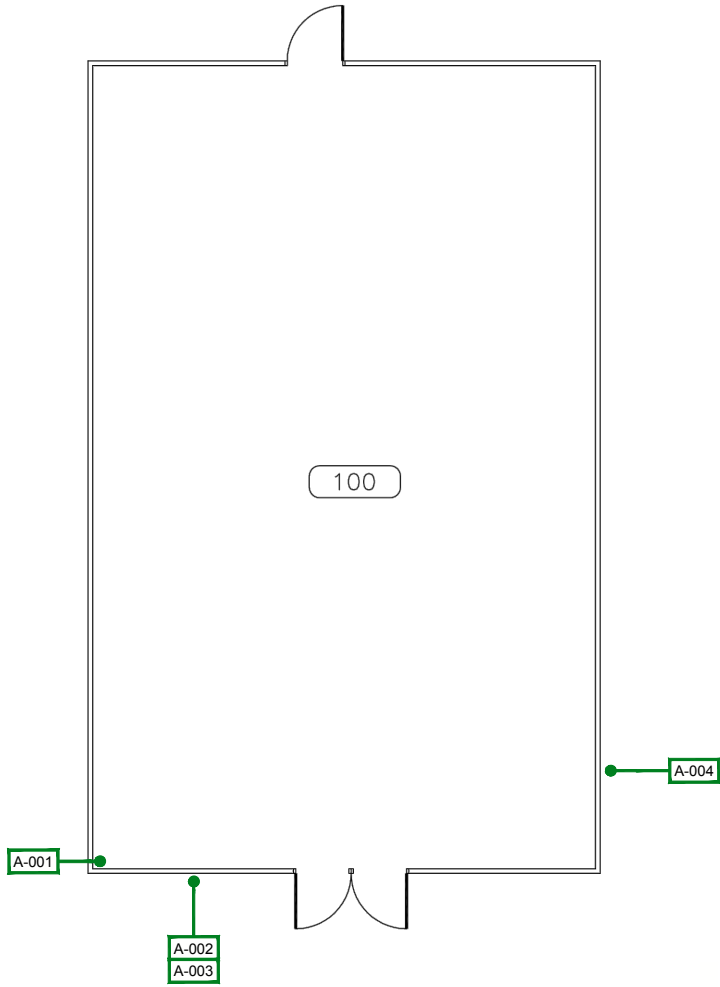
**TITLE**  
MAIN FLOOR

1. ASBESTOS IS A CARCINOGEN. DO NOT BREATHE ASBESTOS DUST.  
2. ASBESTOS-CONTAINING WHITE BUILDING CAULKING IS LOCATED SPORADICALLY ON THE EXTERIOR OF THE BUILDING.
