## CITY OF SASKATOON

# Asbestos-Containing Building Materials Assessment Report - North Central Substation/Electrical Transformer Building

**Report Number: 1667963**

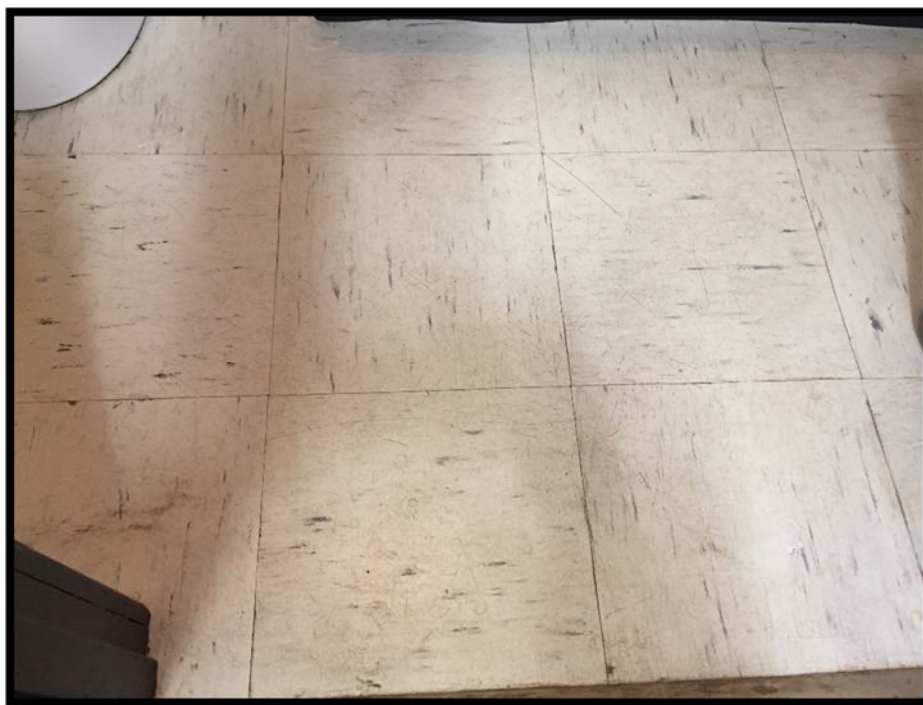
One (1) sample of 1'x1' off-white floor tile with black flecks was collected during the assessment. The sample collected was found to contain trace Chrysotile asbestos. Asbestos-containing 1'x1' off-white floor tile with black flecks (see Photograph 1 in Appendix B) was observed in the following locations:

- Room 106 (approximately 50 ft<sup>2</sup>).

Asbestos was positively identified within the 1'x1' off-white floor tile with black flecks on Site. Asbestos was not identified in the remaining samples collected and analyzed.

**Photograph 1: Asbestos-Containing 1'x1' Off-White Floor Tile with Black Flecks.**

If scheduled for impact, asbestos-containing 1'x1' off-white floor tile with black flecks should be abated following low-risk abatement work procedures as outlined in the *Saskatchewan Asbestos Abatement Manual* (2017). Alternatively, as the 1'x1' off-white floor tiles with black flecks were observed in good condition, and with a priority rating of 5 (please see the room by room spreadsheet provided in Appendix C for a description of the priority ratings), the tiles can be managed in place if not scheduled for impact.
