August 23, 2017

## CITY OF SASKATOON

# Asbestos-Containing Building Materials Assessment Report - Ruth Street Substation

**Report Number: 1667963**

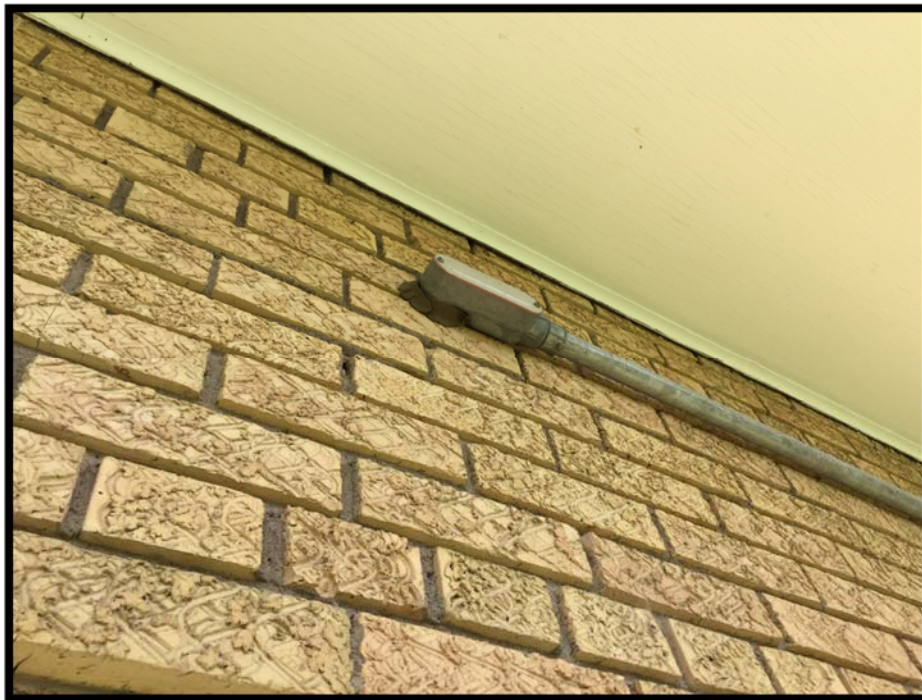
One (1) sample of black firestop was collected during the assessment. The sample collected was found to contain 2.8% Chrysotile asbestos. Asbestos-containing black firestop (see Photograph 2 in Appendix B) was observed in the following locations:

- Exterior (approximately 1 ft<sup>2</sup>).

**Photograph 2: Asbestos-Containing Black Firestop.**

If scheduled for impact, asbestos-containing black firestop should be abated following the low-risk abatement work procedures as outlined in the *Saskatchewan Asbestos Abatement Manual* (2017). Alternatively, as the black firestop was observed in good condition, and with a priority rating of 5 (please see the room by room spreadsheet provided in Appendix C for a description of the priority ratings), it can be managed in place if not scheduled for impact.

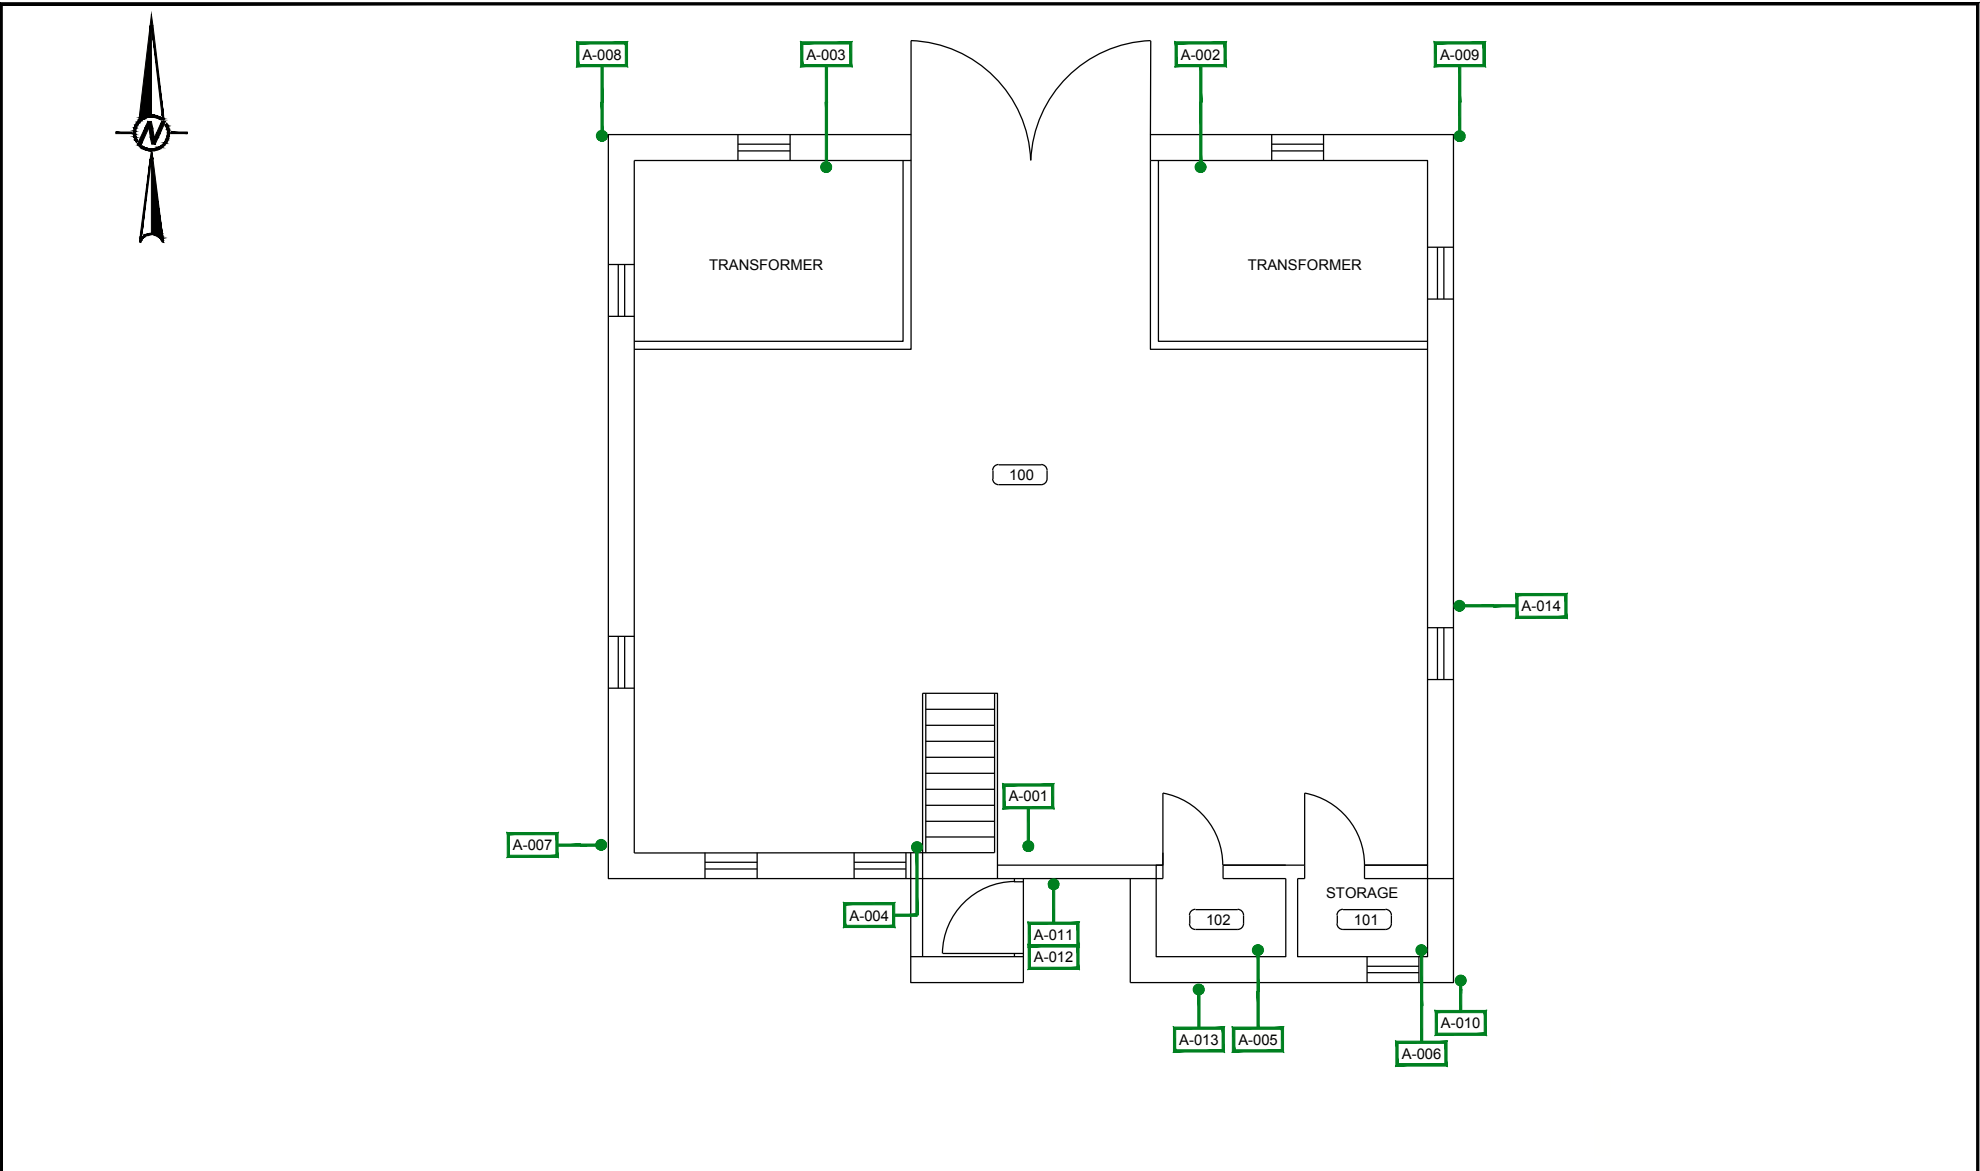
TITLE  
**MAIN FLOOR**

1. ASBESTOS IS A CARCINOGEN. DO NOT BREATHE ASBESTOS DUST.  
2. ASBESTOS-CONTAINING WHITE WINDOW CAULKING AND BLACK FIRESTOP IS LOCATED ON THE EXTERIOR OF THE BUILDING.
