Sutherland Hall Asbestos Survey Report

February 2014

Prepared For: City Of Saskatoon- Infrastructure Services Department
1101 Avenue P North, Saskatoon, SK.
Attn: Brent Anderson

Prepared By: Bersch & Associates Ltd.
Project No. : B67SRB04

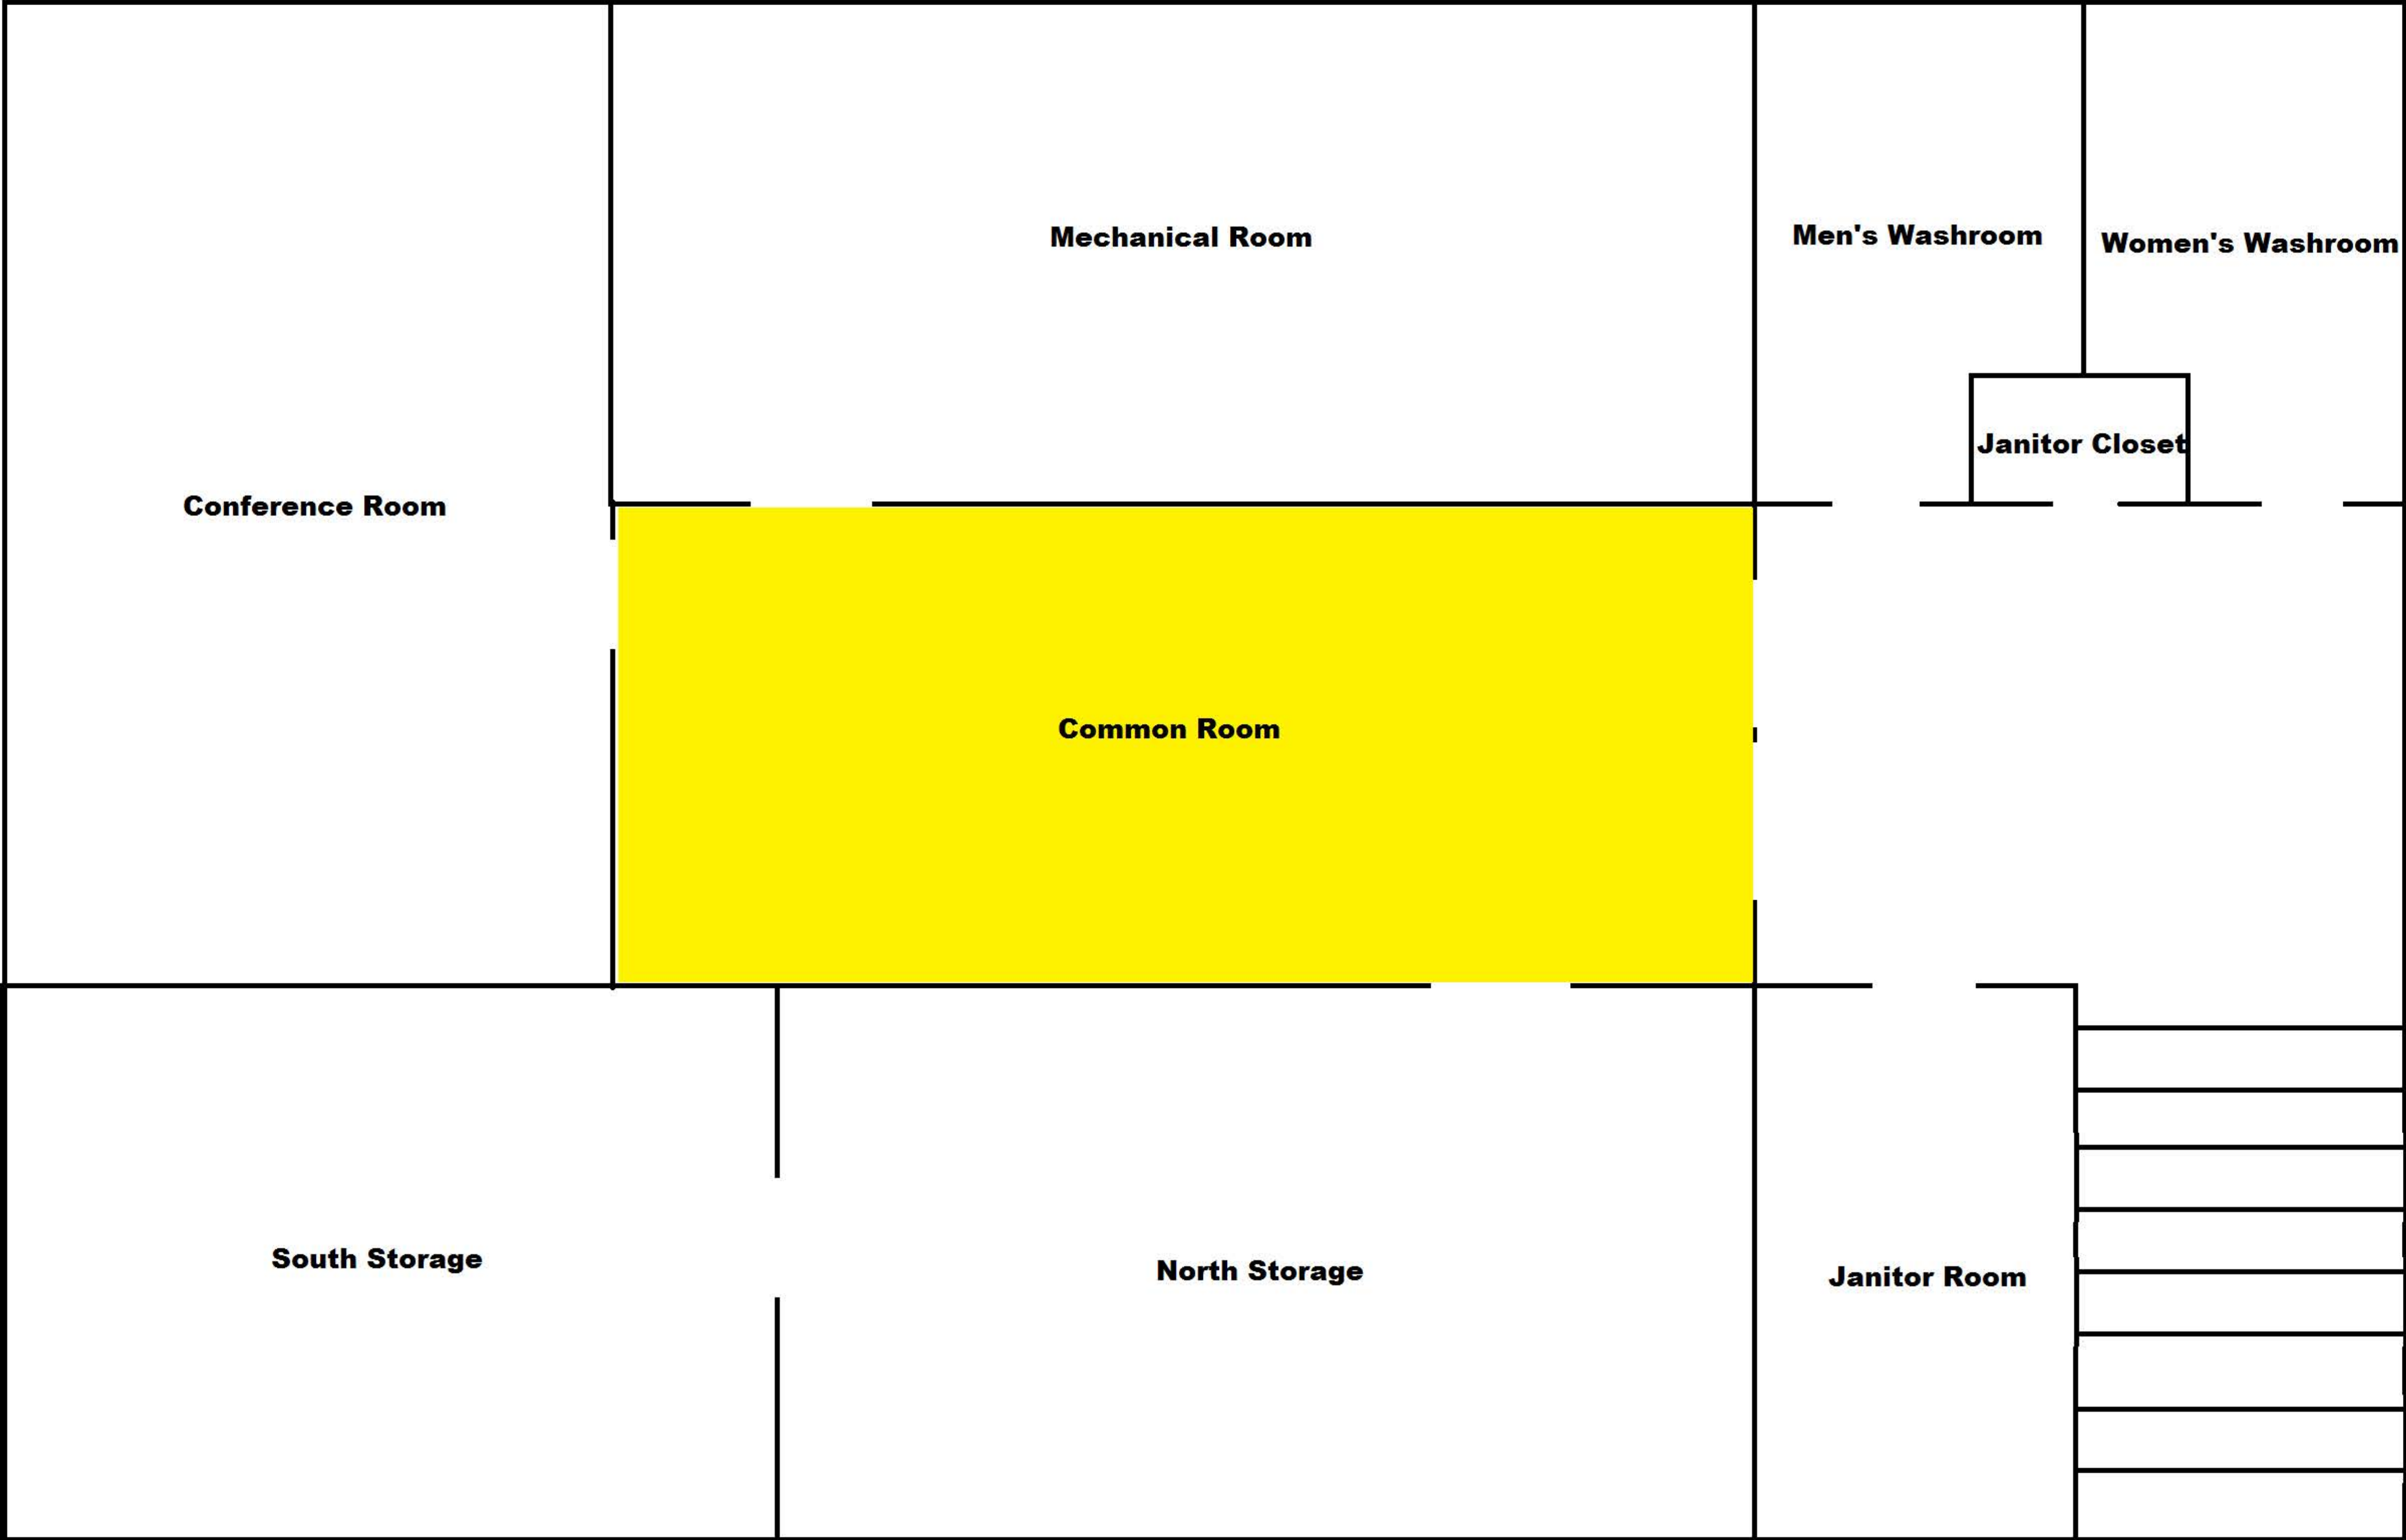
Sutherland Hall - Basement

- **Asbestos Mud Compound** is located on ducting in the Mechanical Room and Storage Rooms within the basement.
- **Asbestos Floor Tile** is located in the basement common room.
- **Heat Shield Material** is found within six light fixtures stored in the basement North Storage Room.

- The Asbestos Mud Compound is identified with a red “ASBESTOS” stencil.
- Asbestos Floor Tile is identified on the Floor Plans in Appendix III of this report.
