CITY OF SASKATOON

Asbestos-Containing Building Materials Assessment Report - Silverwood Golf Course Pump House

Report Number: 1667963

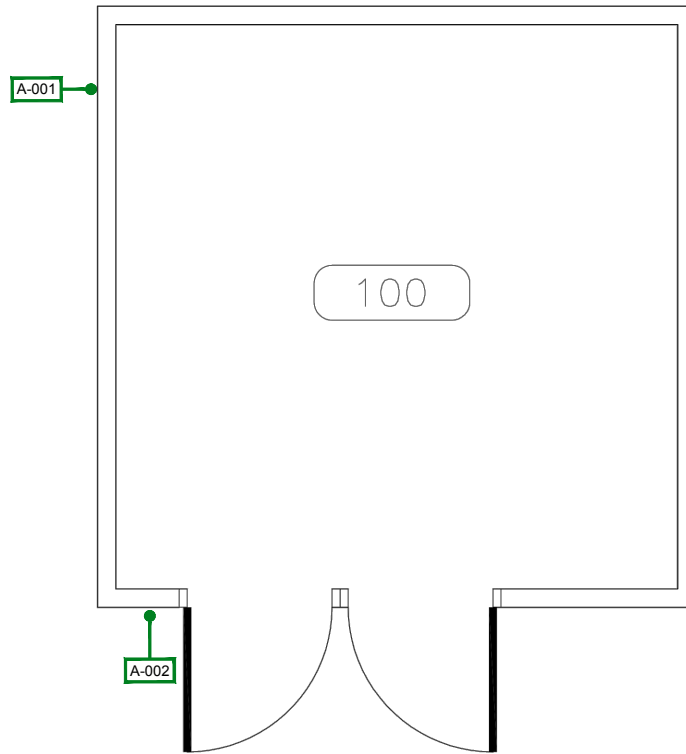
FIGURE
 1

1. ASBESTOS IS A CARCINOGEN. DO NOT BREATHE ASBESTOS DUST.
2. ASBESTOS-CONTAINING MATERIALS WERE NOT OBSERVED WITHIN THE BUILDING AT THE TIME OF THE ASSESSMENT.
