TCU PLACE ASBESTOS HAZARD ASSESSMENT SURVEY REPORT

MAY 2007

**Prepared by: Bersch & Associates Ltd.
Prepared for: Jim Greenshields – City of Saskatoon
Project No. B67.07**

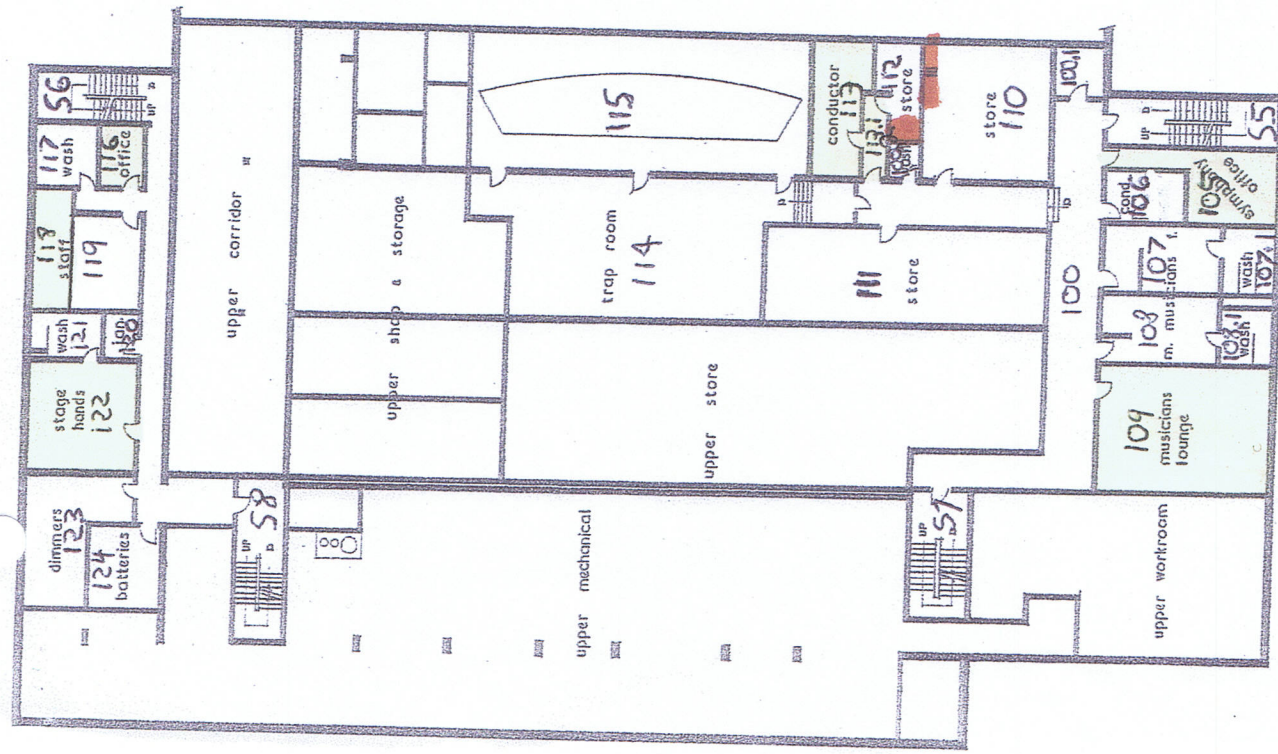
SASKATOON CENTENNIAL AUDITORIUM MEZZANINE FLOOR PLAN

VINYL ASBESTOS Floor TILE
TRANSITE BOARD

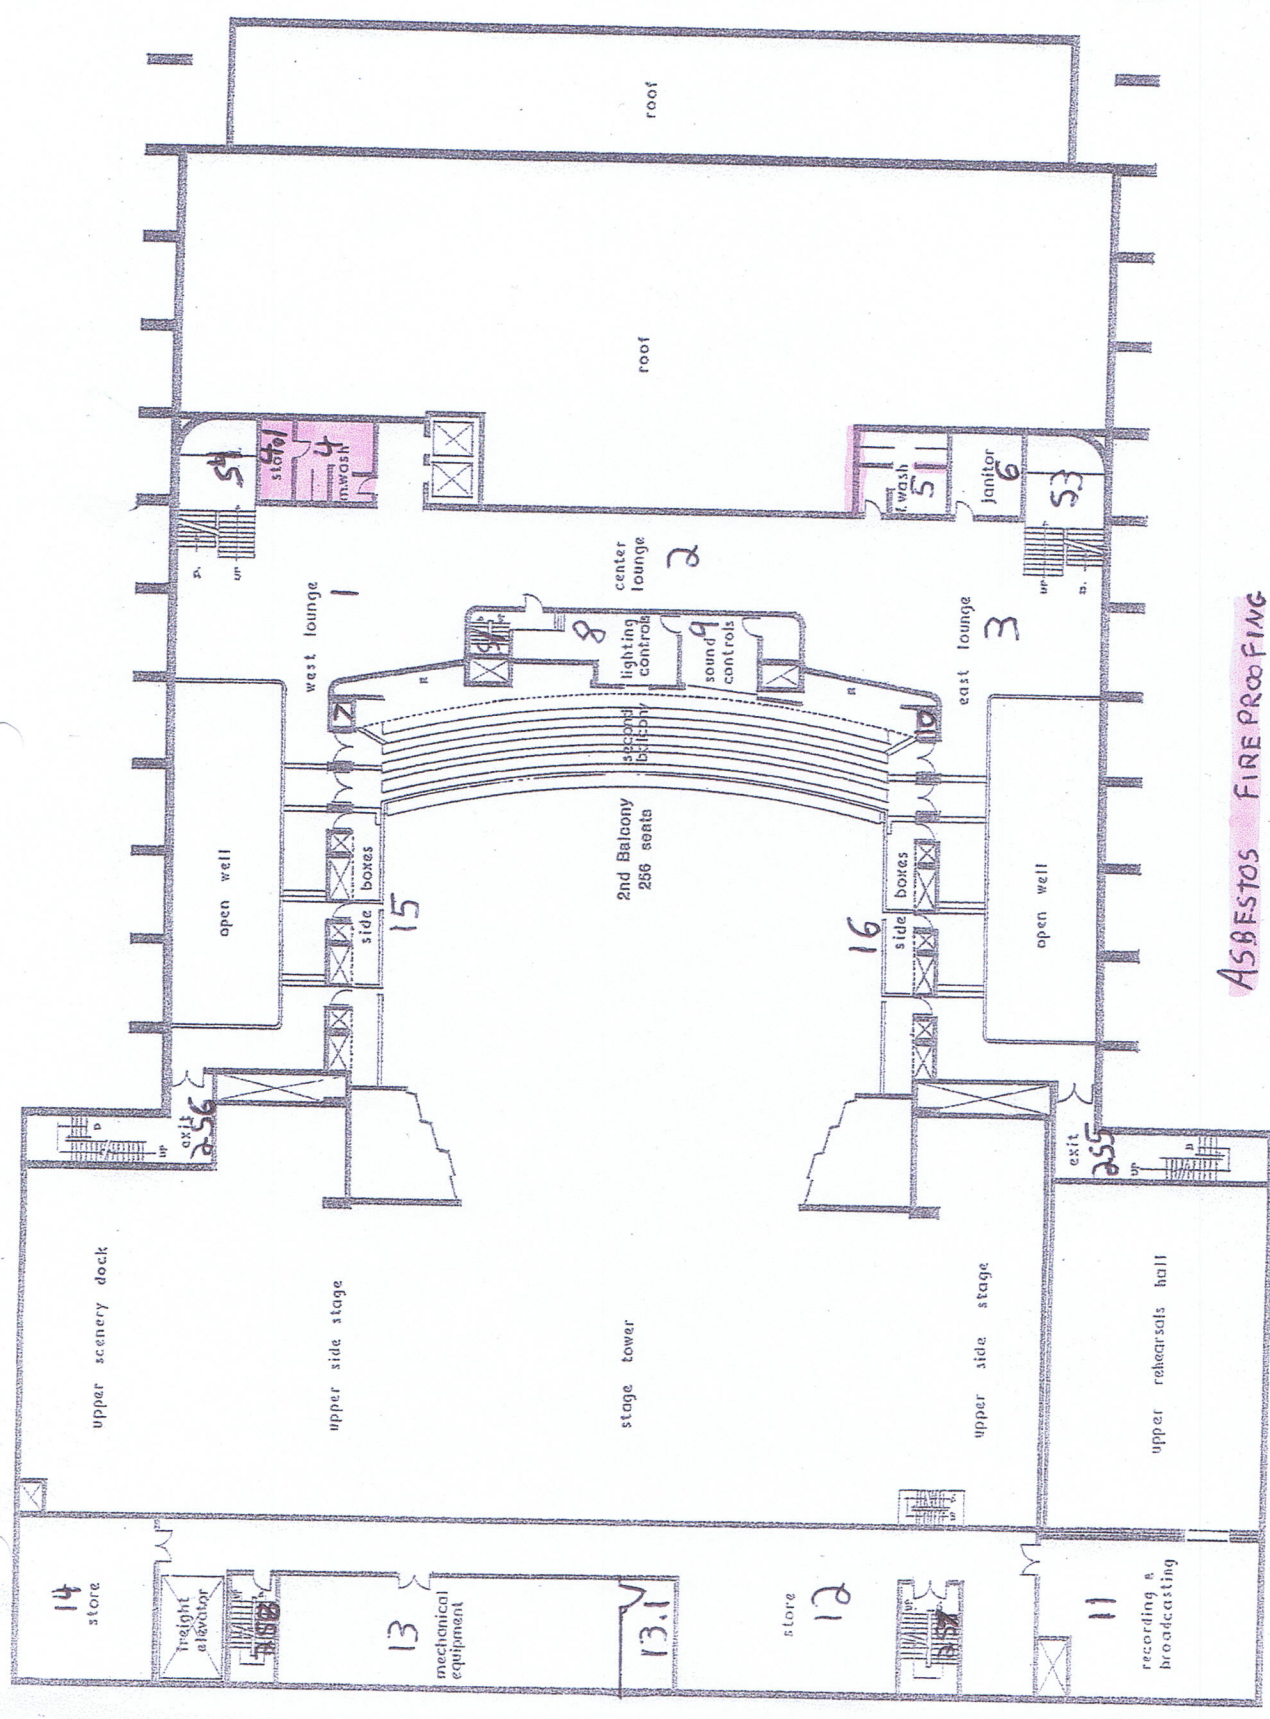
SASKATOON CENTENNIAL AUDITORIUM SECOND FLOOR PLAN

ASBESTOS FIRE PROOFING

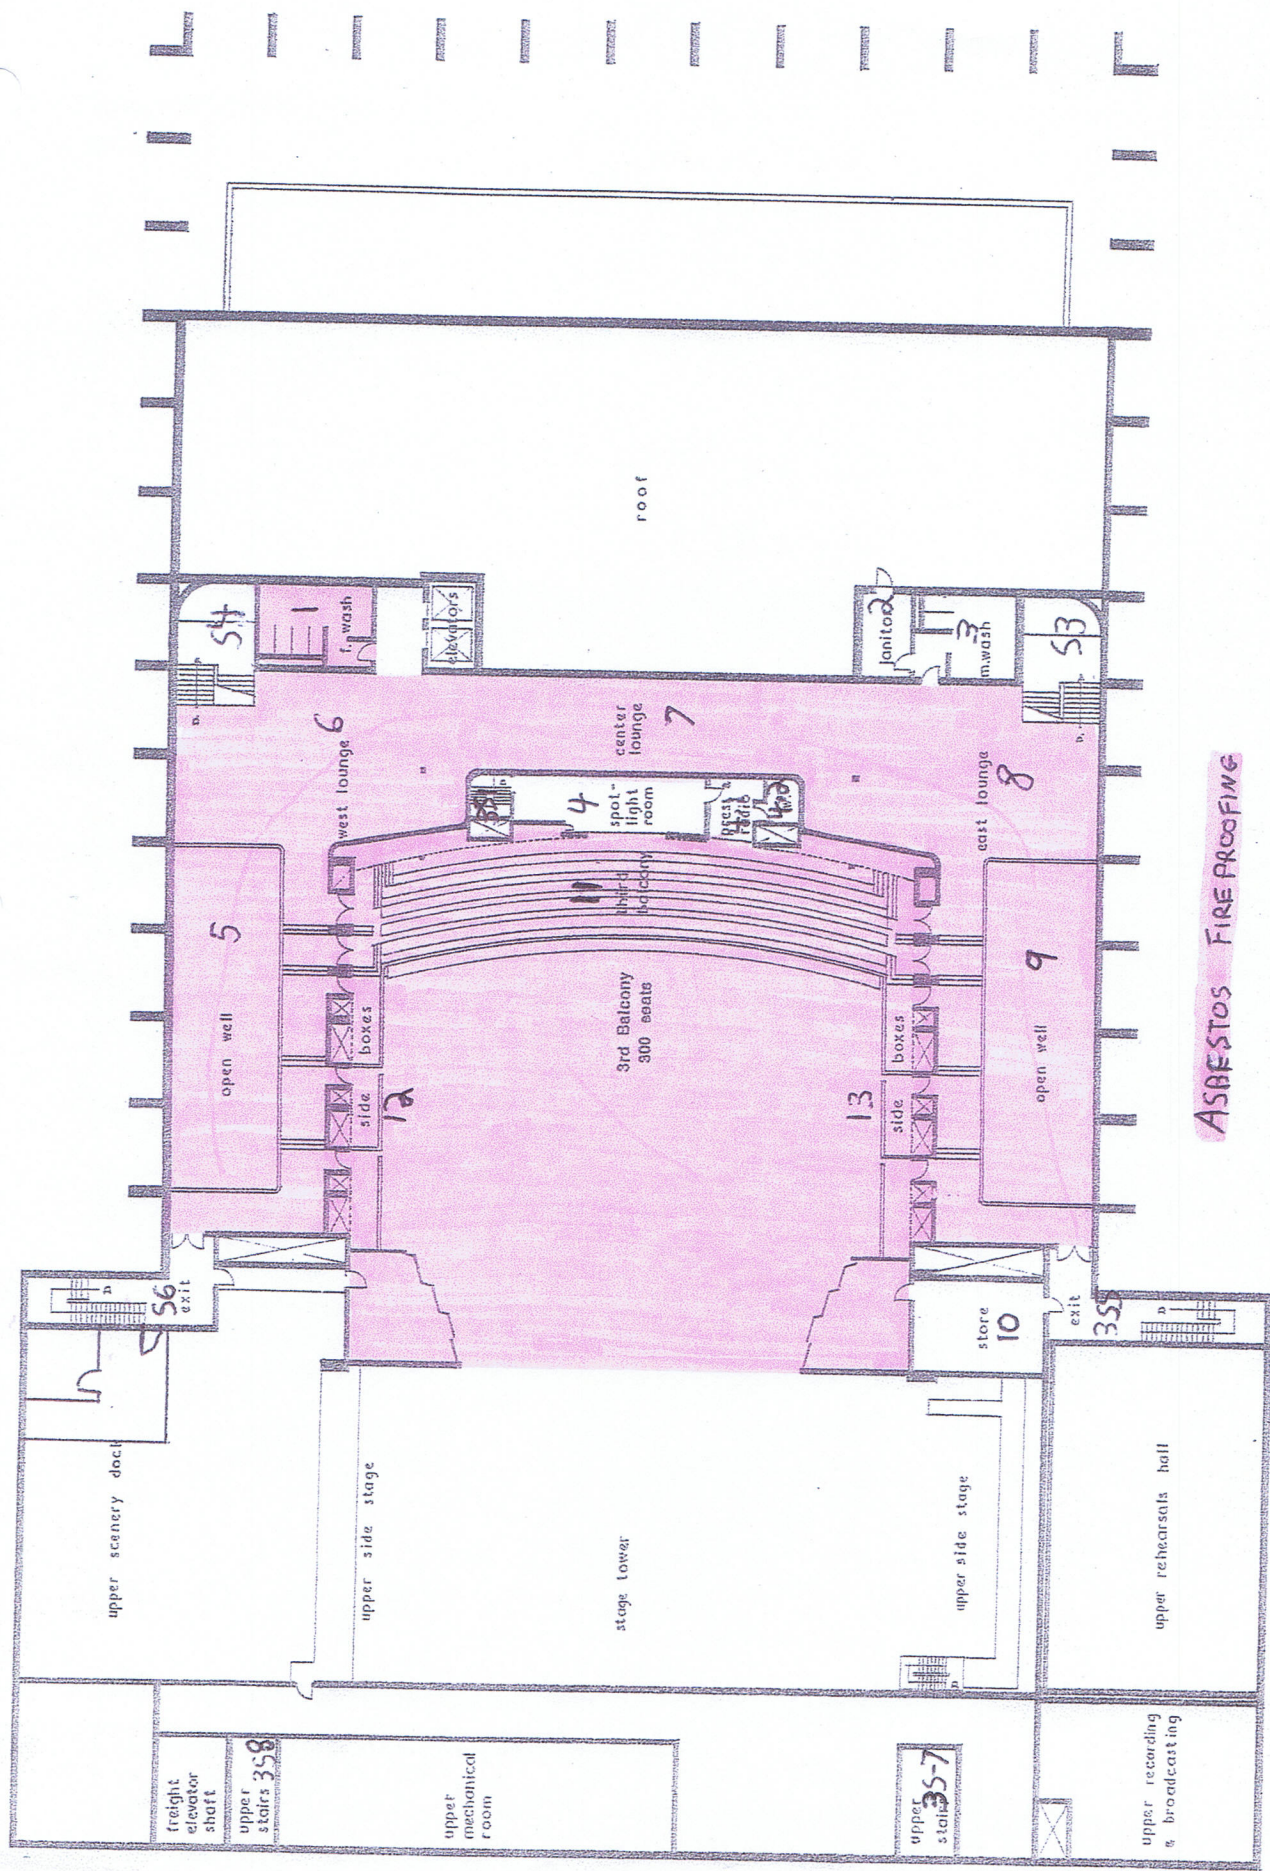
SASKATOON CENTENNIAL AUDITORIUM THIRD FLOOR PLAN

ASBESTOS FIRE PROOFING

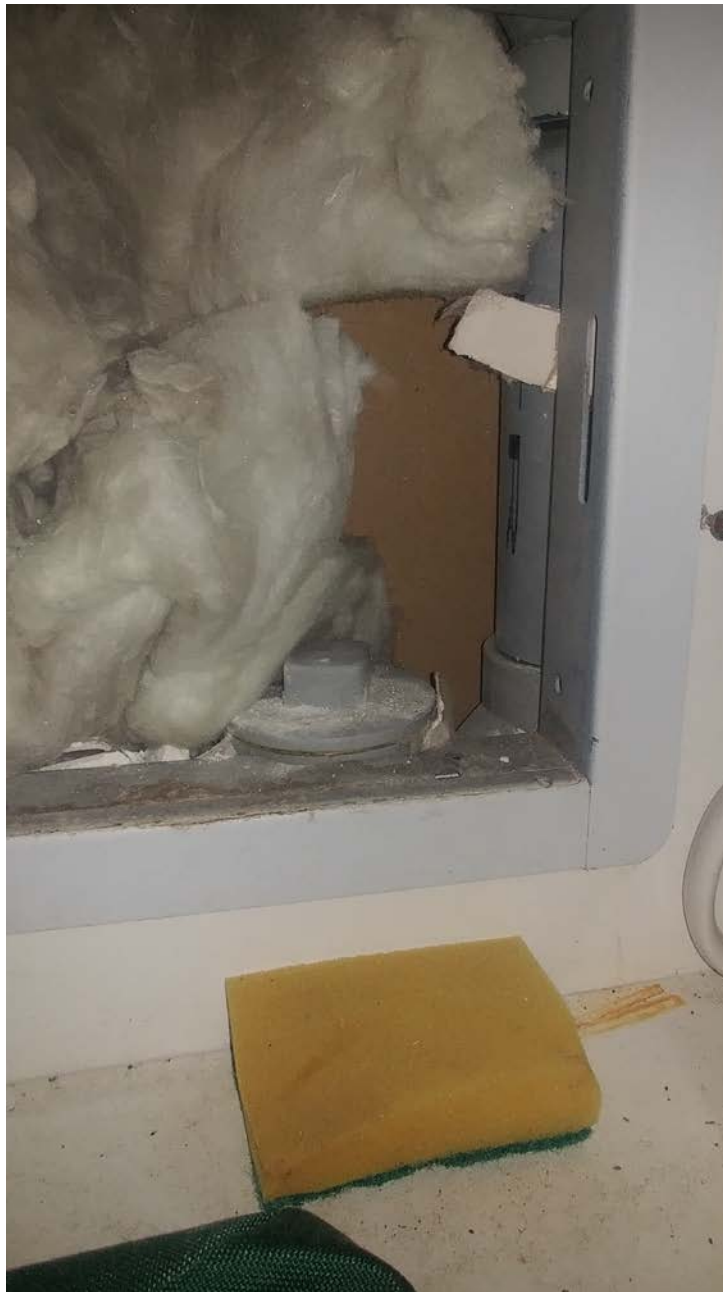
PHOTO 2 – Box Office Washroom- Wall Access Showing Fiberglass Insulation

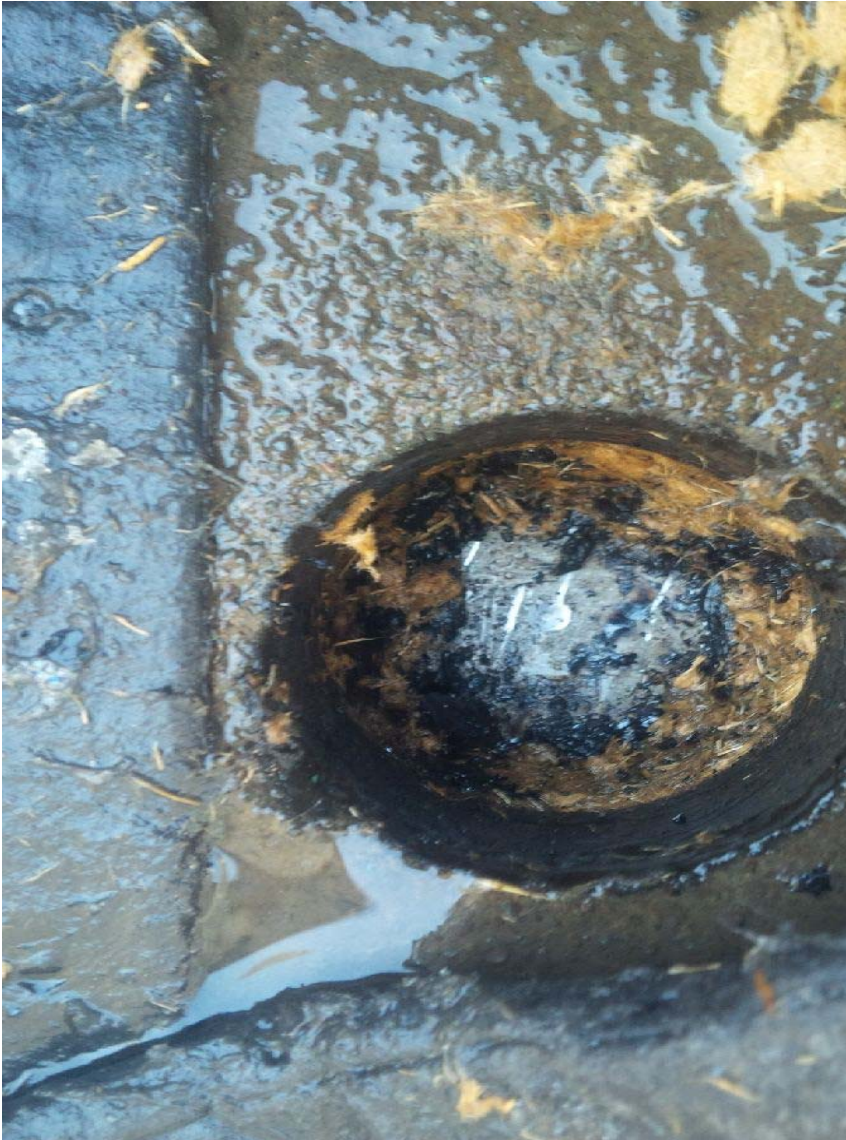
BULK SAMPLE LOCATION

Looking Downward At The Roof Surface – Cored Thru To Metal Decking

Top layer of asphalt roof membrane, tar layer, fibre board and metal decking.
