## **Trades Offices Asbestos Survey Report**

**January 2014**

**Prepared For: City Of Saskatoon- Infrastructure Services Department**  
1101 Avenue P North, Saskatoon, SK.  
Attn: Brent Anderson

**Prepared By: Bersch & Associates Ltd.**  
**Project No. : B67SRD30**

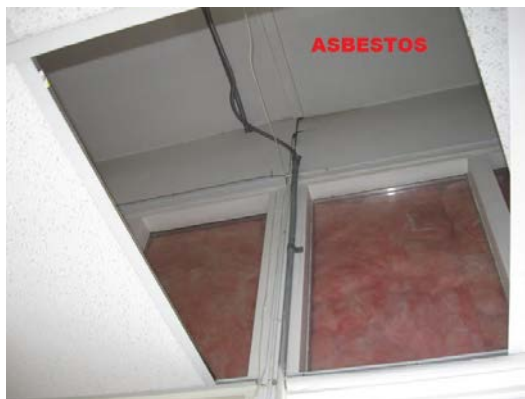
#1) Transite Board

- **Transite Board** is located above the windows and on the ceiling above the suspended ceiling of various rooms on the ground floor.
- **Heat Shield Material** is located within the incandescent light fixture within 101 Main Entry.

NO.	DATE	SAMPLE INFORMATION	ASBESTOS	%	ANALYST
1	30-Apr-13	Room 114 - Transite Board above window`s, above ceiling tile (board is also on ceiling above ceiling tile)	Chrysotile	25	WB
2	30-Apr-13	Room 115 Washroom - Sheet flooring, yellow and brown 6`` squares	None detected		WB
3	30-Apr-13	113 Corridor - 2` by 4` ceiling tile, slash marks with pin holes	None detected		WB
4	30-Apr-13	Basement Boiler Room - Pipeline fitting on medium green line overhead between boilers	None detected		WB
5	30-Apr-13	Room 105 - Textured ceiling	None detected		WB
6	30-Apr-13	106 Corridor - 1`by 1`ceiling tile	None detected		WB
7	30-Apr-13	101 Main Entry - Light fixture with heat shield material	Chrysotile	60	WB

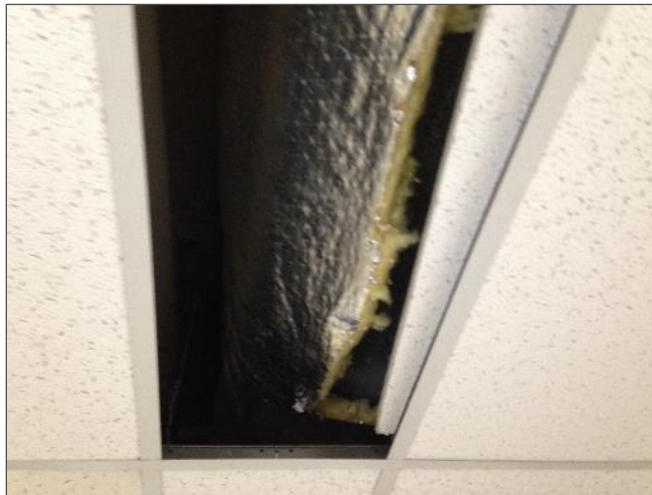
Photo 3: Ducts insulated with non-asbestos containing fiberglass insulation, Hallway (Location 117).

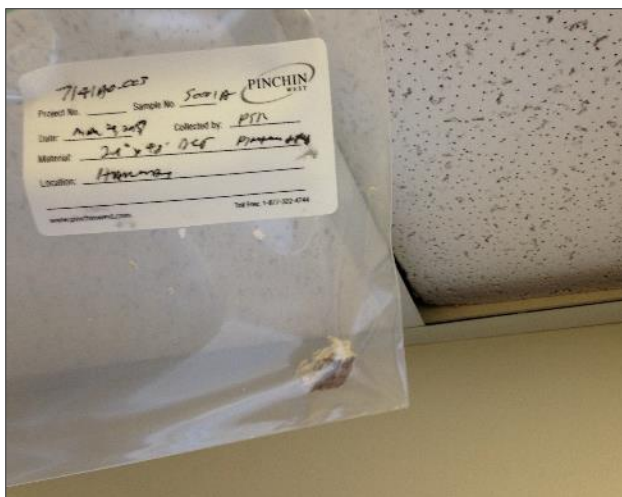
Photo 4: Acoustic Ceiling Tile, 24"x48" Pinhole and Fissure (Sample S0001A-C) Hallway Location (117).

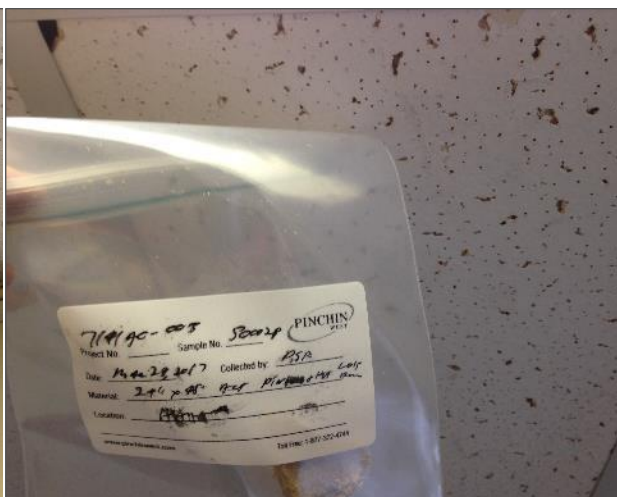
Photo 5: Acoustic Ceiling Tile, 24"x48" Pinhole and Fissure "Pattern less dense" (Sample S0002A-C) Hallway Location (117).

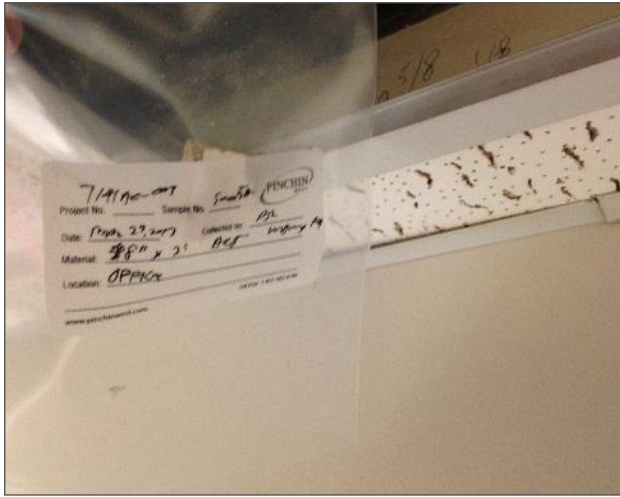
Photo 6: Acoustic Ceiling Tile, 24"x48" Pinhole and Wavy Fissure, (Sample S0005A-C) Office Location (119).

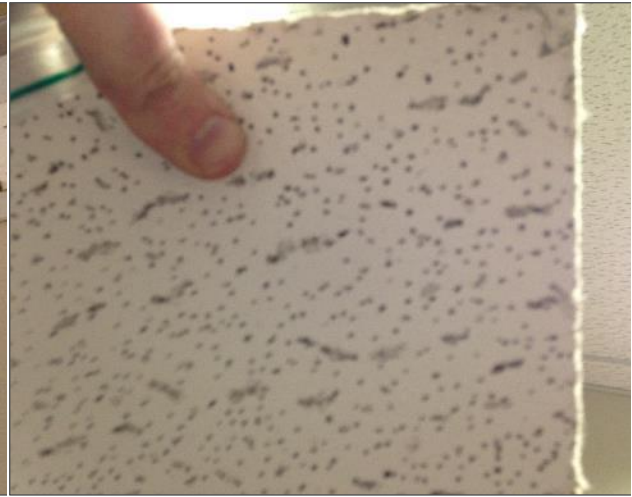
Photo 7: Acoustic Ceiling Tile, 24"x48" Pinhole and Fissure, Date Stamp 05/13/13, Office Location (119).

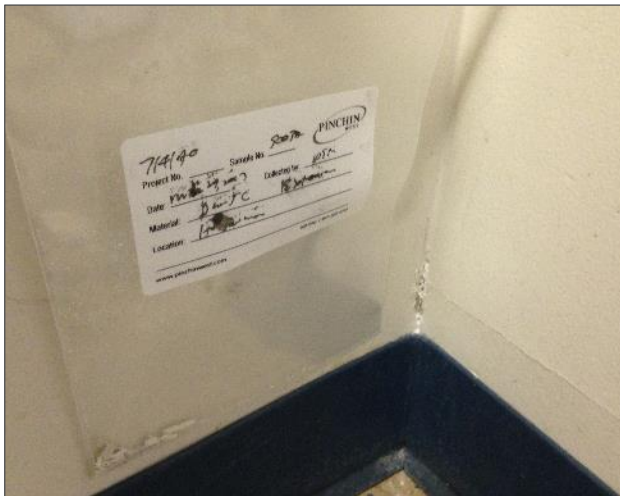
Drywall (gypsum board) and drywall joint compound is present as a wall finish in the Greenhouse and Trades Office building. Based on the results of the testing on exterior walls (samples S0003a-c) and the interior wall that separates office 119 and 120 where the data drop will be (samples S0004a-c), the drywall joint compound in the assessed area does not contain asbestos.

Photo 8 - Drywall Joint Compound on exterior walls (Sample S0003A-C) Hallway Location (117)

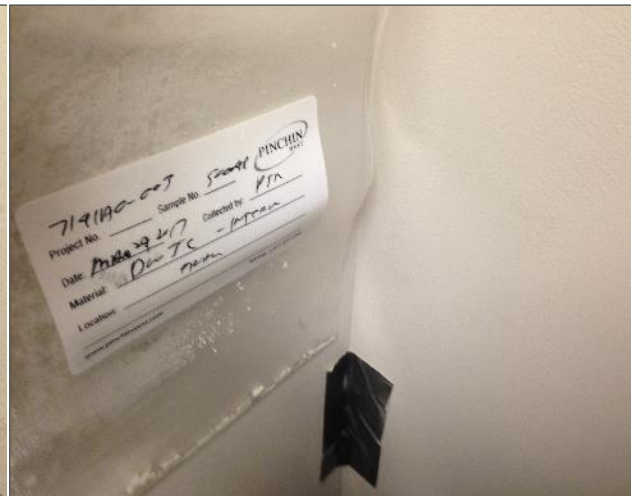
Photo 9 - Drywall Joint Compound on interior walls (Sample S0004A-C) Office Location 119
